EXHIBIT E-3

Galli Group

Photo Log of Failing Embankments

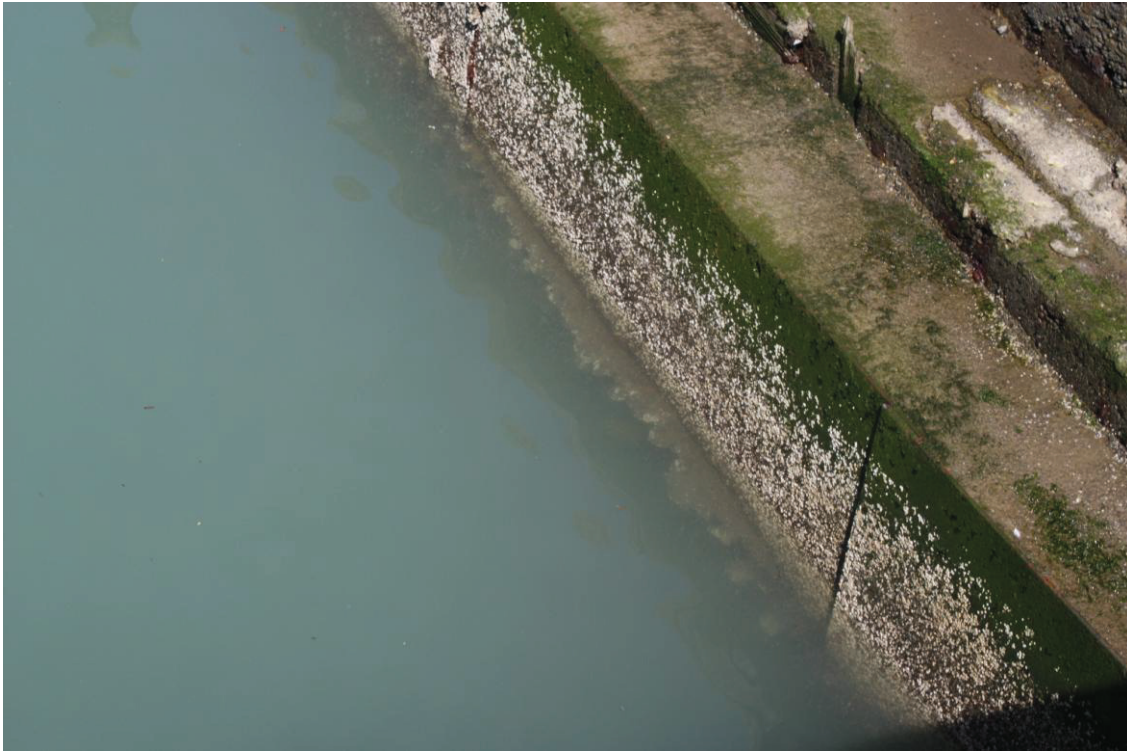
PHOTO 1: Note Undermining of Footing

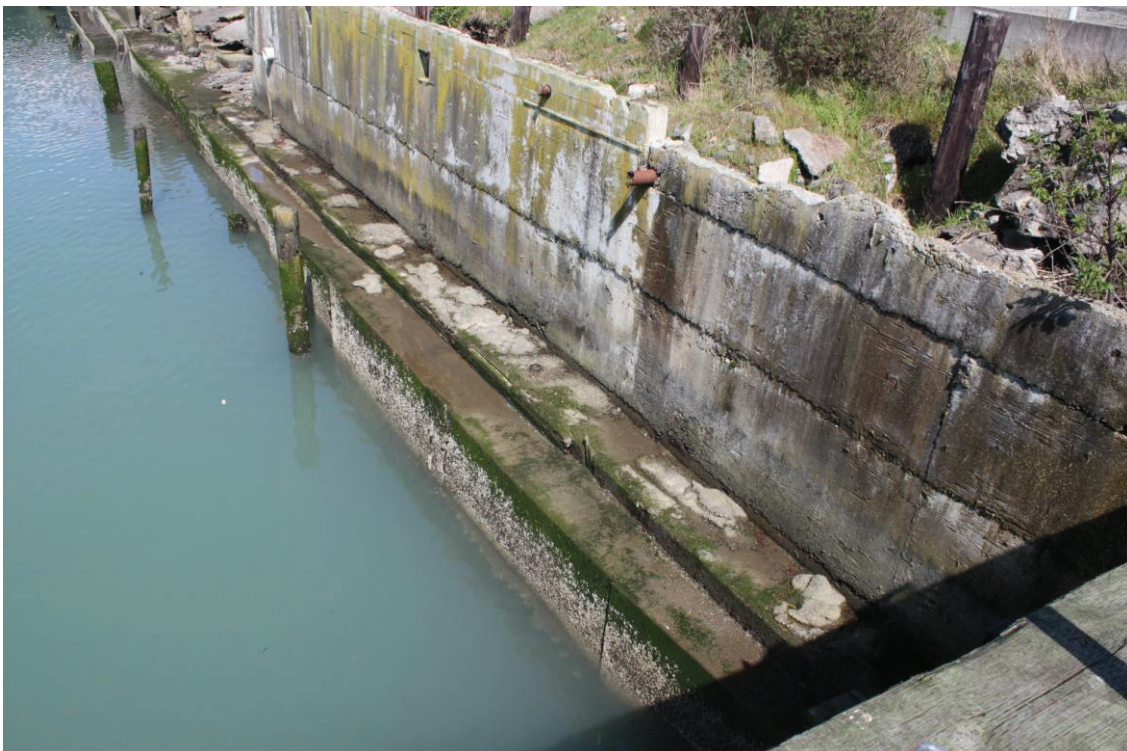
PHOTO 2: Seawall with Scour Beneath Footing
