# **EXHIBIT E-5**

**EMC-Engineers/Scientists**  
**Preliminary Dock Analysis**

**MEMO-11917-01**

To: Gary Dehlinger  
Manager, Port of Brookings  
From: Jack Akin  
EMC-Engineers/Scientists, LLC  
RE: Landing to the Port Fuel Dock

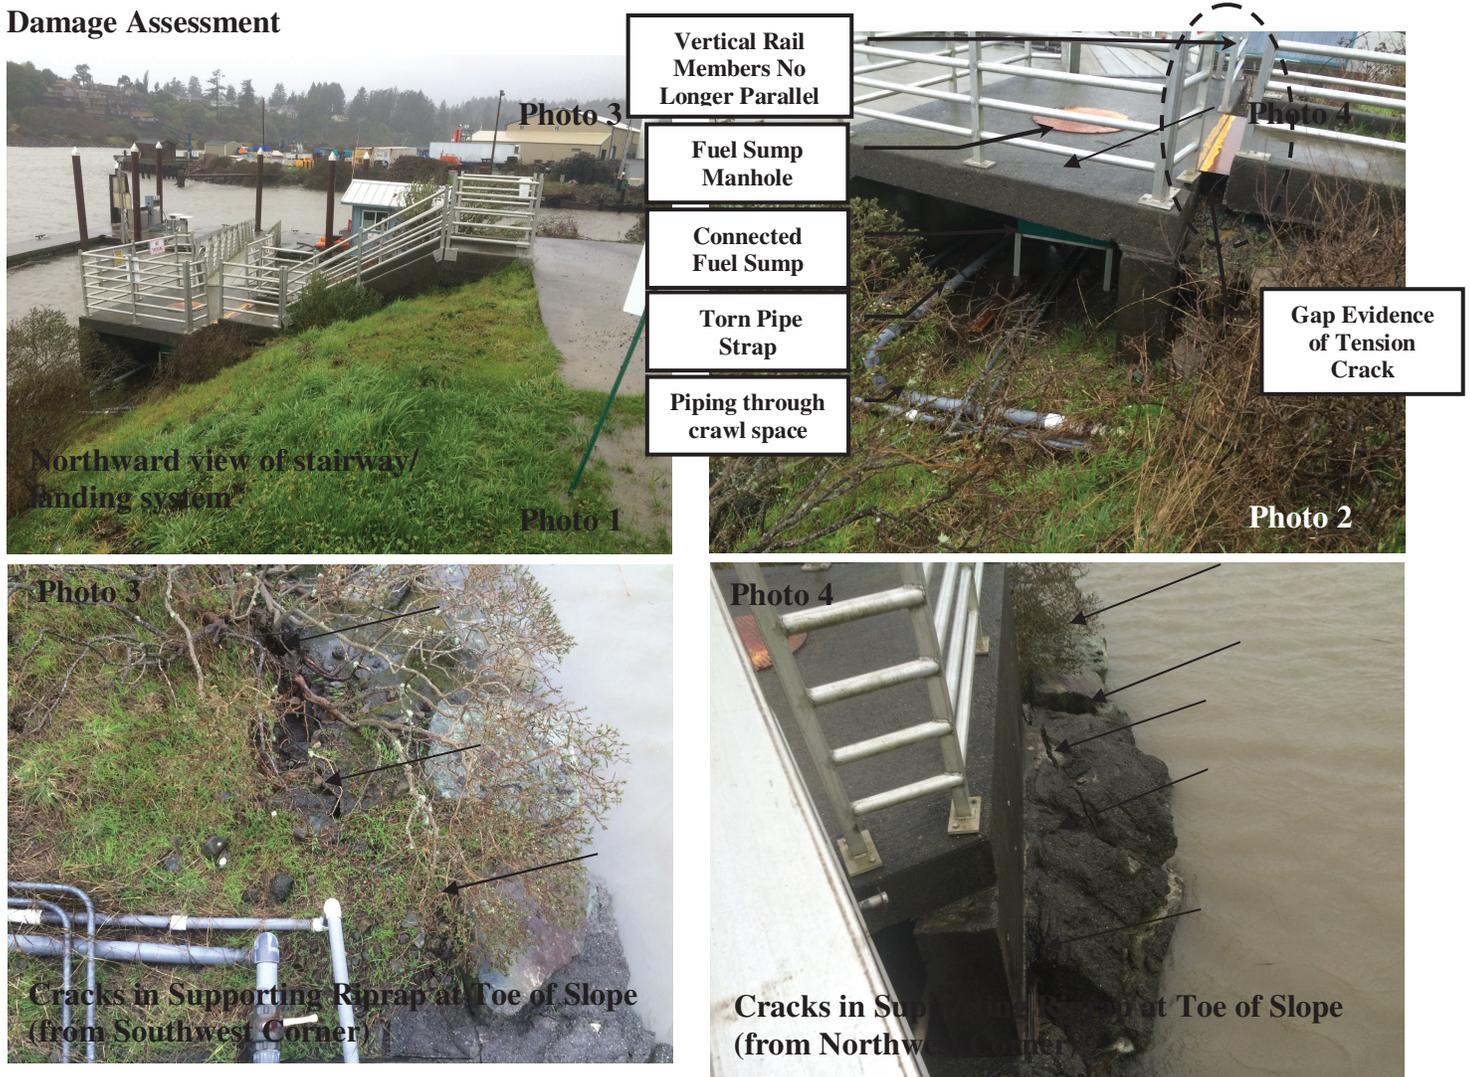
The pad, underlying support soils and rip rap are failing along a slip surface estimated to be located as shown in the attached **Exhibit A**. This slip surface is estimated to be a sector of about 26 feet from the theoretical center of moment, which provides a surface resisting force of about 30 feet in length. It is noted that the lowest elevation of the slip is several feet higher than the designed H-beam support. Resisting force was designed to have been provided by the cohesion of soils and rock beneath the structure, rip rap at the toe and the five W12 x 53 piles. The unsaturated load is roughly estimated to be about 76 tons, which is the primary disturbing force. Indications of the failure of the supporting soils and rip rap can be seen in **Photo 3** (cracking as viewed from the southwest pad corner) and **Photo 4** (cracking as viewed from the northwest pad corner).

The resulting slipping of the entire pad system (concrete pad, underlying fill, riprap and native soils) is shown in **Photos 1 and 2**. **Photos 1 and 2** are northward views of the pad and stairway approach, and **Photo 2** provides a closer look at the pad and its connection to the stairway. As is noted on this photo, a tension crack on the east side of the pad has developed, creating a gap between the stairway approach and the pad (note the metal plate temporarily placed to prevent trip hazard). The separation is also indicated by the fact that the rails bolted to the stairway approach and to the pad are no longer parallel as shown in **Exhibit A**. The sliding of the entire pad system, including the concrete support, is also noted by the pull-away of the piping from its brackets. It appears that soil saturation from pour water and seepage has adequately reduced the soil cohesion factor, and increased the weight of the normally unsaturated soils by as much as 12 lbs./cubic foot (over 300 lbs/cy).

This preliminary structural analysis concludes that the identified disturbing forces are greater than the available resisting forces of this system. Therefore the safety factor is less than one and the total failure of this slope is eminent. Excessive soil saturation and resulting soil weight and loss of cohesion appear to be at the root of the failure. The resistance against lateral slipping is limited to the cohesiveness of the soils, strength of the toe and pinning to supporting riprap. Since a considerable loss in cohesion and cracking in the toe riprap has occurred, only the weight of the pinned riprap remains to hold the pad in place. Since the slip surface is below this pinned riprap, it provides little resistive force against failure. It must be noted that if the H-beams had been placed according to the original design, the lateral support provided by the beams would have been adequate to prevent this failure. The beam design, as can be seen in **Exhibit A**, shows these columns driven to an elevation below extreme low water and well below the estimated slip surface.

The existing slip of the system westward will continue. When full failure occurs the attached lines and conduit are likely to be severed. Additionally, the gangway approach to the fuel dock from the pad would be damaged and possibly lost. It appears that the potential loss of fuels (spillage into the waterways) is limited by fuel tank dispenser controls and the piping configuration from the tanks. Properly working anti-siphon valves are assumed to be located in the piping beneath the fuel pumps at the tanks.

- 1) The fuel lines attached to the failing system be drained and blinded (or disconnected);
- 2) public access to the system be prohibited, and appropriate signage be placed, employees should minimize the use of the landing access to the fuel dock, when use is deemed necessary employees must use this access with extreme caution, and the potential safety hazards must be communicated in writing to all employees permitted to use the access;

- 3) failure of this system is likely to occur along the slip surface identified on **Exhibit A**, and consequently such options as tieback, helical supports, etc. are not recommended without removal of the existing concrete landing and loosened underlying soils and riprap, and slope stabilization;

- 4) tieback/deadman system, correctly designed, could then be placed in lieu of H-beam pile, if underlying soils/rock cannot be penetrated;
- 5) if piles are used, penetration should be designed and should be driven to several feet below the theoretical slip surface, noting that the slip surface shown in **Exhibit A** is a preliminary estimation, and a more thorough analysis would be required if H-beam support is elected and
