# **Port of Brookings Harbor**

## **WEEKLY OPERATION REPORT**

**DATE:** Sunday 03/27/17 to Saturday 04/01/17

To: Gary Dehlinger  
Manager, Port of Brookings  
From: Jack Akin  
EMC-Engineers/Scientists, LLC  
RE: North Basin Boardwalk

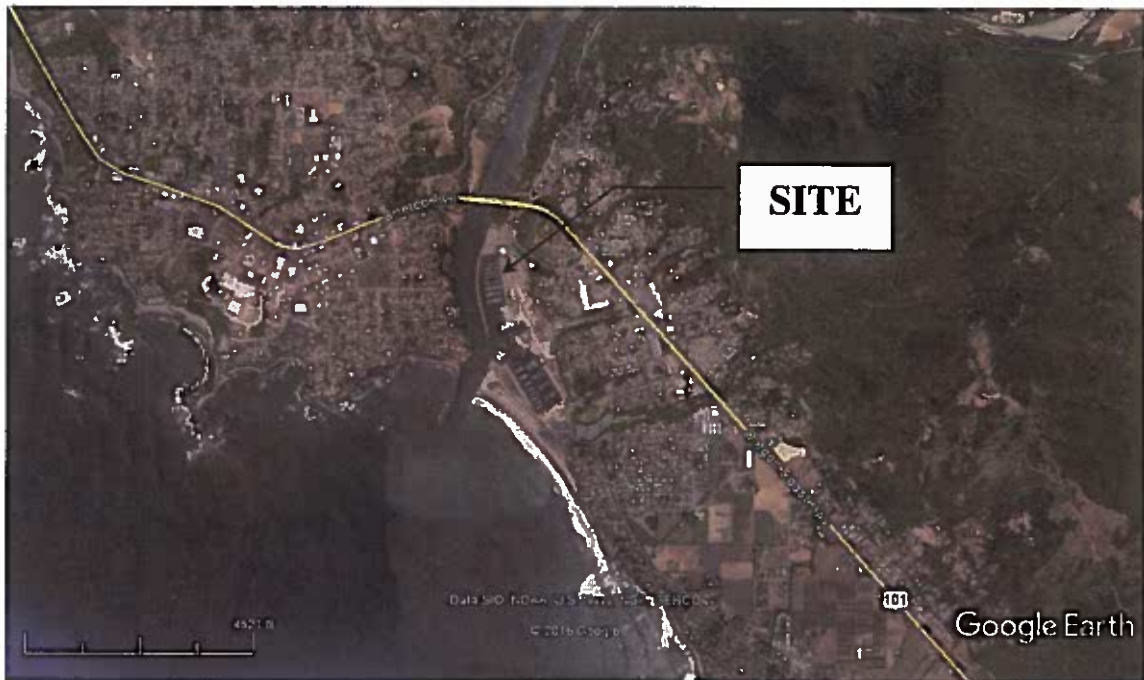
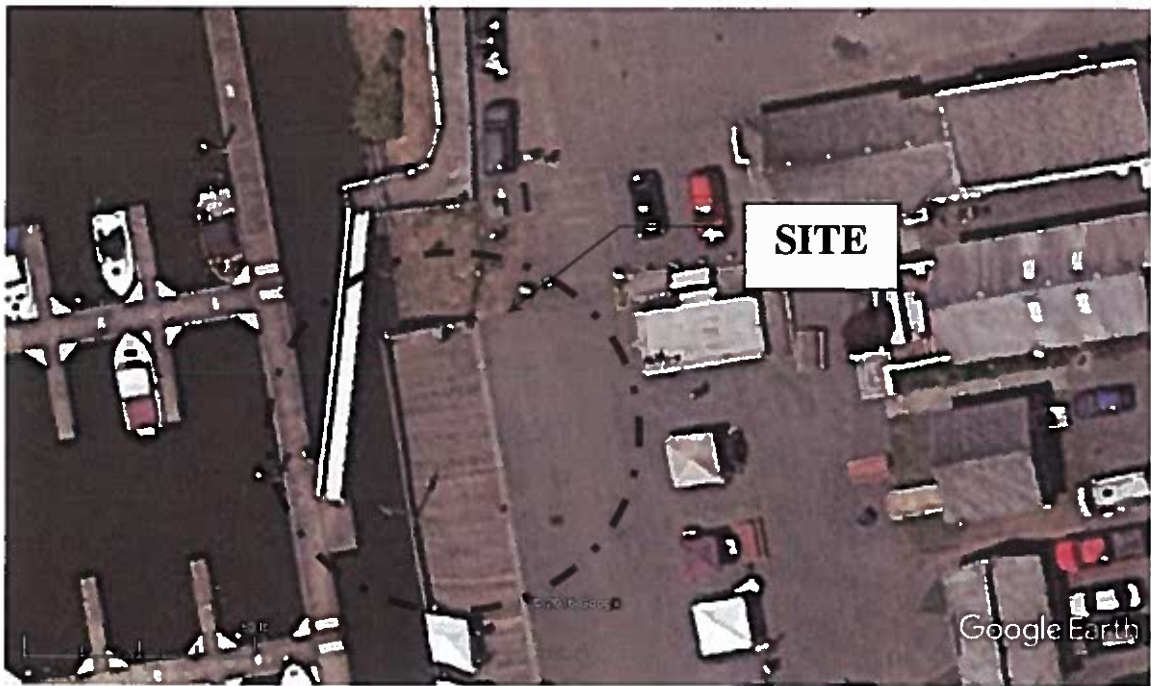
**Exhibit 2 - NORTH BOAT BASIN BOARDWALK**

Though some loss is indicated, this backfilled section of the sideslope profile appears fairly stable from north to south beneath the boardwalk, except in the damaged north area. This north area, seen in the foreground in the top photo of Exhibit 2, shows considerably more soil loss in the assumed fill area. This area is also nearly entirely outside of the deck and is exposed to stormwater. It also appears that the soils in this area have to some extent lost some of its cohesion and pressed against the retaining wall. Subsequently the wall sections have been pressed against the H-beam supports and moved the wall to press against the outer piles (see Exhibit 5).

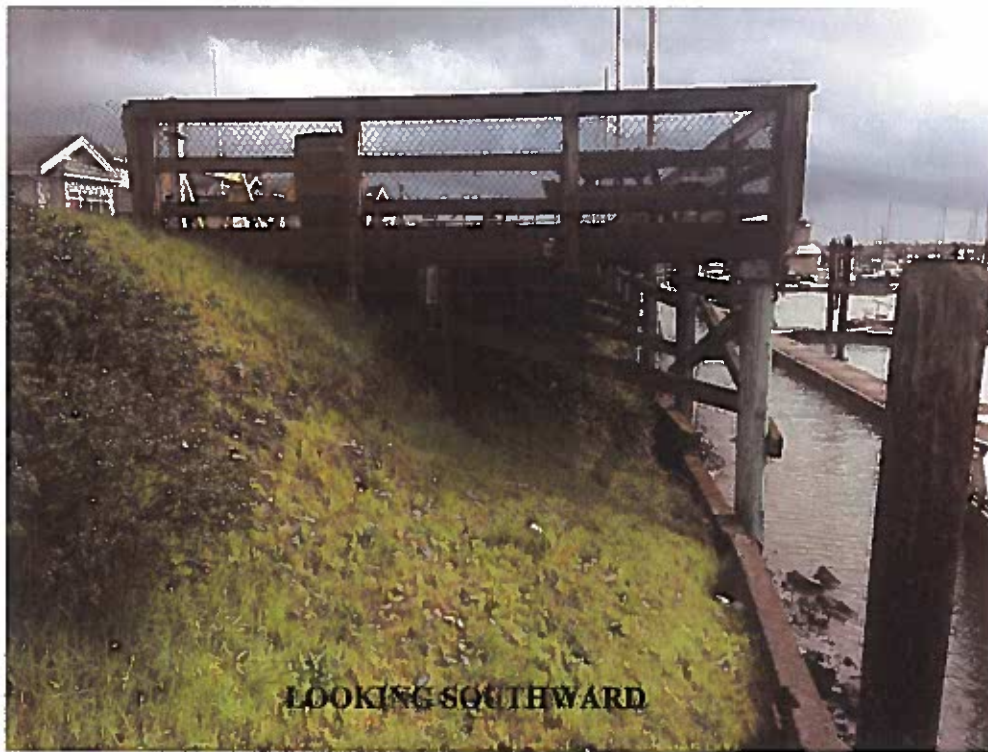
**LOOKING SOUTHWARD**

The boardwalk is a wood structure supported and anchored by 16" dia. wood piles. The piles were driven to an unknown depth. The walking deck is of 2" x 12" x 20' planks and rests atop two rows of piles as seen in the attached photos (see Exhibit 2 for southward and eastward views, and Exhibit 3 for a better view of the deck sub-structure). Lateral support against live-loading is provided by pile-to-pile 4" x 10" cross-bracing. The outer pile row is driven into the Port basin mudline, and the inner row through the soils comprising the slope.

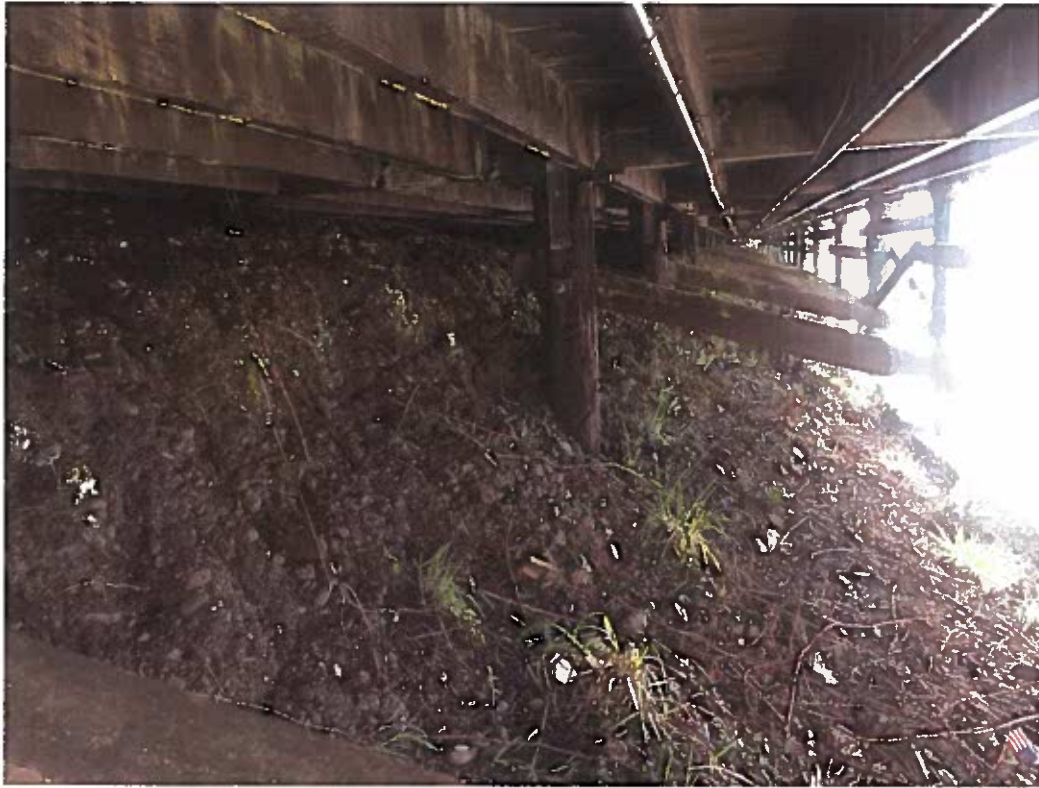
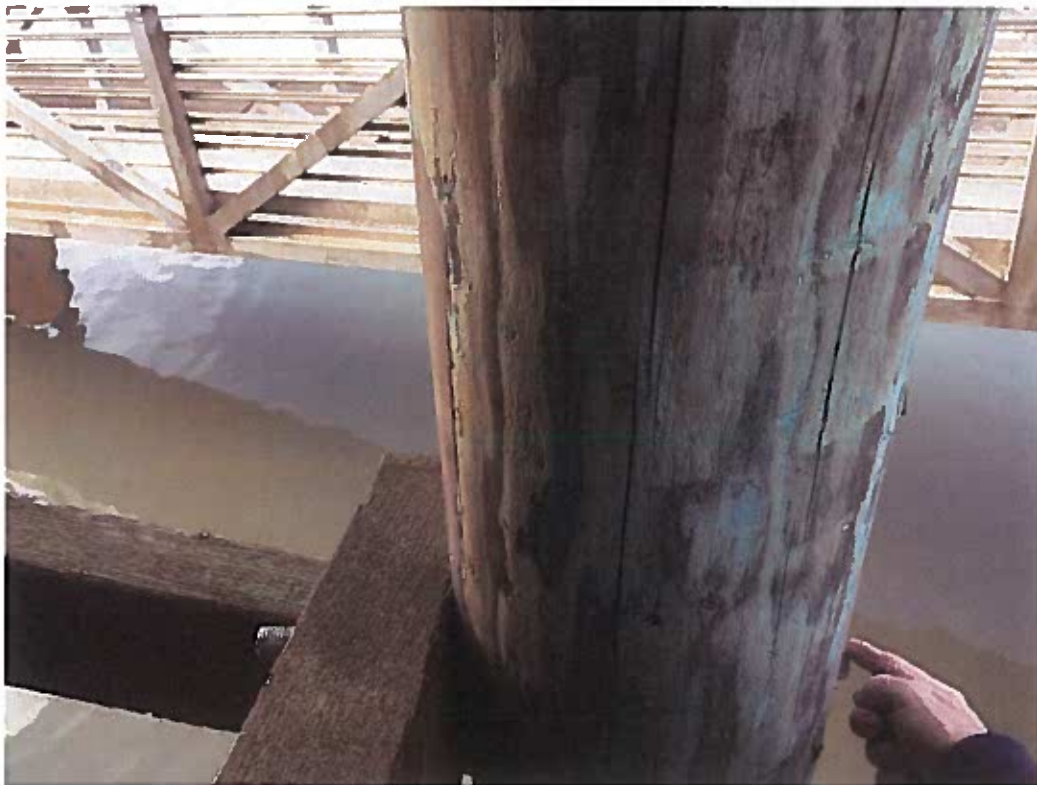
**EXHIBIT 3 – BOARDWALK SUPPORT STRUCTURE**

As seen in Exhibit 4, a stress crack has developed between the boardwalk and the bordering concrete sidewalk slab. The crack shows a movement westward of the boardwalk structure itself. The NW corner of the concrete sidewalk slab and anchor bolt on the deck NE corner, as seen in the lower photo in Exhibit 4, has been broken away. The bolt pinning the 4" x 10" cross-brace (connecting the inner pile to the outer pile on the north end of the deck) appears to be slightly bent off-center (see lower photo in Exhibit 3).

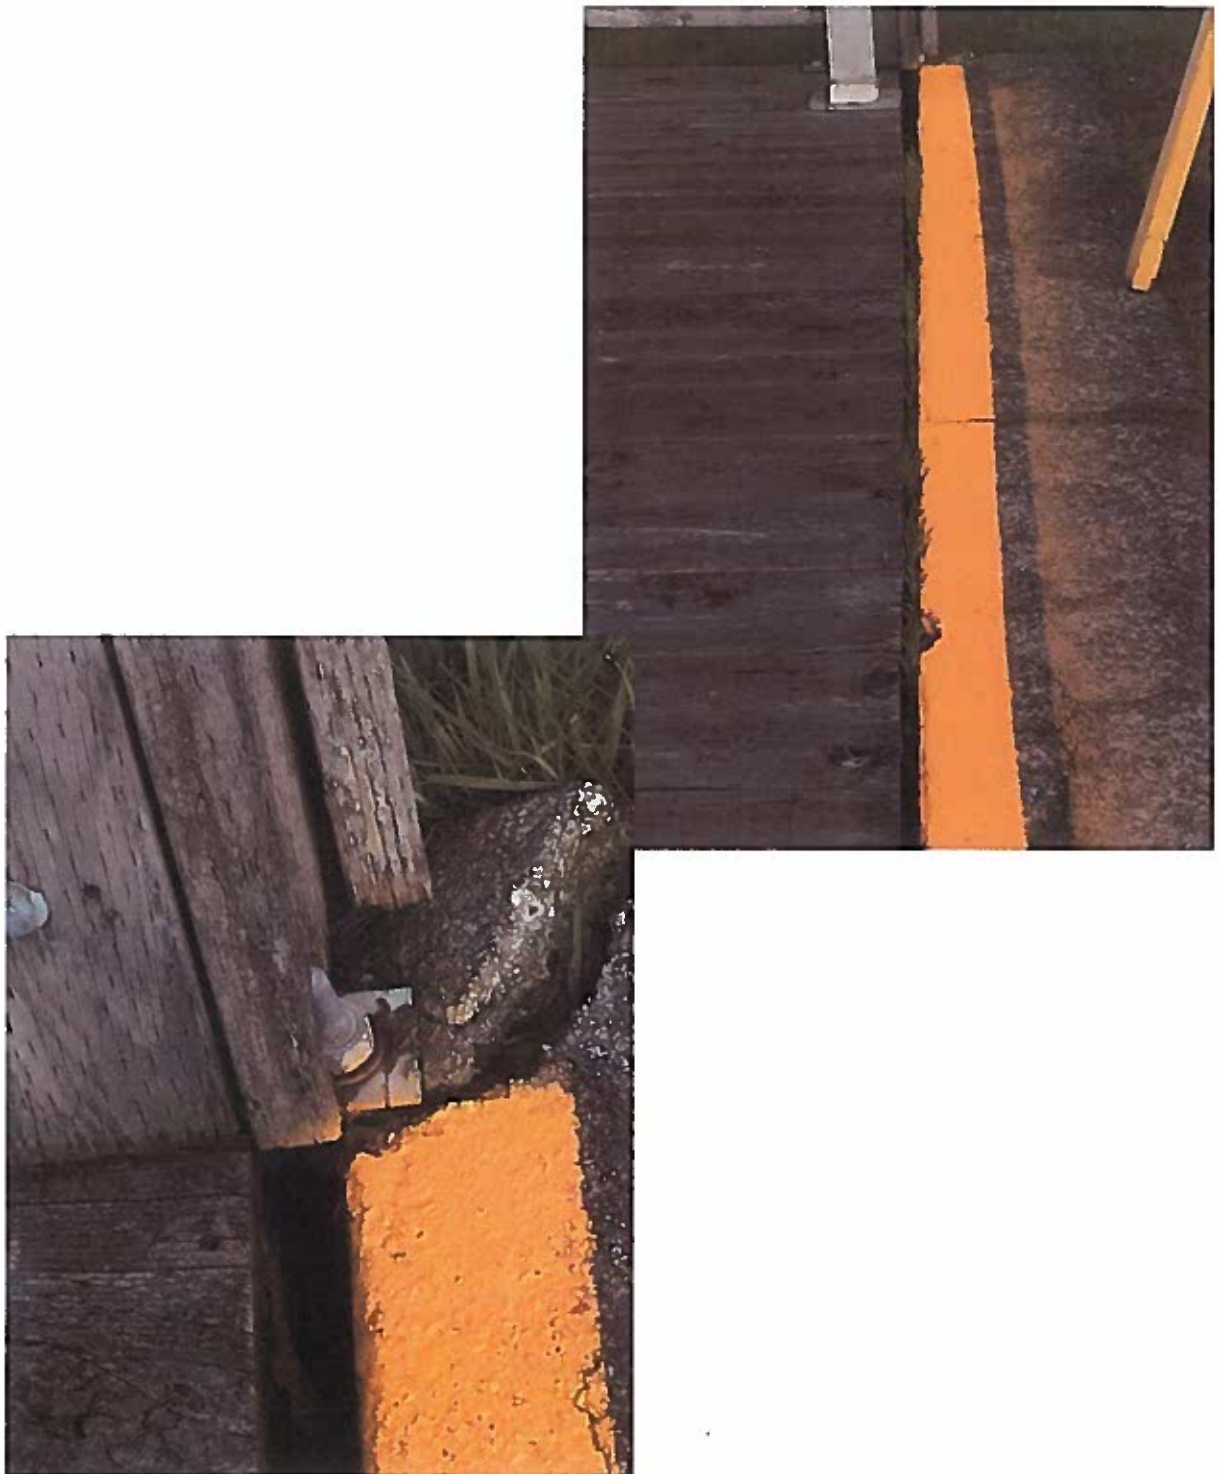
Exhibit 4

STRESS CRACK AT TOP OF DECK

Meanwhile it is recommended that a bi-weekly inspection (going to weekly if no significant crack width or length is observed after six observations) be logged that would include 1) width and length of stress crack shown in Exhibit 4, and the condition of Pins A and B, shown on the first page of Exhibit 7. If the crack increases to a width of six inches or greater, or if Pins A and/or B fail, a qualified professional engineer should be consulted immediately.

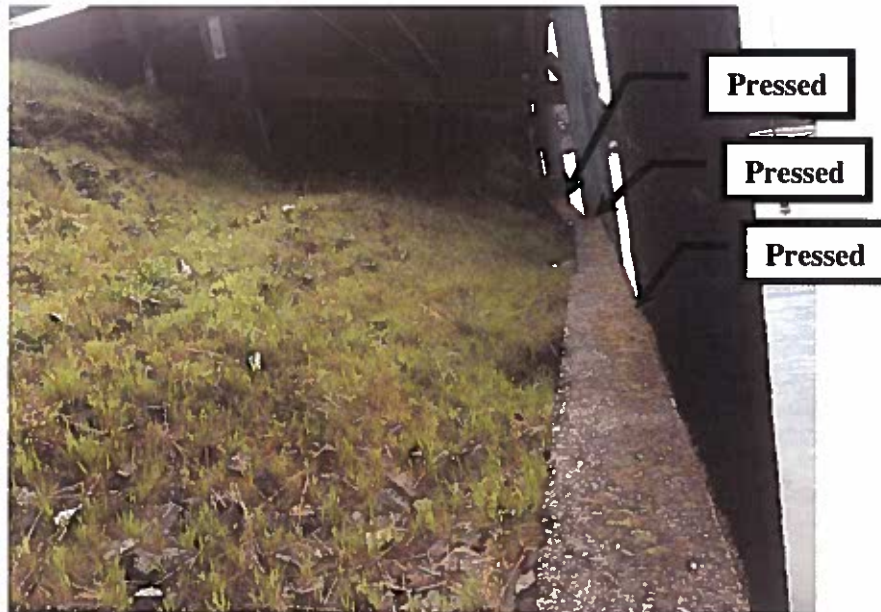
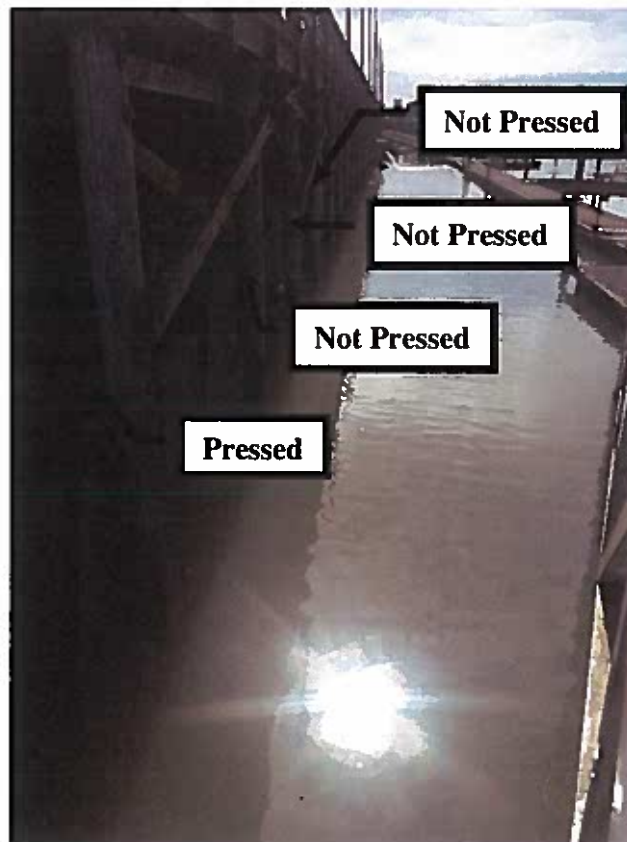
The slope stabilization and boardwalk systems are observed to be designed and to have been constructed as two entirely independent systems. The retaining wall sections observed southward of the damaged areas appear vertical, more or less level, and are not pressed against the deck-supporting outer row of wood piles (see Exhibit 5).

**Exhibit 5 CONCRETE WALL SECTIONS PRESSED AGAINST SUPPORT COLUMNS**

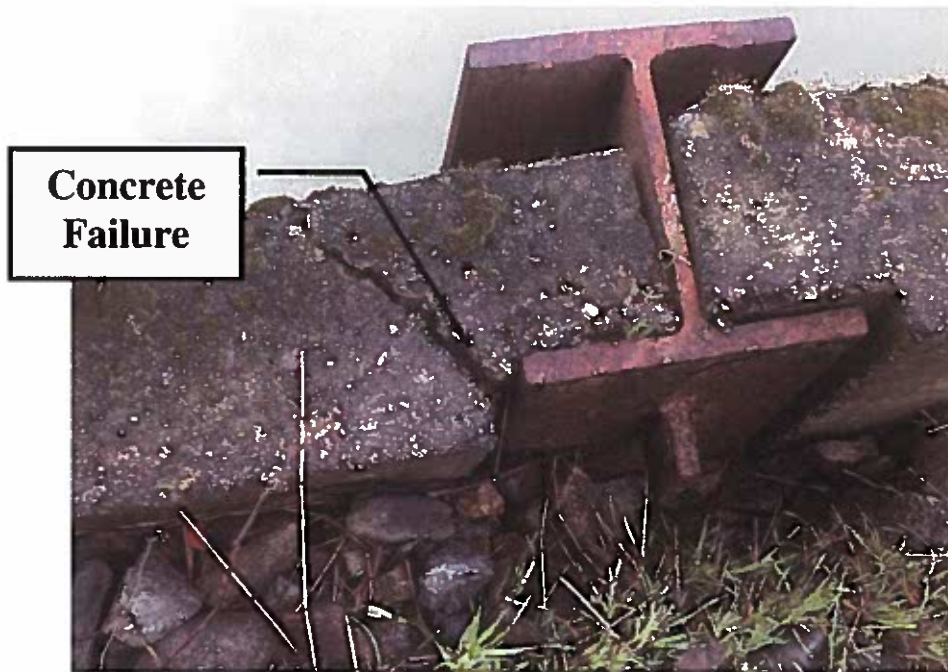
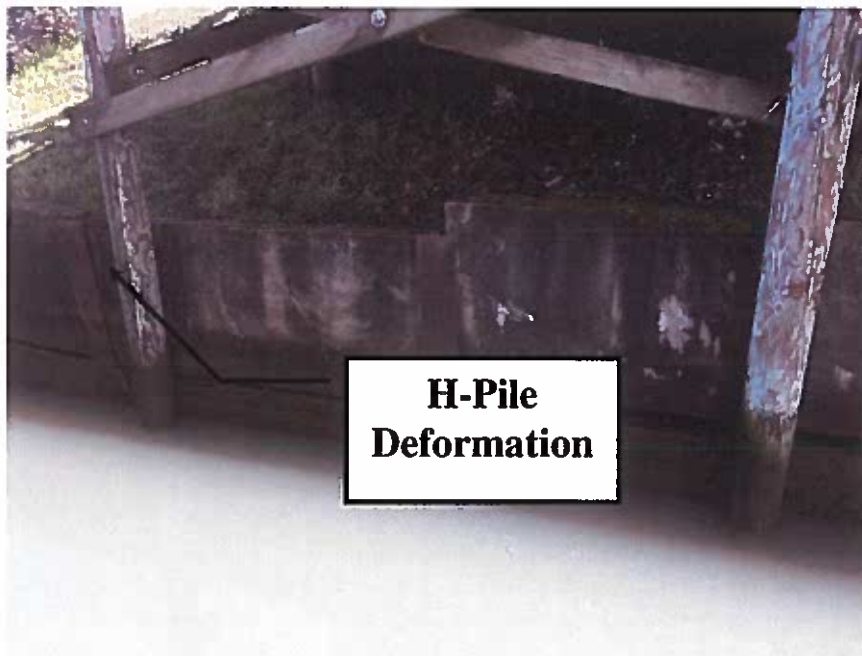
**Exhibit 6**

The soil slope beneath the deck is retained by 4 inch thick concrete wall sections that are supported by steel H-beams that have been driven to an unknown depth into the Port basin mudline (see Exhibit 6 upper photo for a top view of beam-concrete wall section system). The side slope native soils (see excavator tooth-marks in top photo of Exhibit 3) seem to have originally been excavated to above the elevation of the inner row of piles, and then, after construction of the concrete panel/H-beam system, the rest of the slope to the wall was backfilled. Plastic sheeting appears to have been placed beneath the top four feet or so of the backfill. This assumption is only based on the observation of plastic sheeting protruding out beneath the top concrete panel section along the west face of the wall.

**CONCRETE FAILURE AT H-PILE**

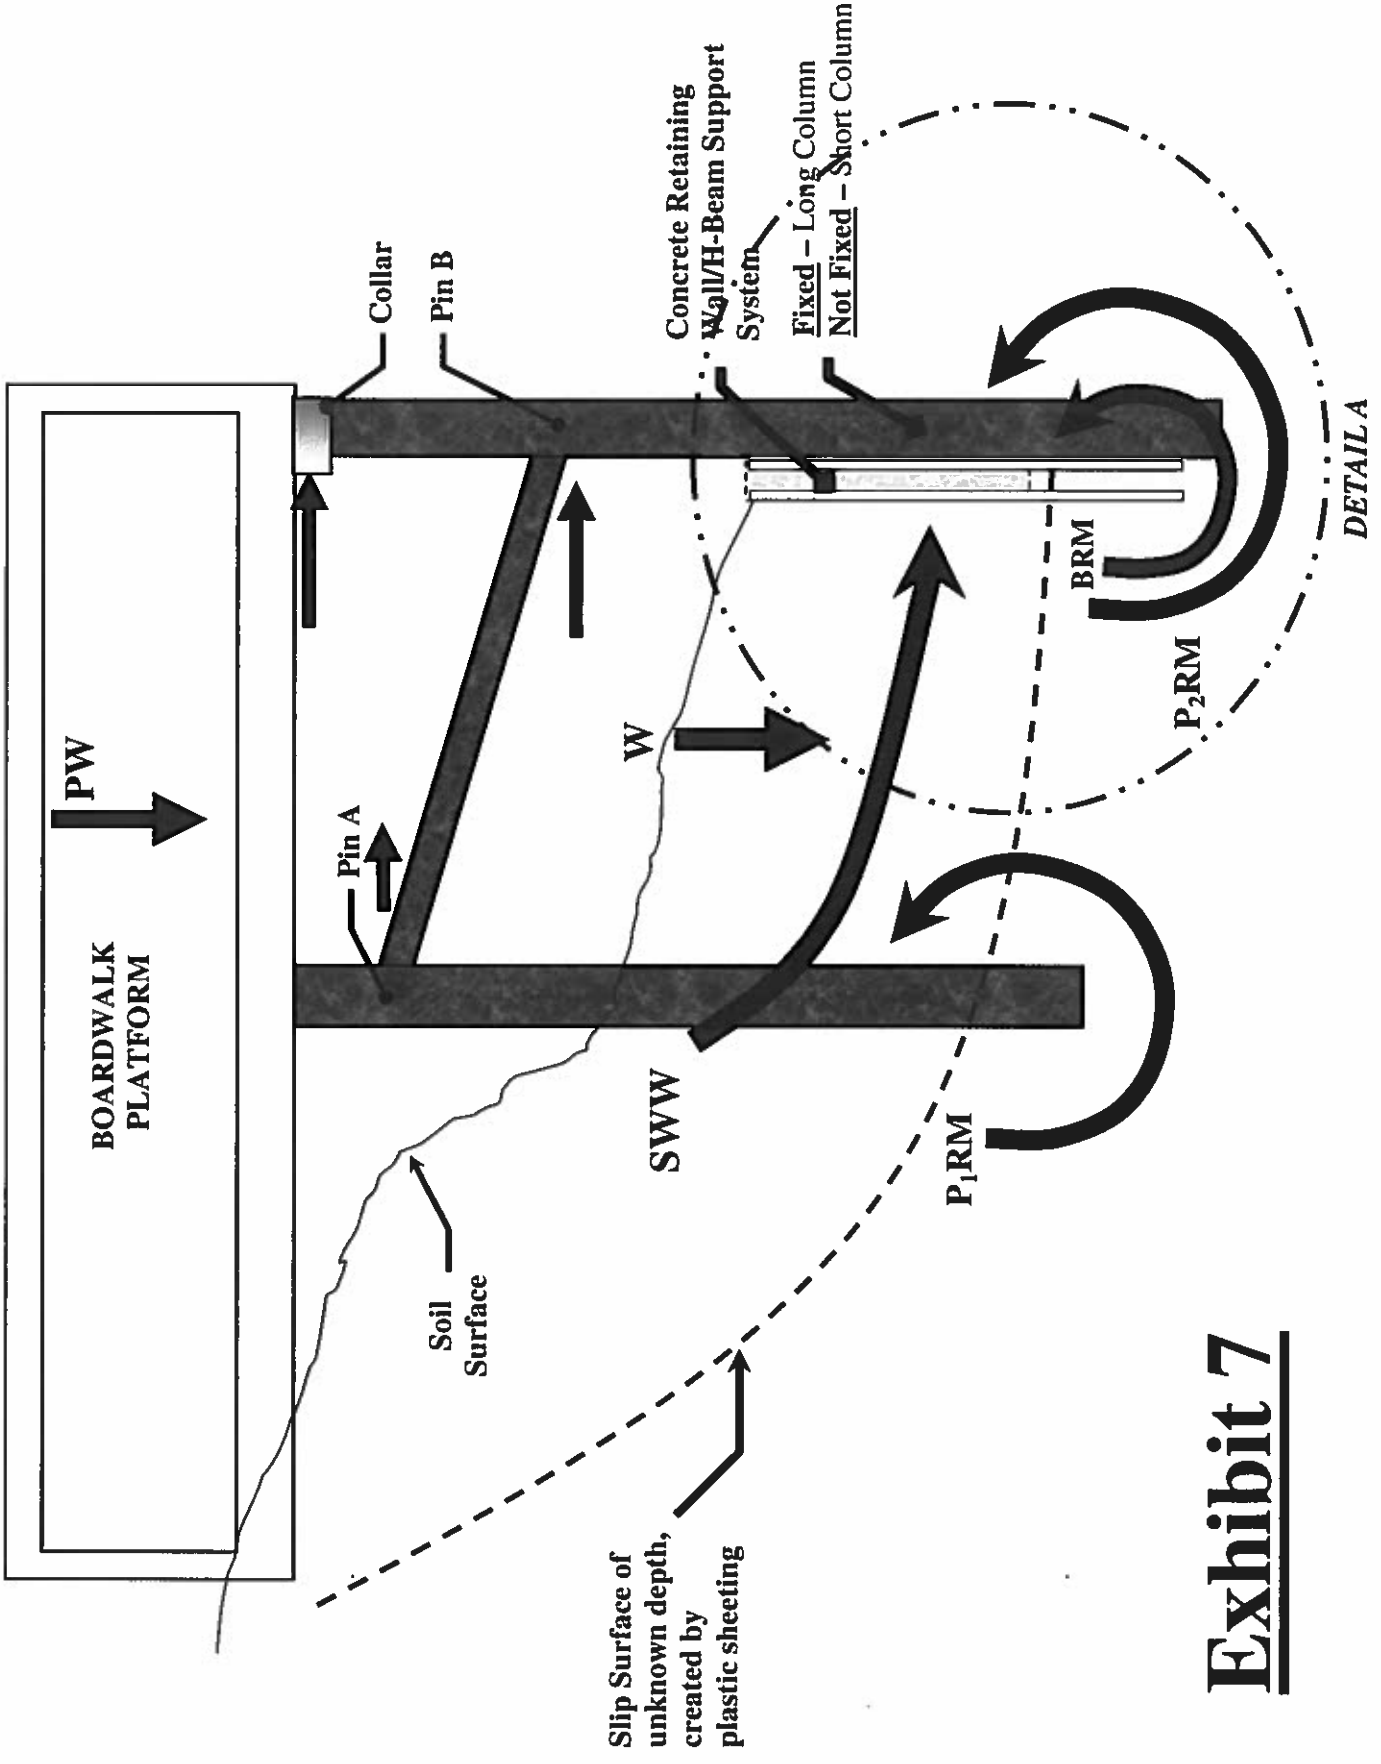
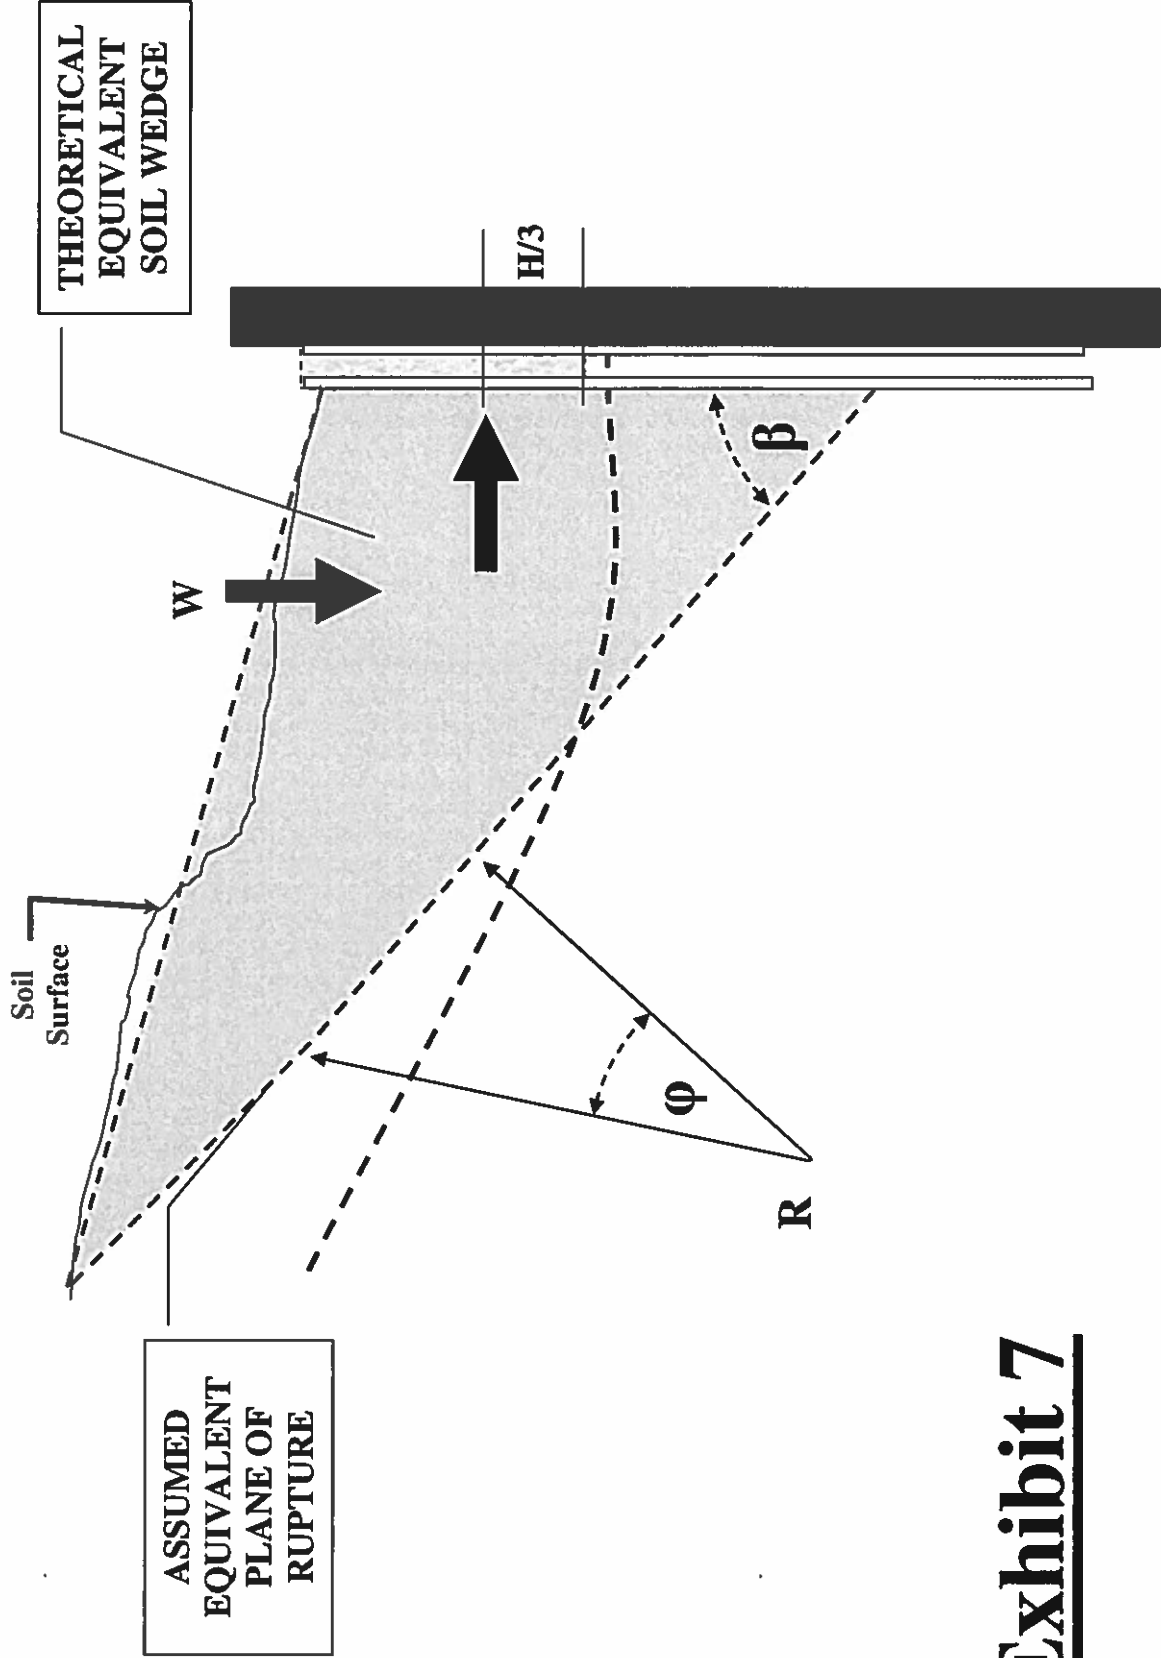
# Exhibit 7

For preliminary purposes only, a Rankine analysis is taken, utilizing backfill slope and internal soil friction angles, both conservatively estimated to be 30 degrees. Thus a horizontal  $K_a$  of 0.75 is estimated. Projecting a plane of rupture per Rankine-derived theoretic equivalent soil wedge (see figures in Exhibit 7), a soil load of about 3500 psf (25 psi) is assumed to be retained by the concrete sections. Since the larger sections are assumed to be 10 feet wide, the walls are rigid, and are supported at both ends by the H-piles, 35,000 pounds are assumed to be supported at each edge, to result on a uniformly loaded 260 psi along edge, after adding 2000 pounds from the concrete panel. Shear strength of the weakest concrete (about 870 psi) after adding 2000 pounds from the concrete panel is more than adequate design against this slope.. A W-6 H-beam with 36 ksi  $F_y$  of 25' in length (estimated to be a minimum of 10.2 kips from a point of fixity) can be assumed to adequately support this load.

The wedge theory suggests that a triangular wedge of soil would slide down if the retaining wall was removed suddenly and the wall has to sustain this wedge of soil. Exhibit 7 shows free body lateral forces acting on retaining walls.

The Rankine method of Lateral Earth Pressure Calculation is selected for the purposes of this report (see 2<sup>nd</sup> page of Exhibit 7: Free body of lateral forces acting on retaining wall).
