**Commercial Building “Green Building”
Request For Proposals
DUE January 22, 2019**

Commercial/Retail Building

Prepared by
Eagle Two Development Corporation
March 30, 2011

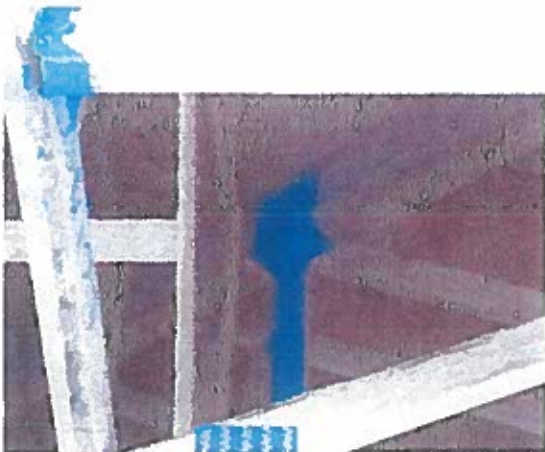
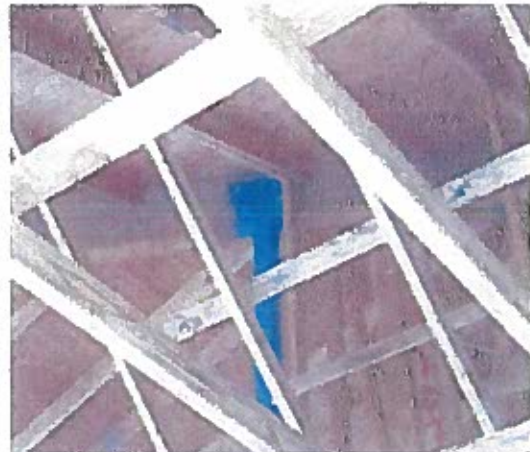
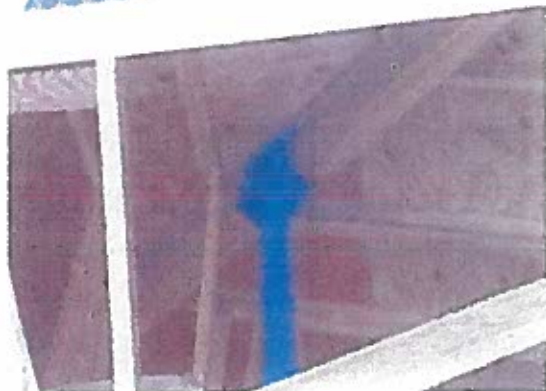
In our discussions with the Curry County building officials and after examination of the inspection reports it was concluded that only two official inspections were made and include a stem wall pour and the roof. A courtesy inspection of the framing of the building was performed and found that the framing had not been constructed in accordance with the engineered framing plan. The main issue appears to be the notching of laminated beams at the posts located along the four corners of the roof (see pictures below). It appears that no further work on the building took place after this time.

These pictures are of the corner roof trusses. As can be seen here the beams have been improperly notched to fit the upright support piers. A structural engineer may be able to design an adequate support without removing the beams. If not, the beams may need to be replaced.

Prior to continuing any inside construction a structural engineer will need to determine if the integrity of the framing has been compromised and if so how or if it can be repaired. Once a structural engineer determines the framing is safe a report of such will need to be submitted to the County for review and approval.
