January 21, 2017 Storm Damage

PORT OF BROOKINGS HARBOR

BASIN 2 DOCK REPAIRS

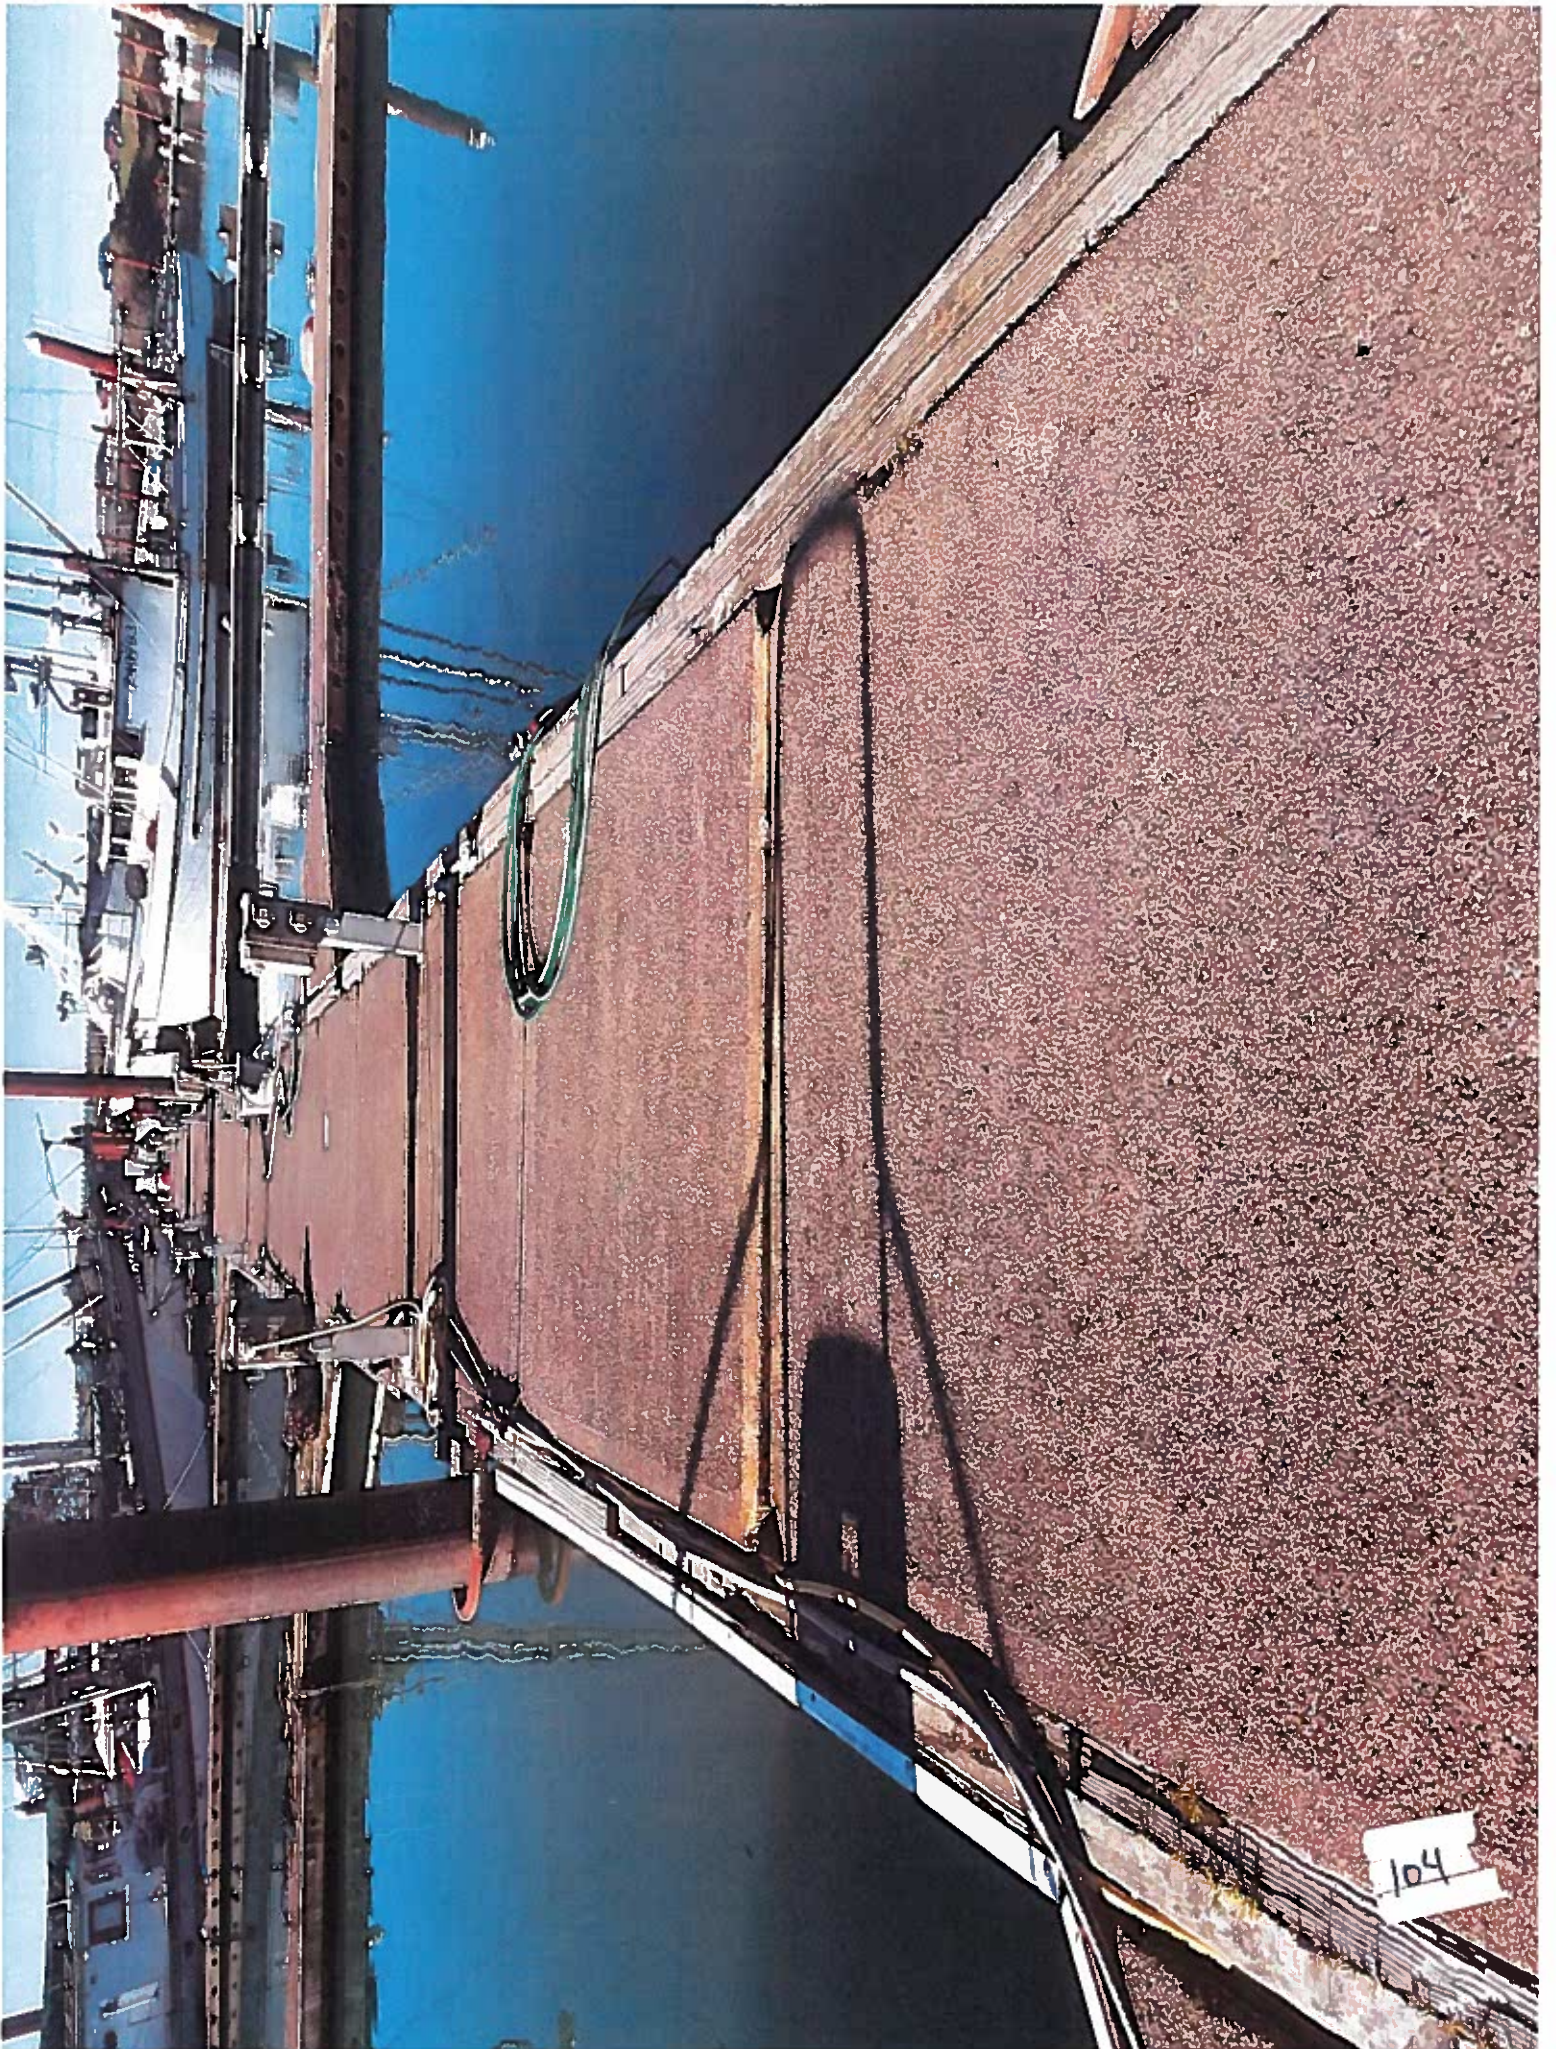
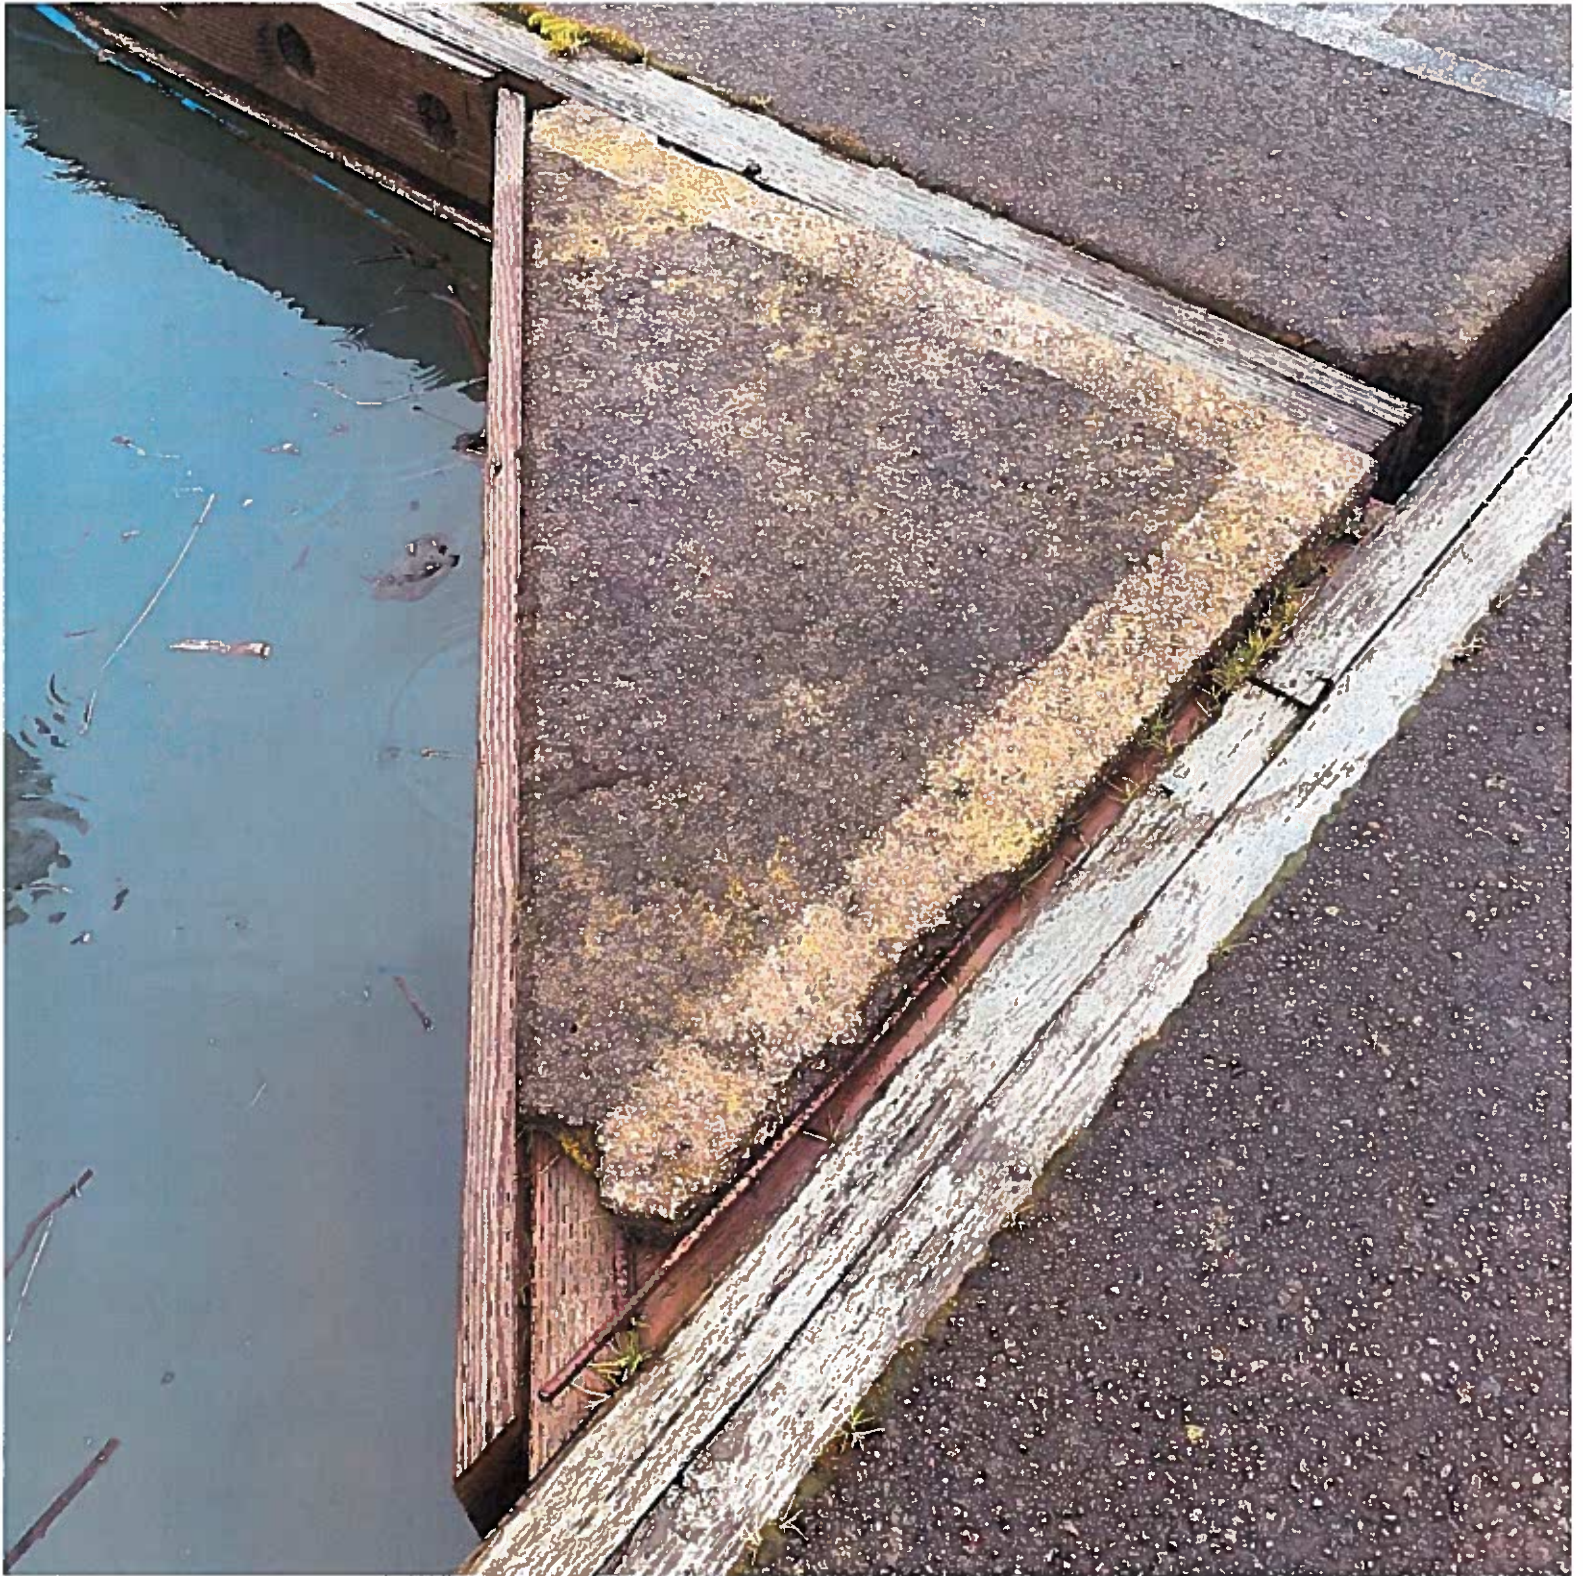
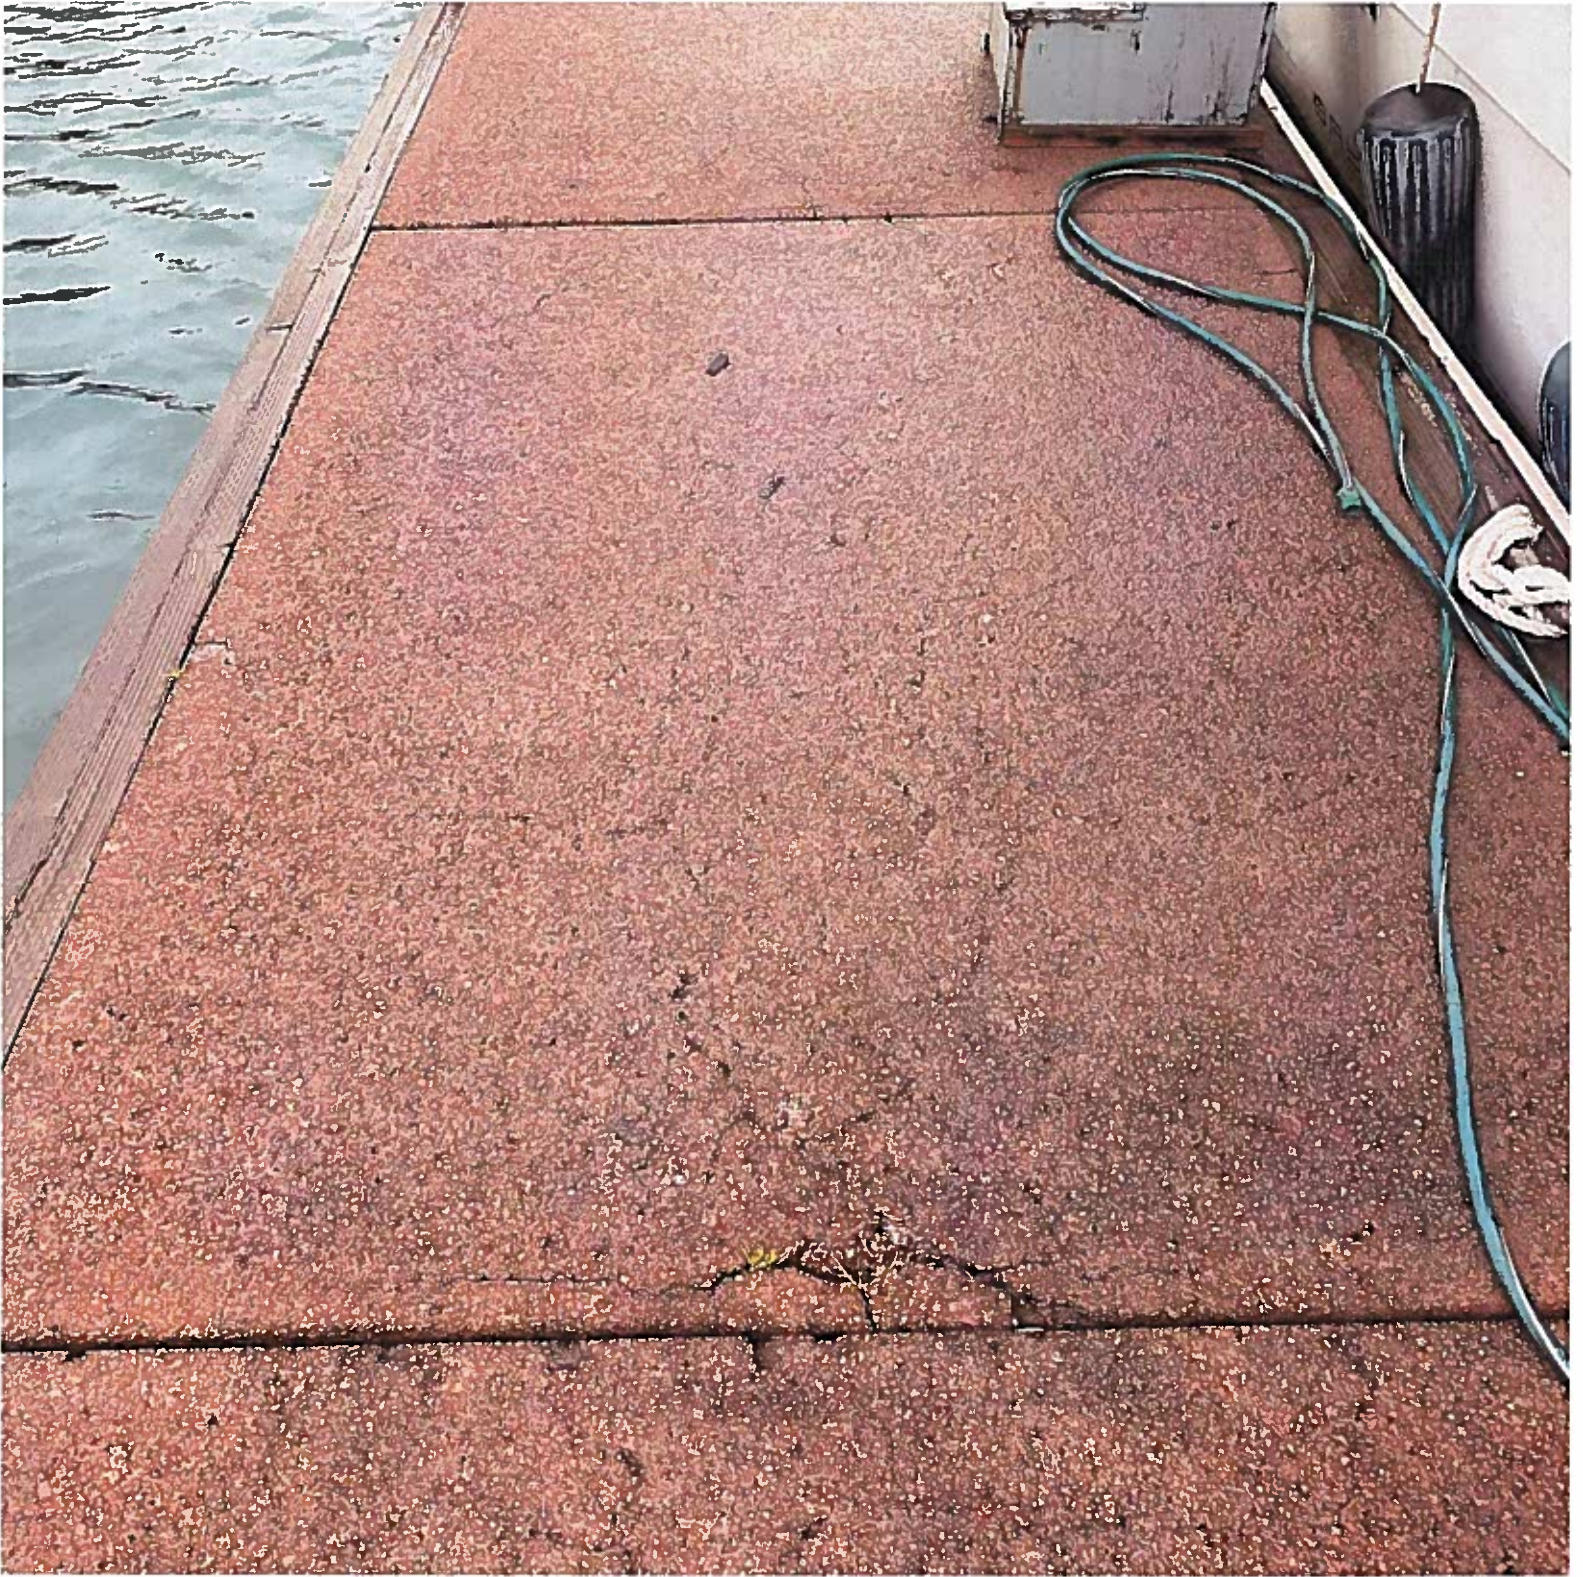
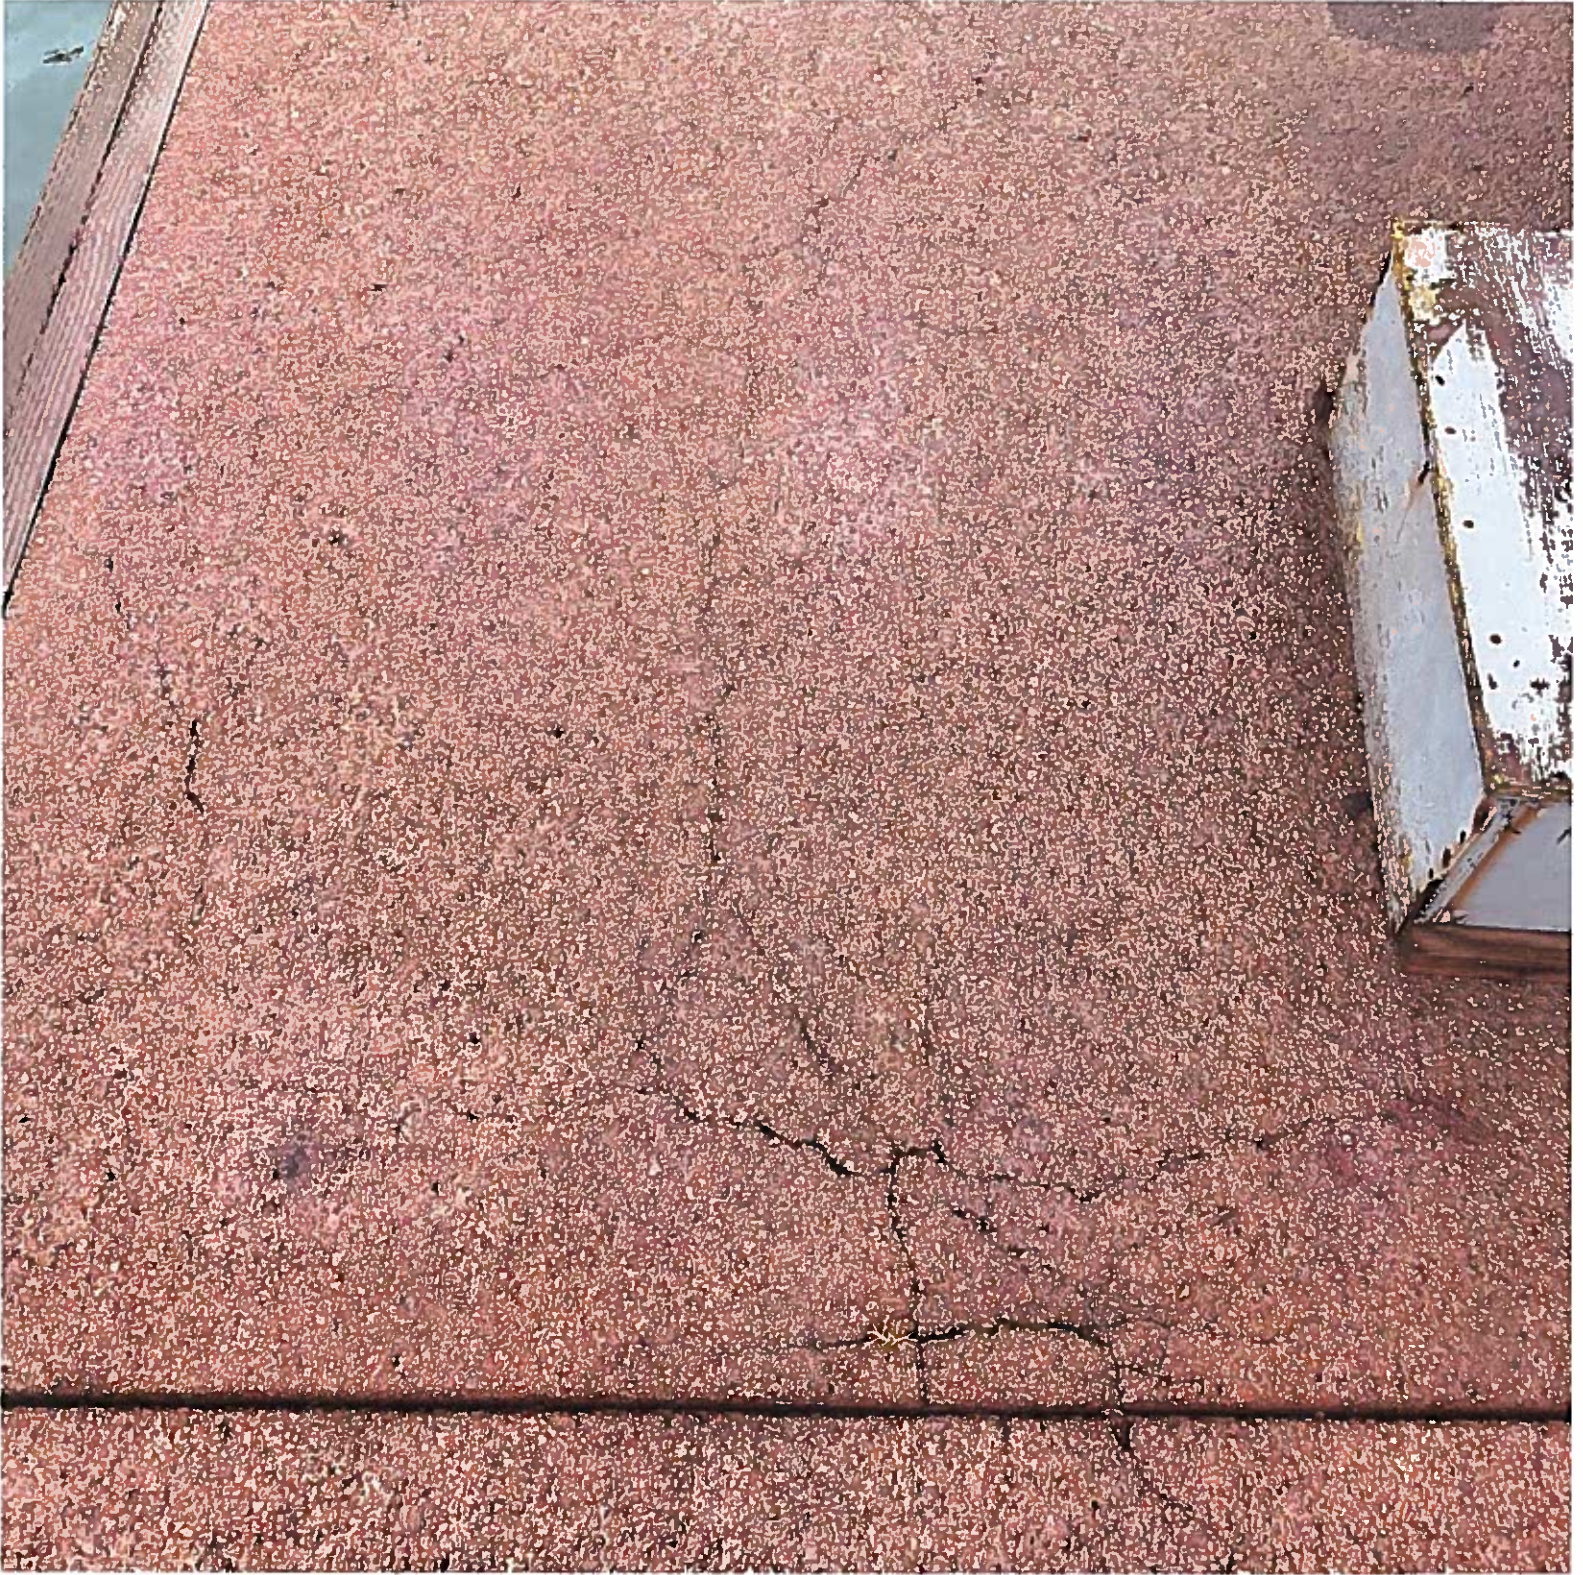
Issue #	CIP Rank	Description of Condition	Priority	Option 1	Estimated Cost	Option 2	Estimated Cost	Option 3	Estimated Cost	Funds Available Y/N
31	11	Basin 2 - Commercial Dock repairs	2	Repair broken docks	250,000	Replace with new docks	1,000,000			No
32	11	Basin 2 - Commercial Sport Dock repairs	2	Repair broken docks	300,000	Replace with new docks	1,000,000			No
Board meeting 02-26-2019 Decision

Option 2 if funding happens before repairs are needed.

- 1) Closed dock fingers until repairs can be made.
- 2) Making repairs when necessary.

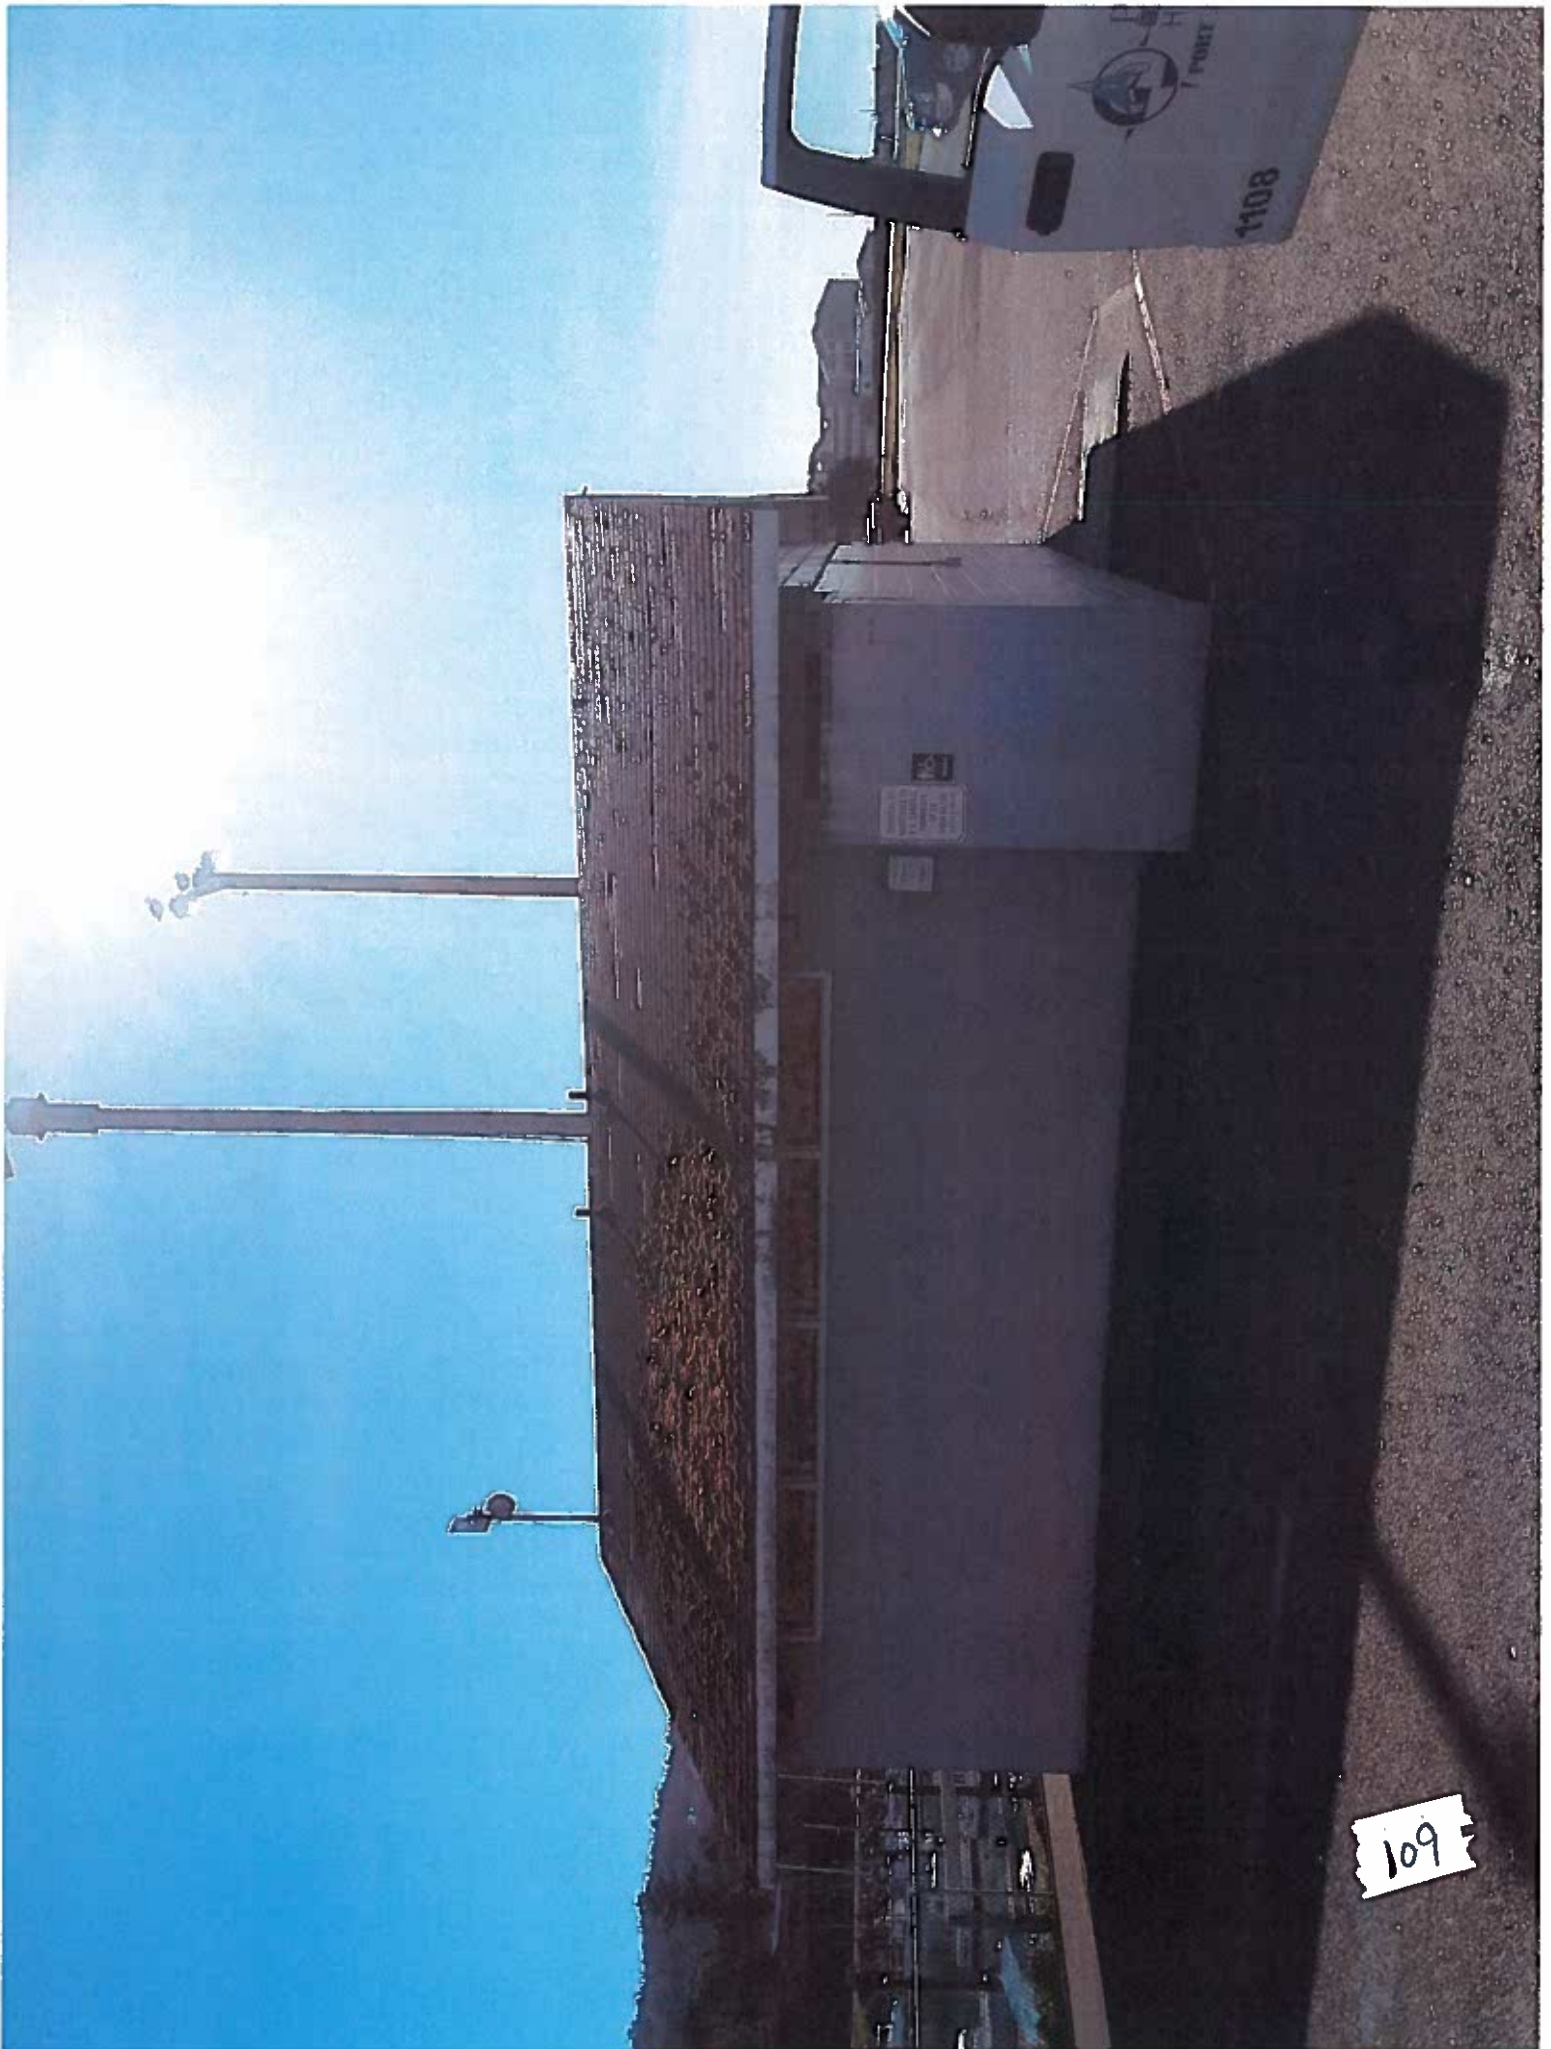
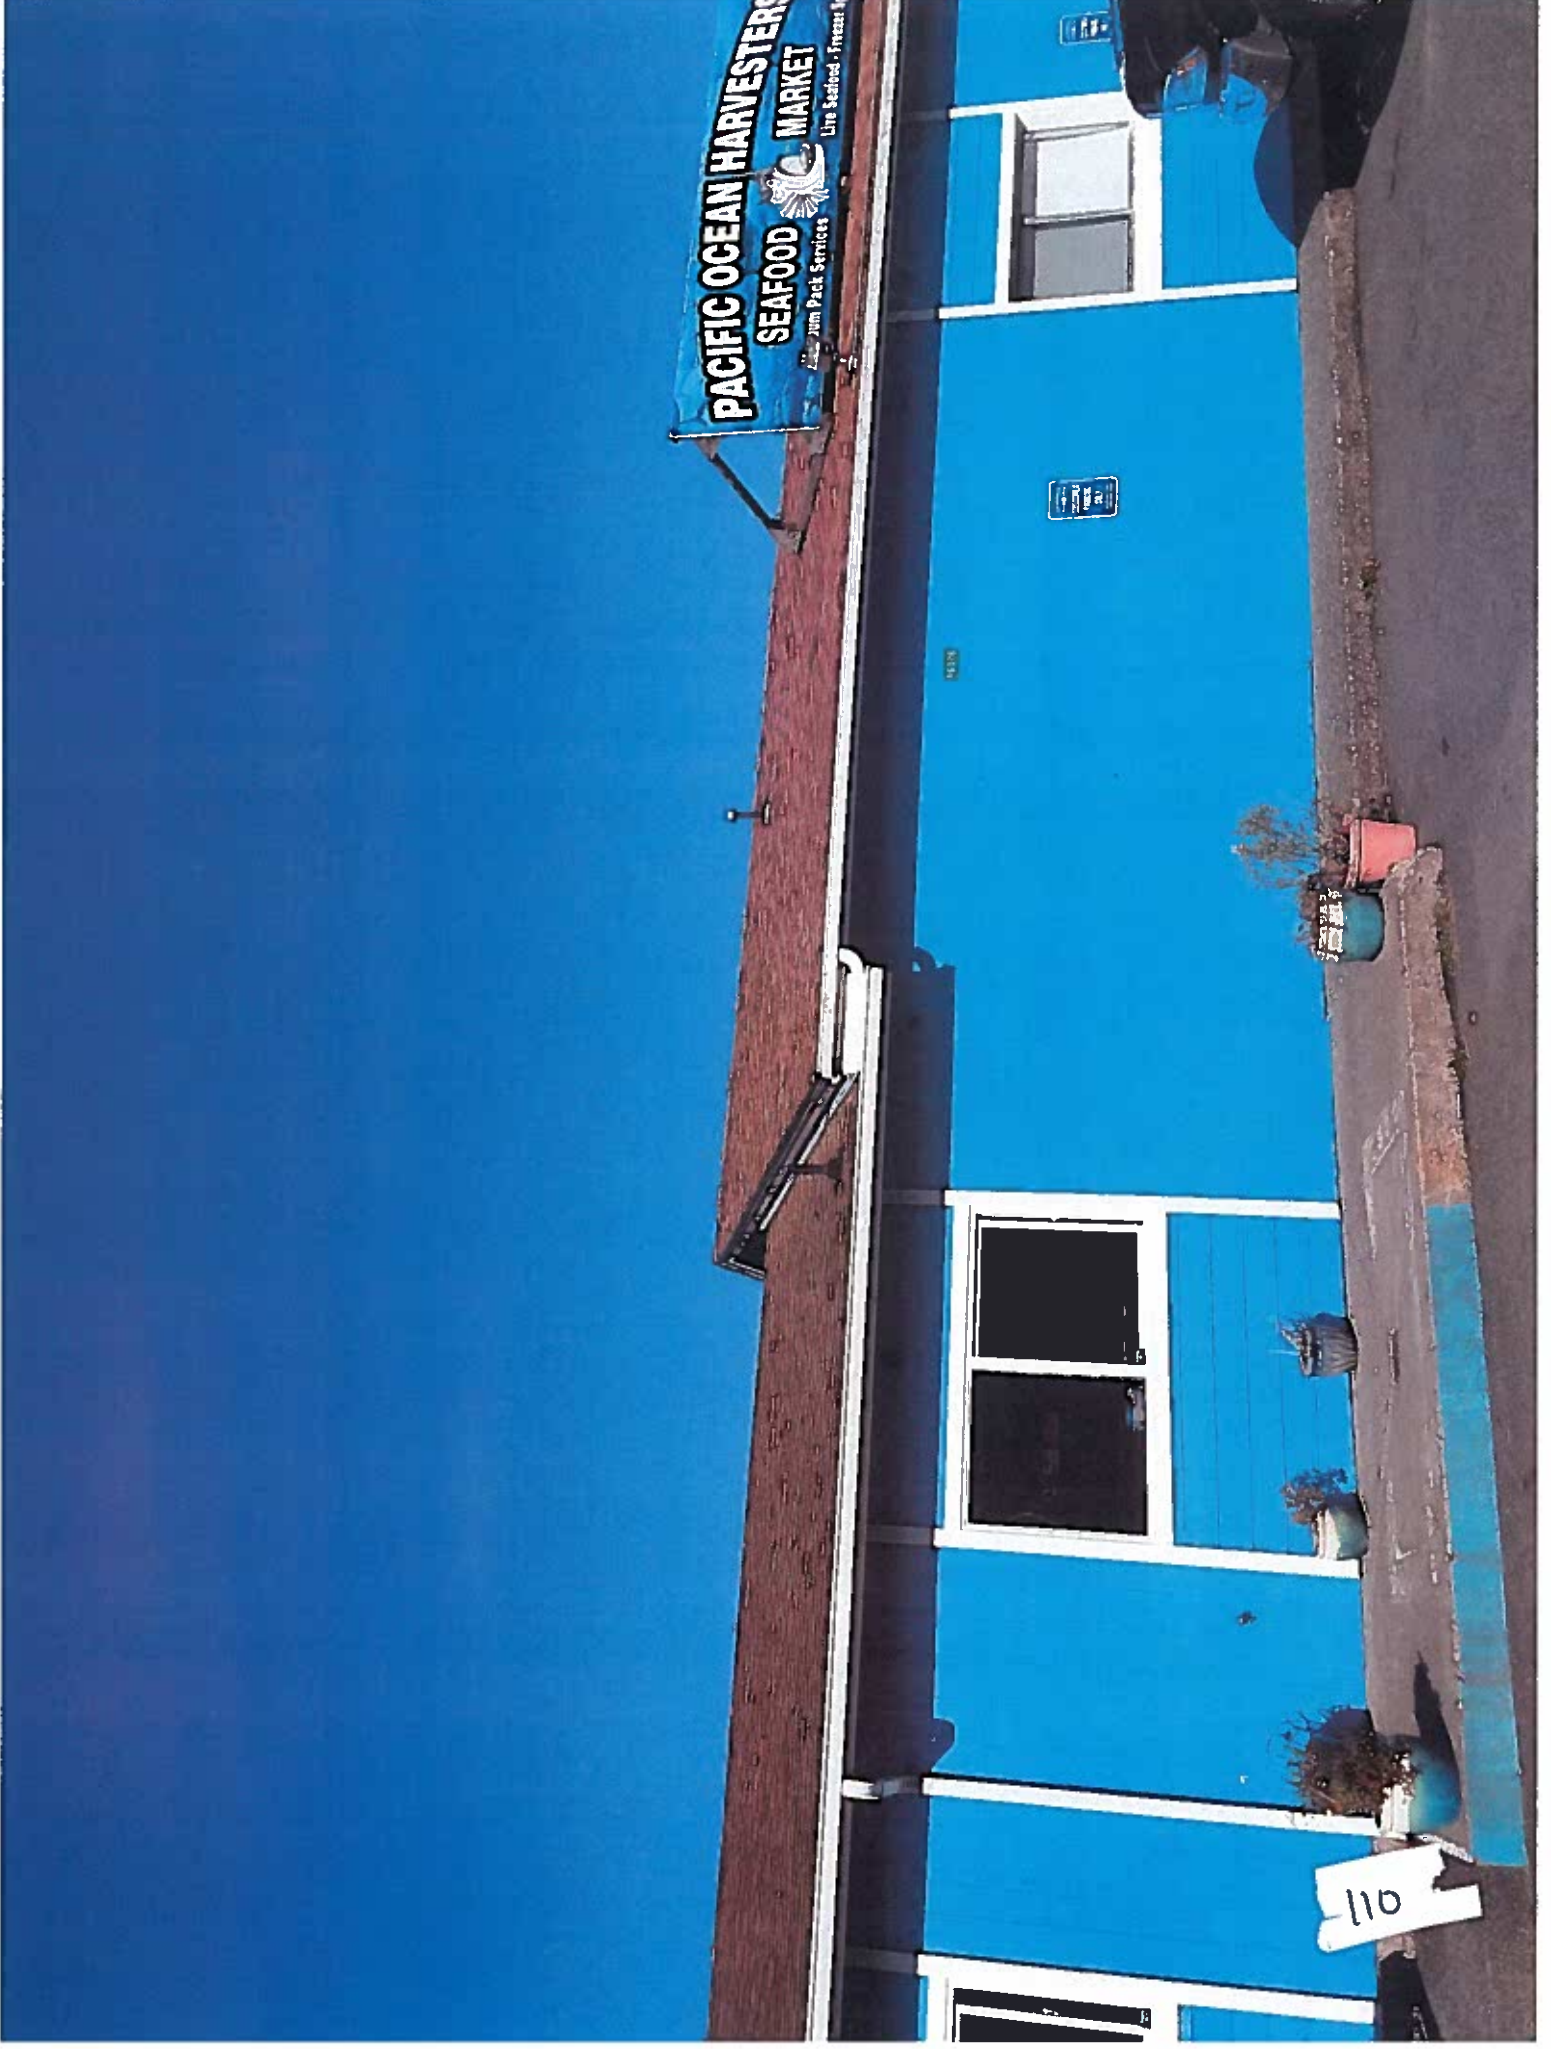
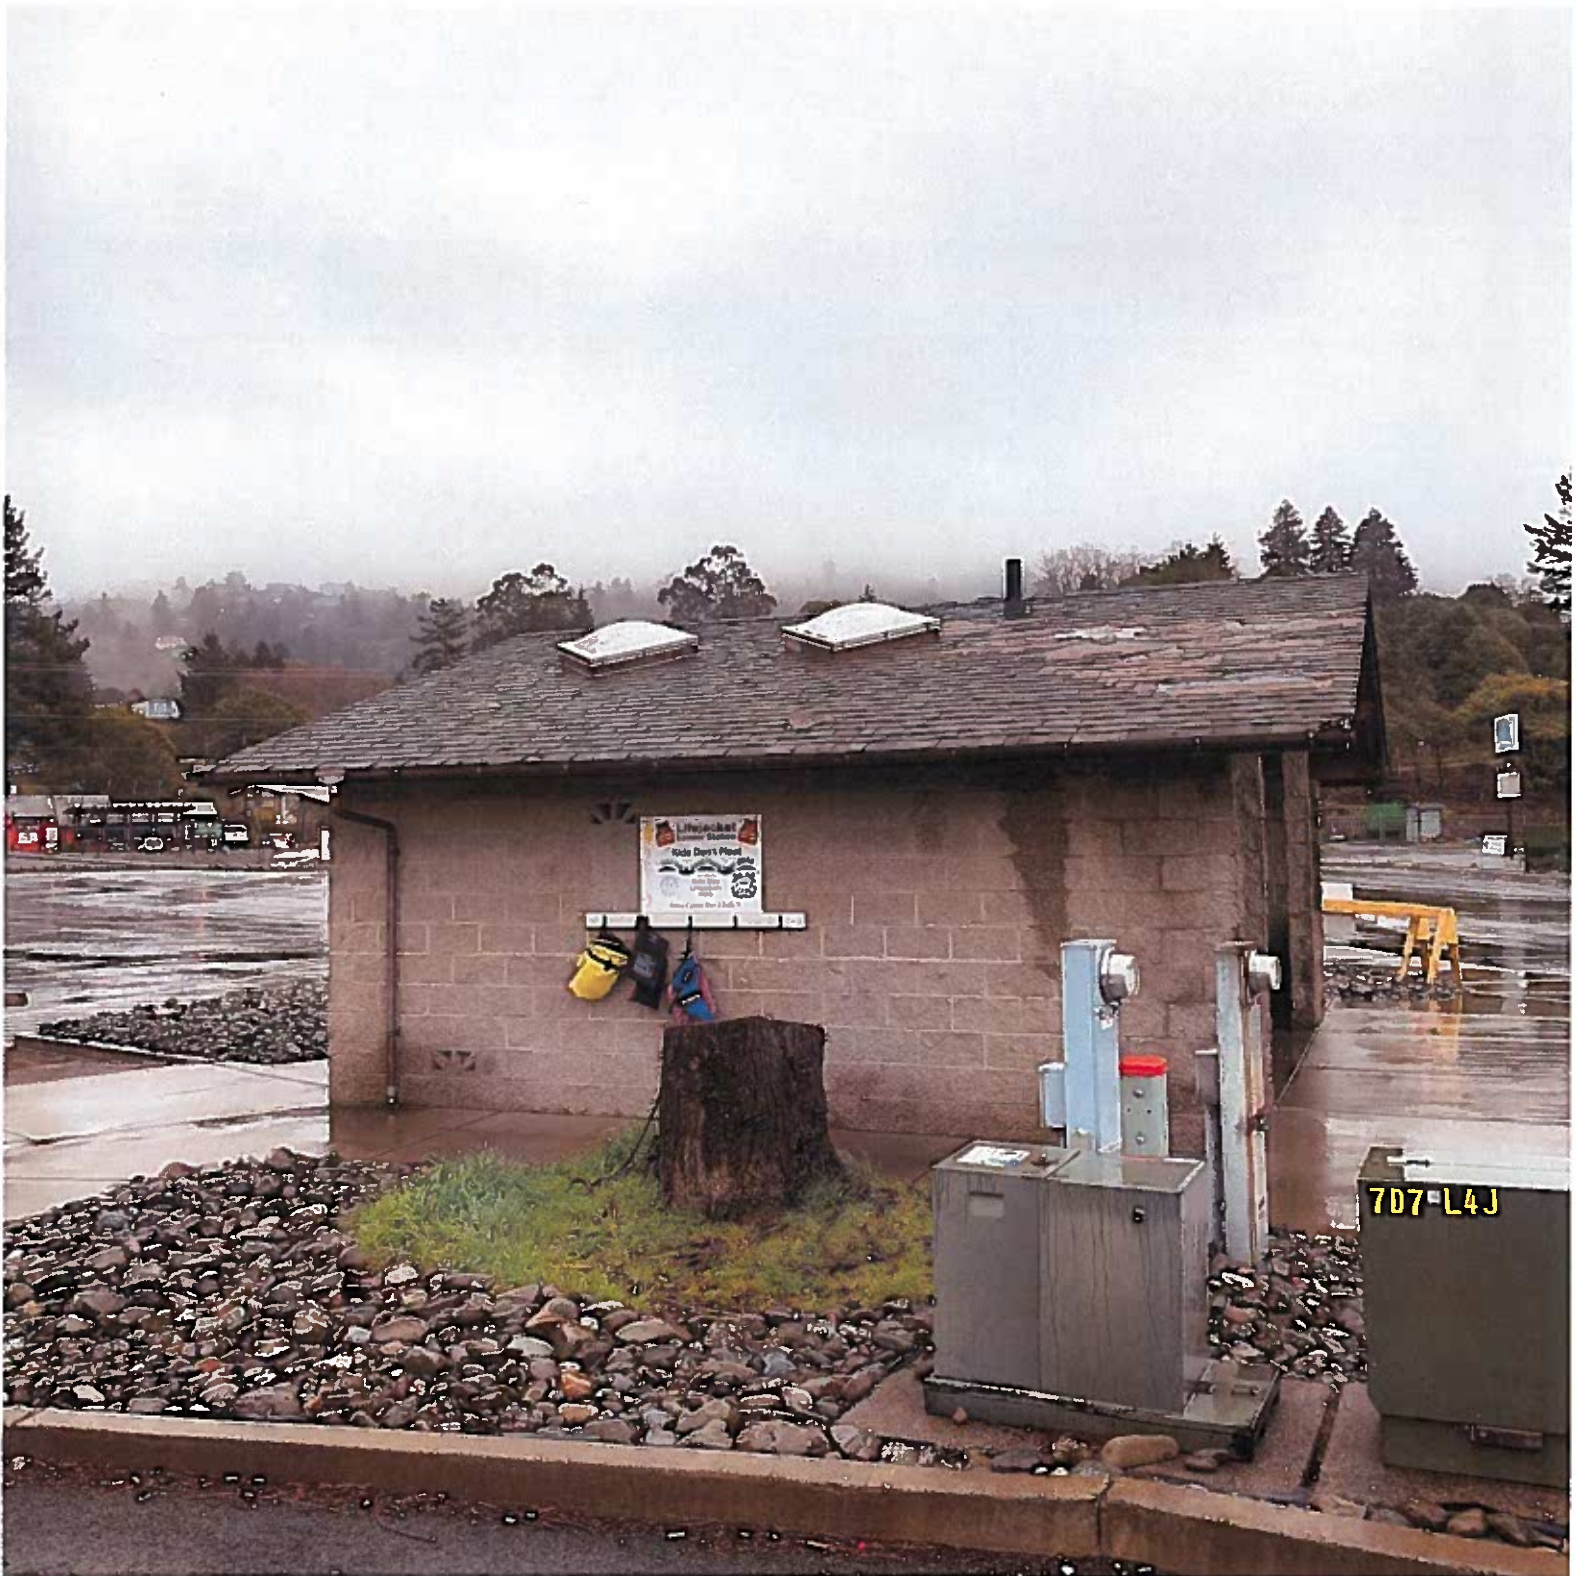
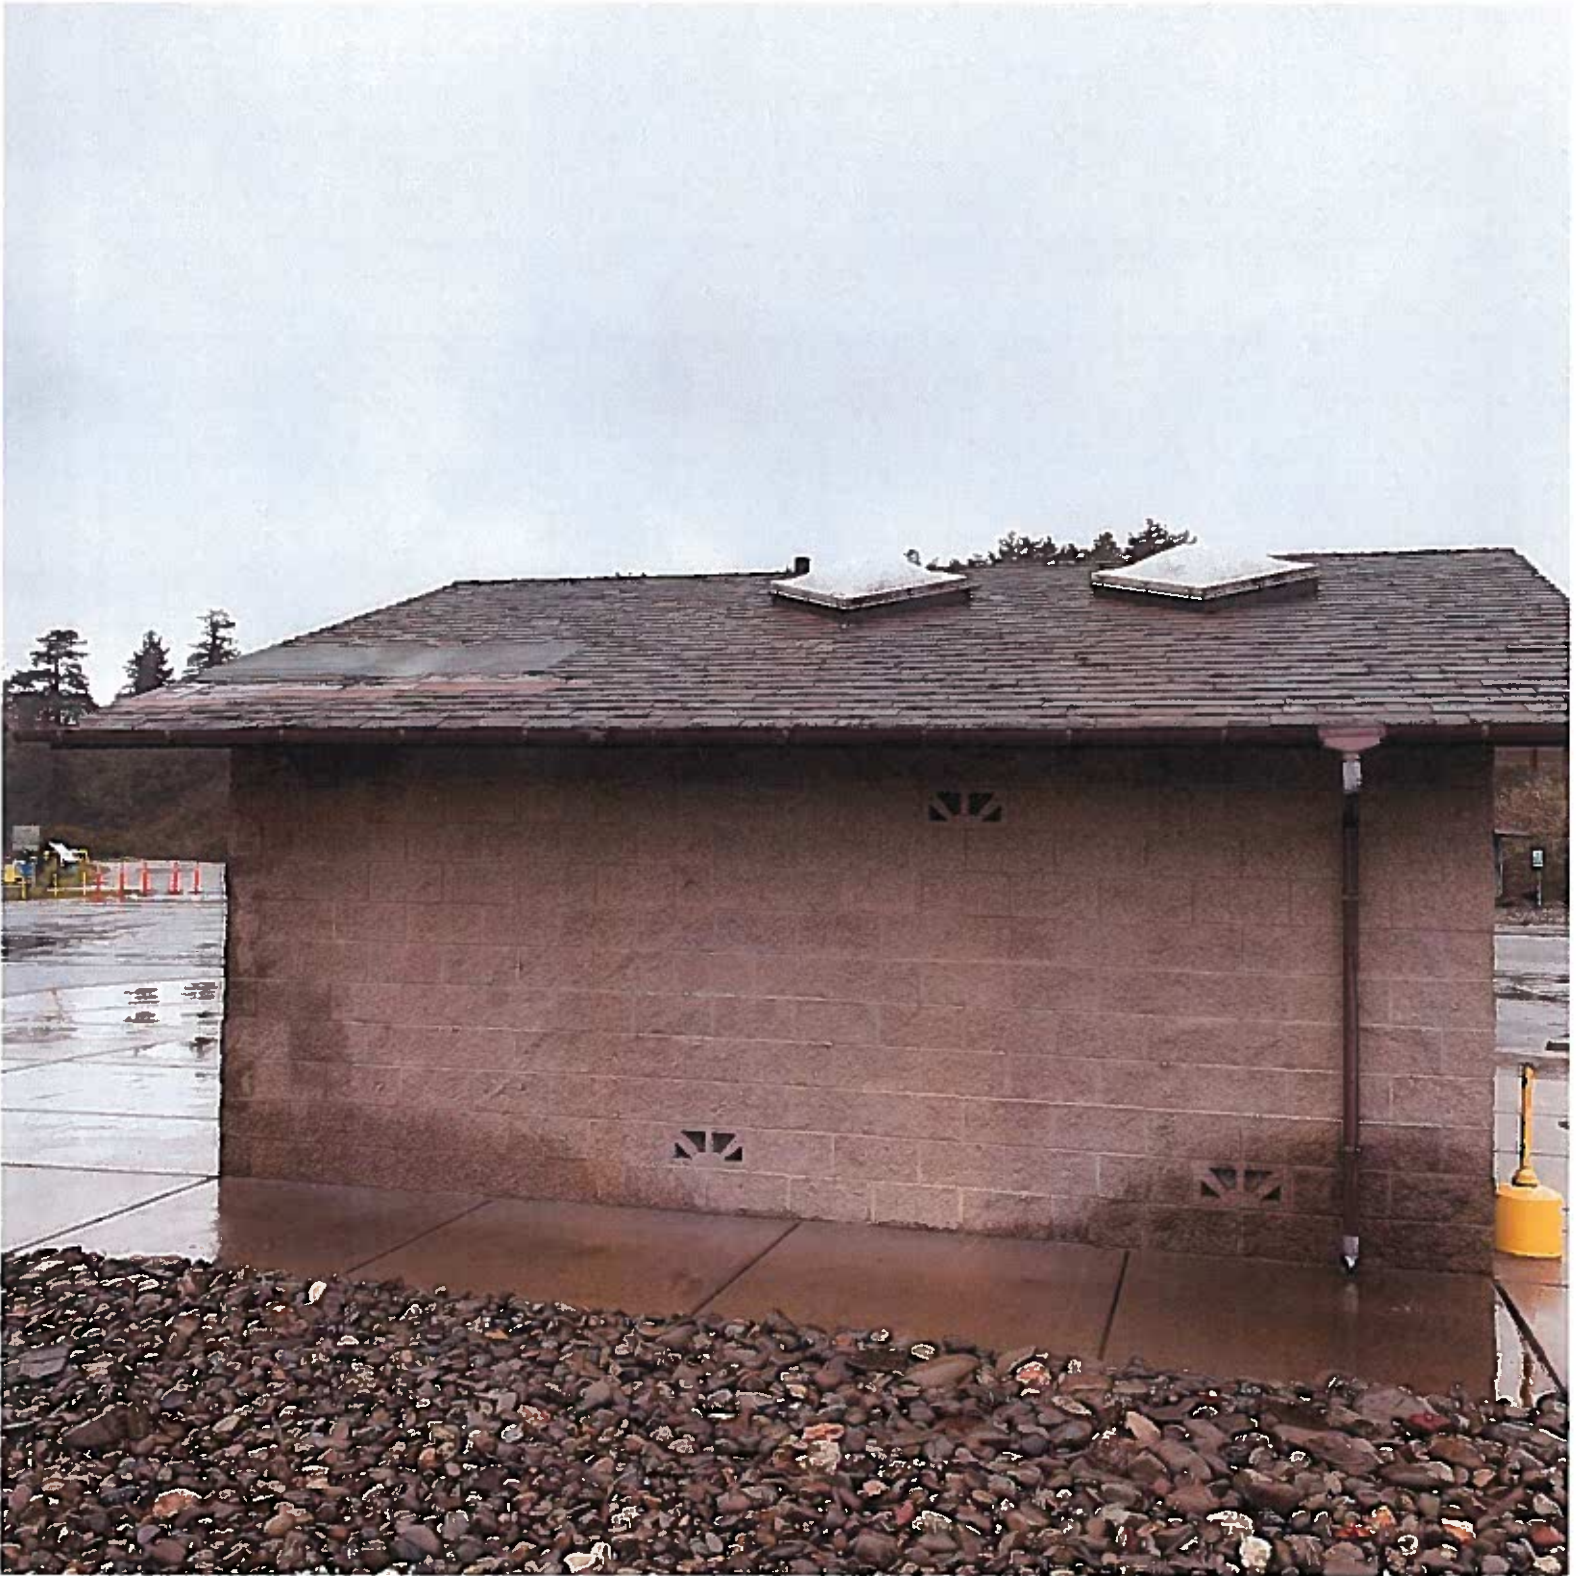
Issue #	CIP Rank	Description of Condition	Priority	Option 1	Estimated Cost	Option 2	Estimated Cost	Option 3	Estimated Cost	Funds Available Y/N
36	18	Repair Kite Field Restrooms and Upgrade	1	Install new roof	10,000					No
51	18	Repair roofs and repaint all restrooms	1	Install new roof	10,000					No
64		Replace Pacific Ocean Harvester Roof		Install new roof	25,000					No
Board meeting 02-26-2019 Decision

Option 1
