January 21, 2017 Storm Damage

PORT OF BROOKINGS HARBOR

BASIN 2 DOCK REPAIRS

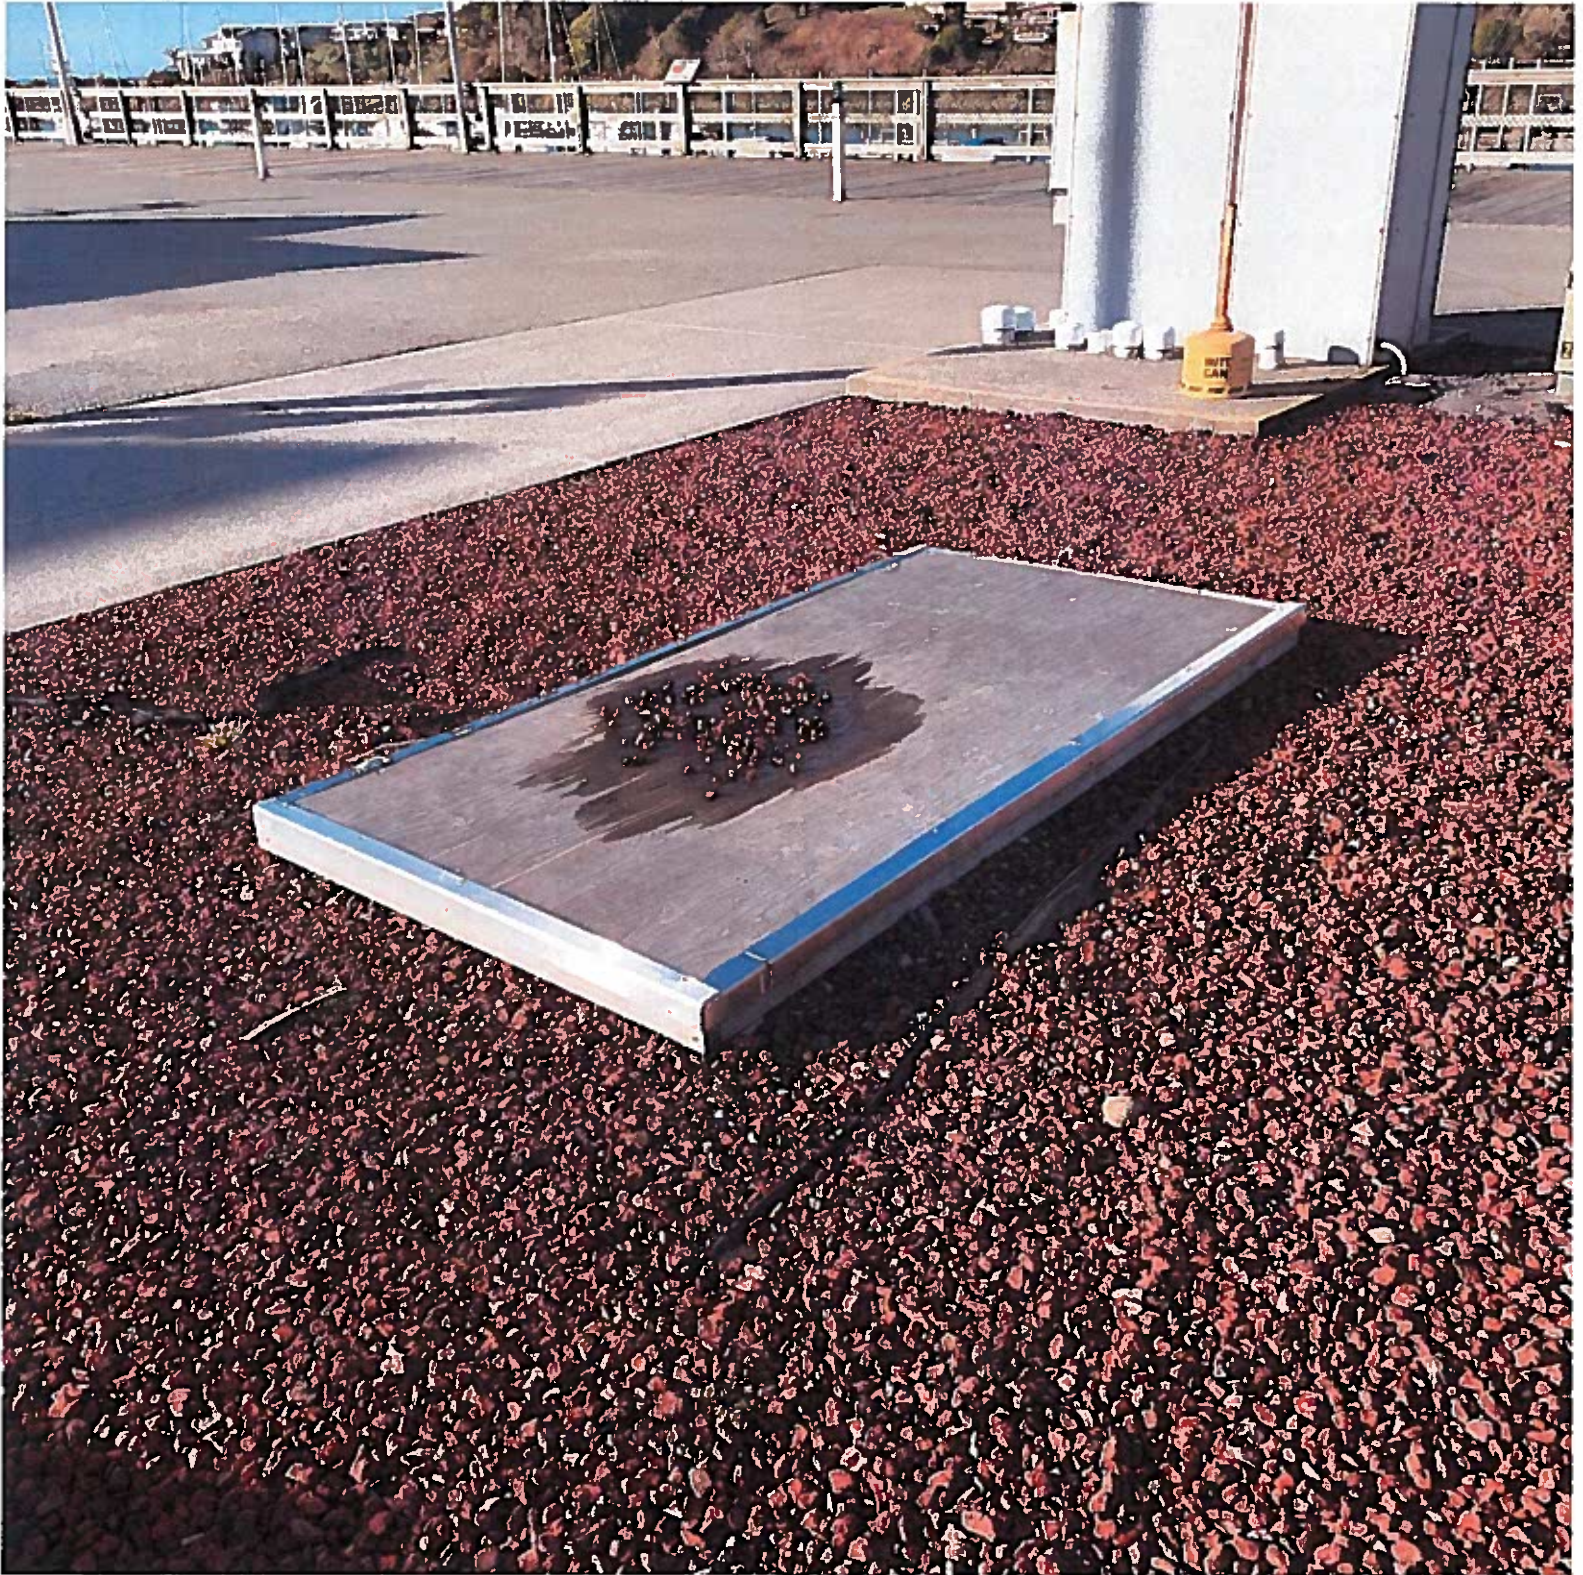
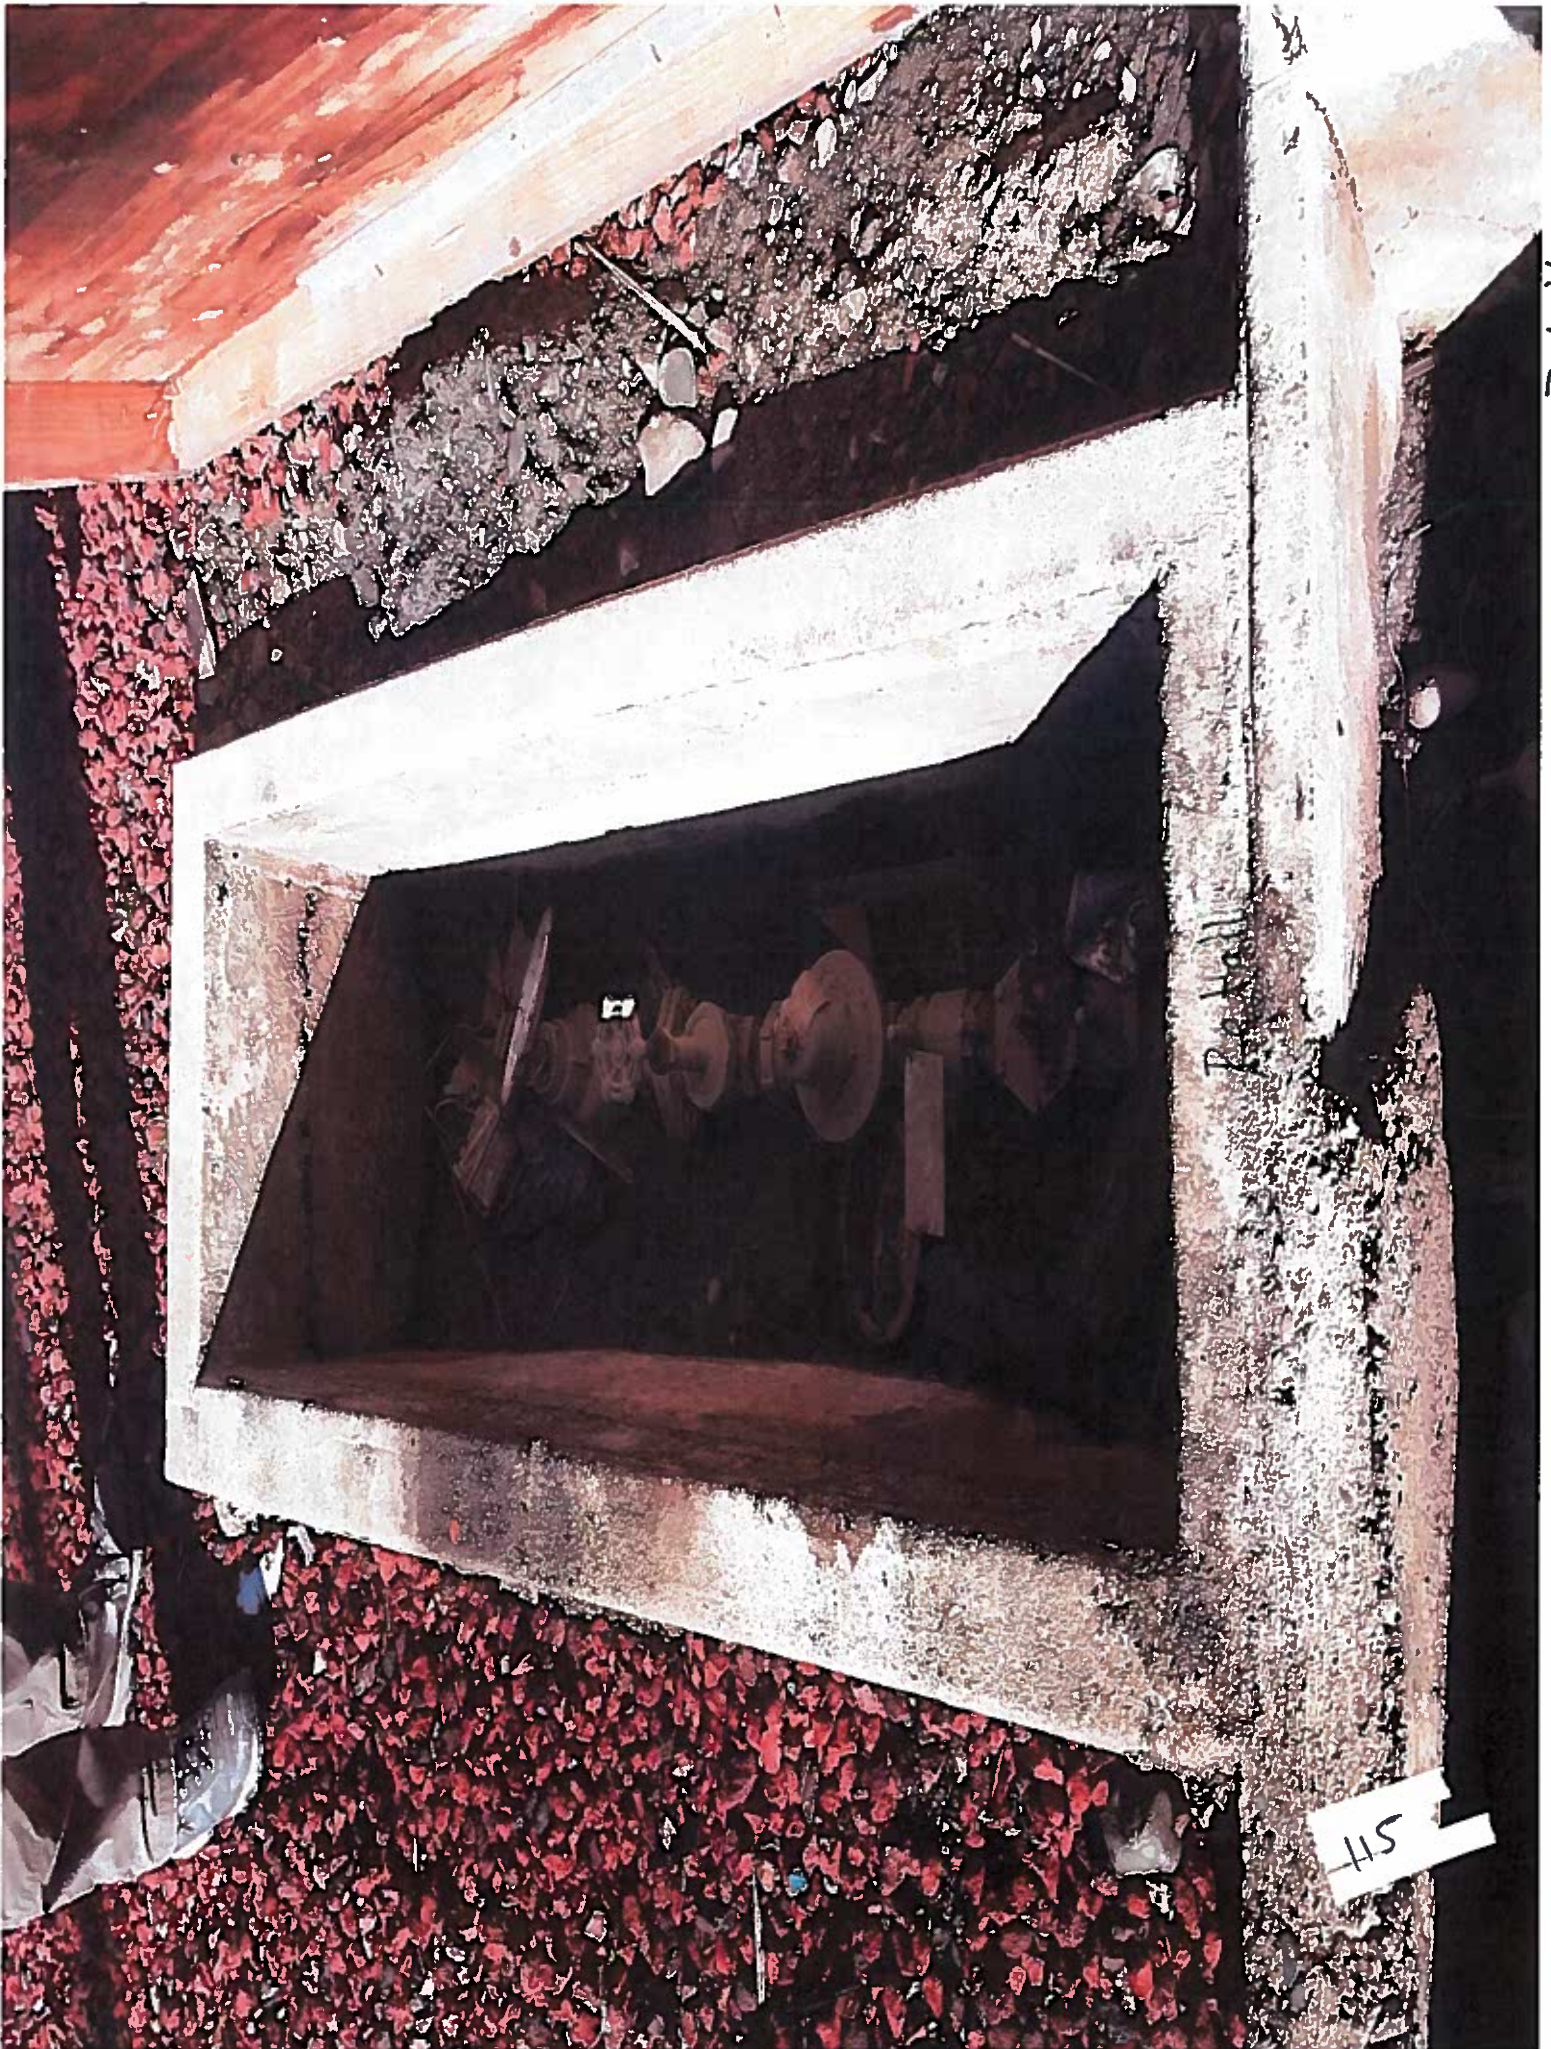
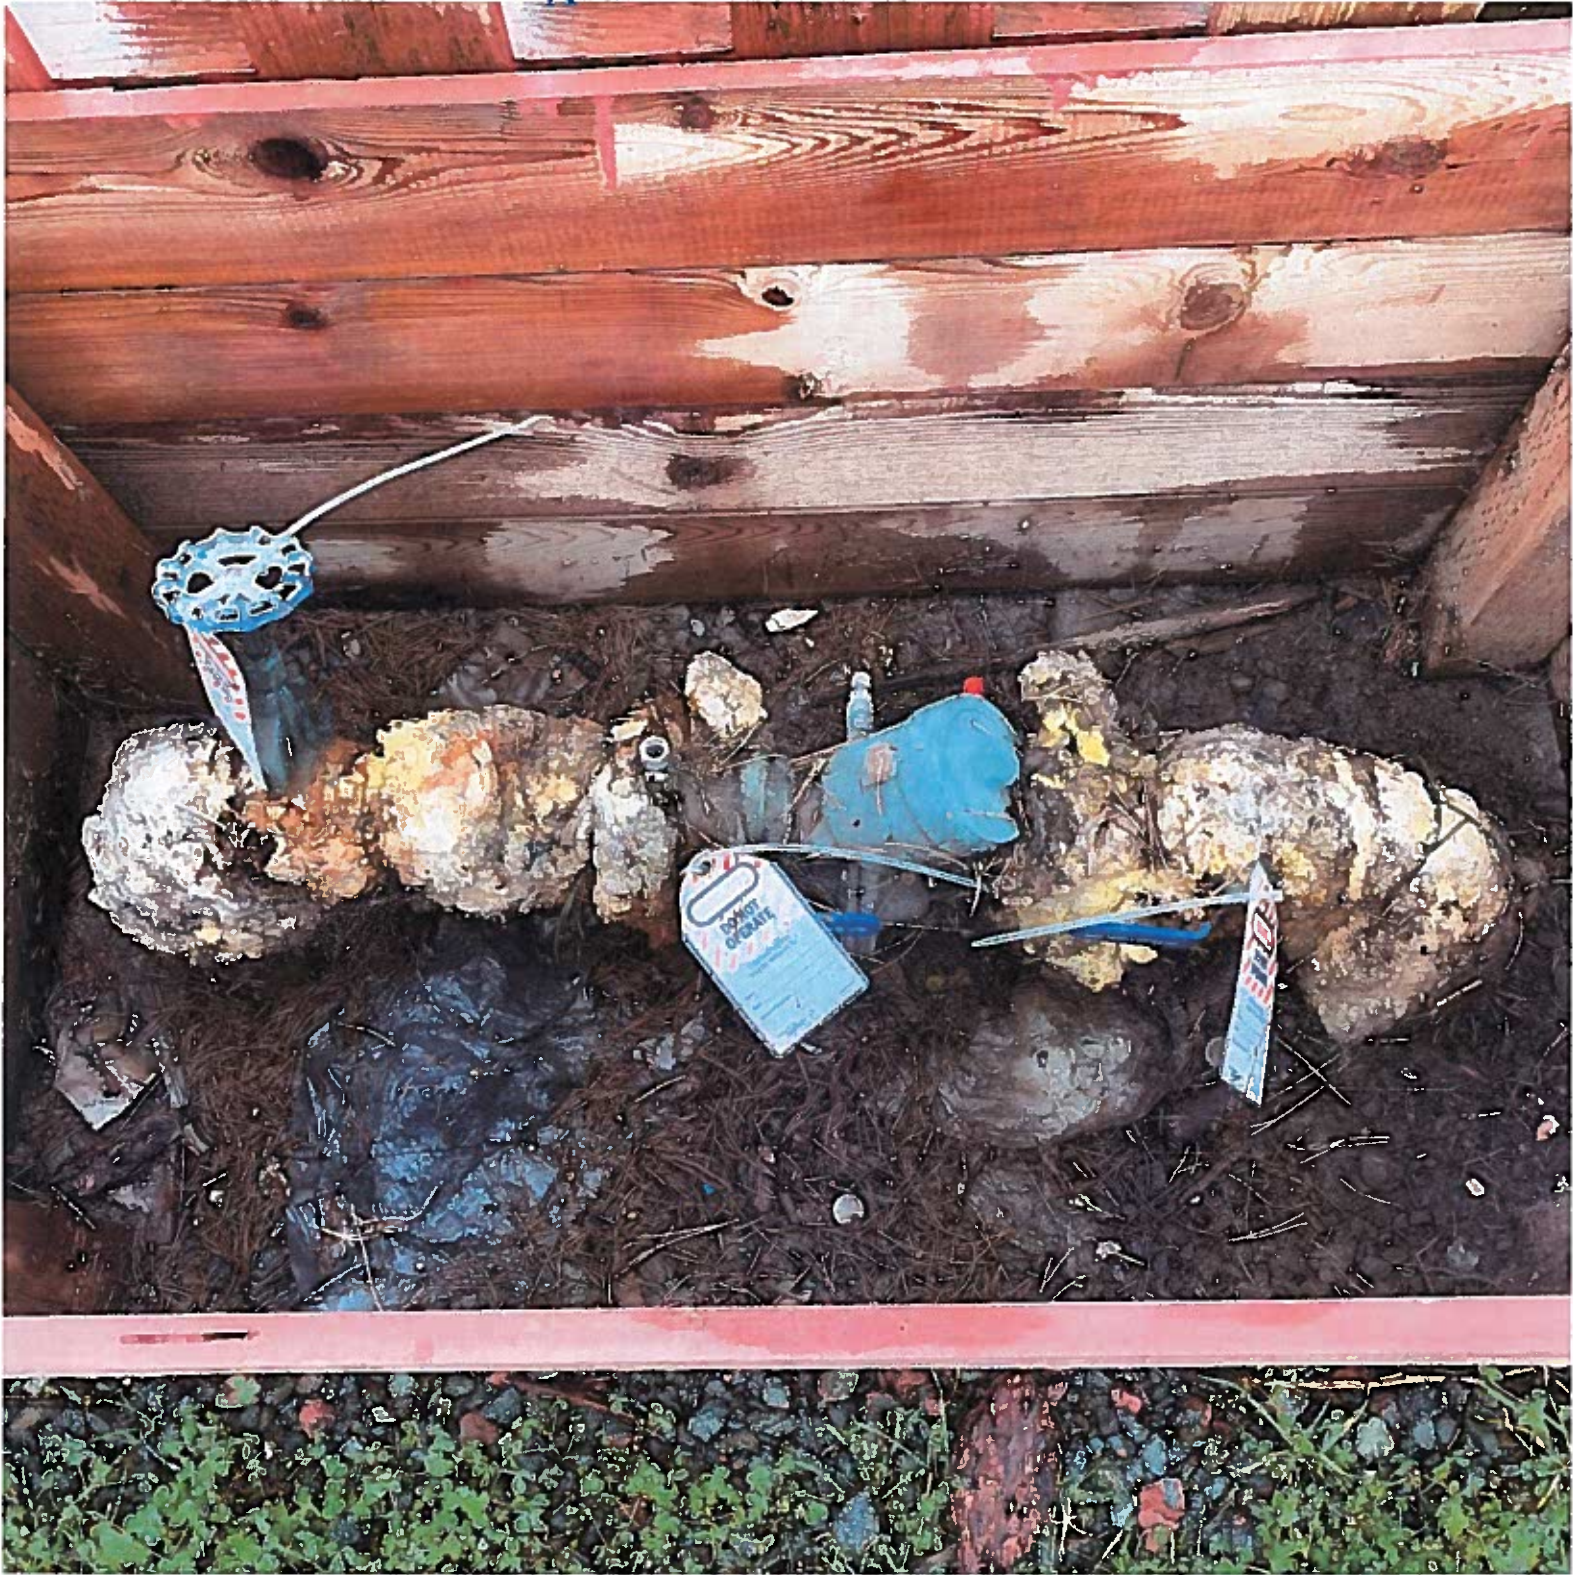
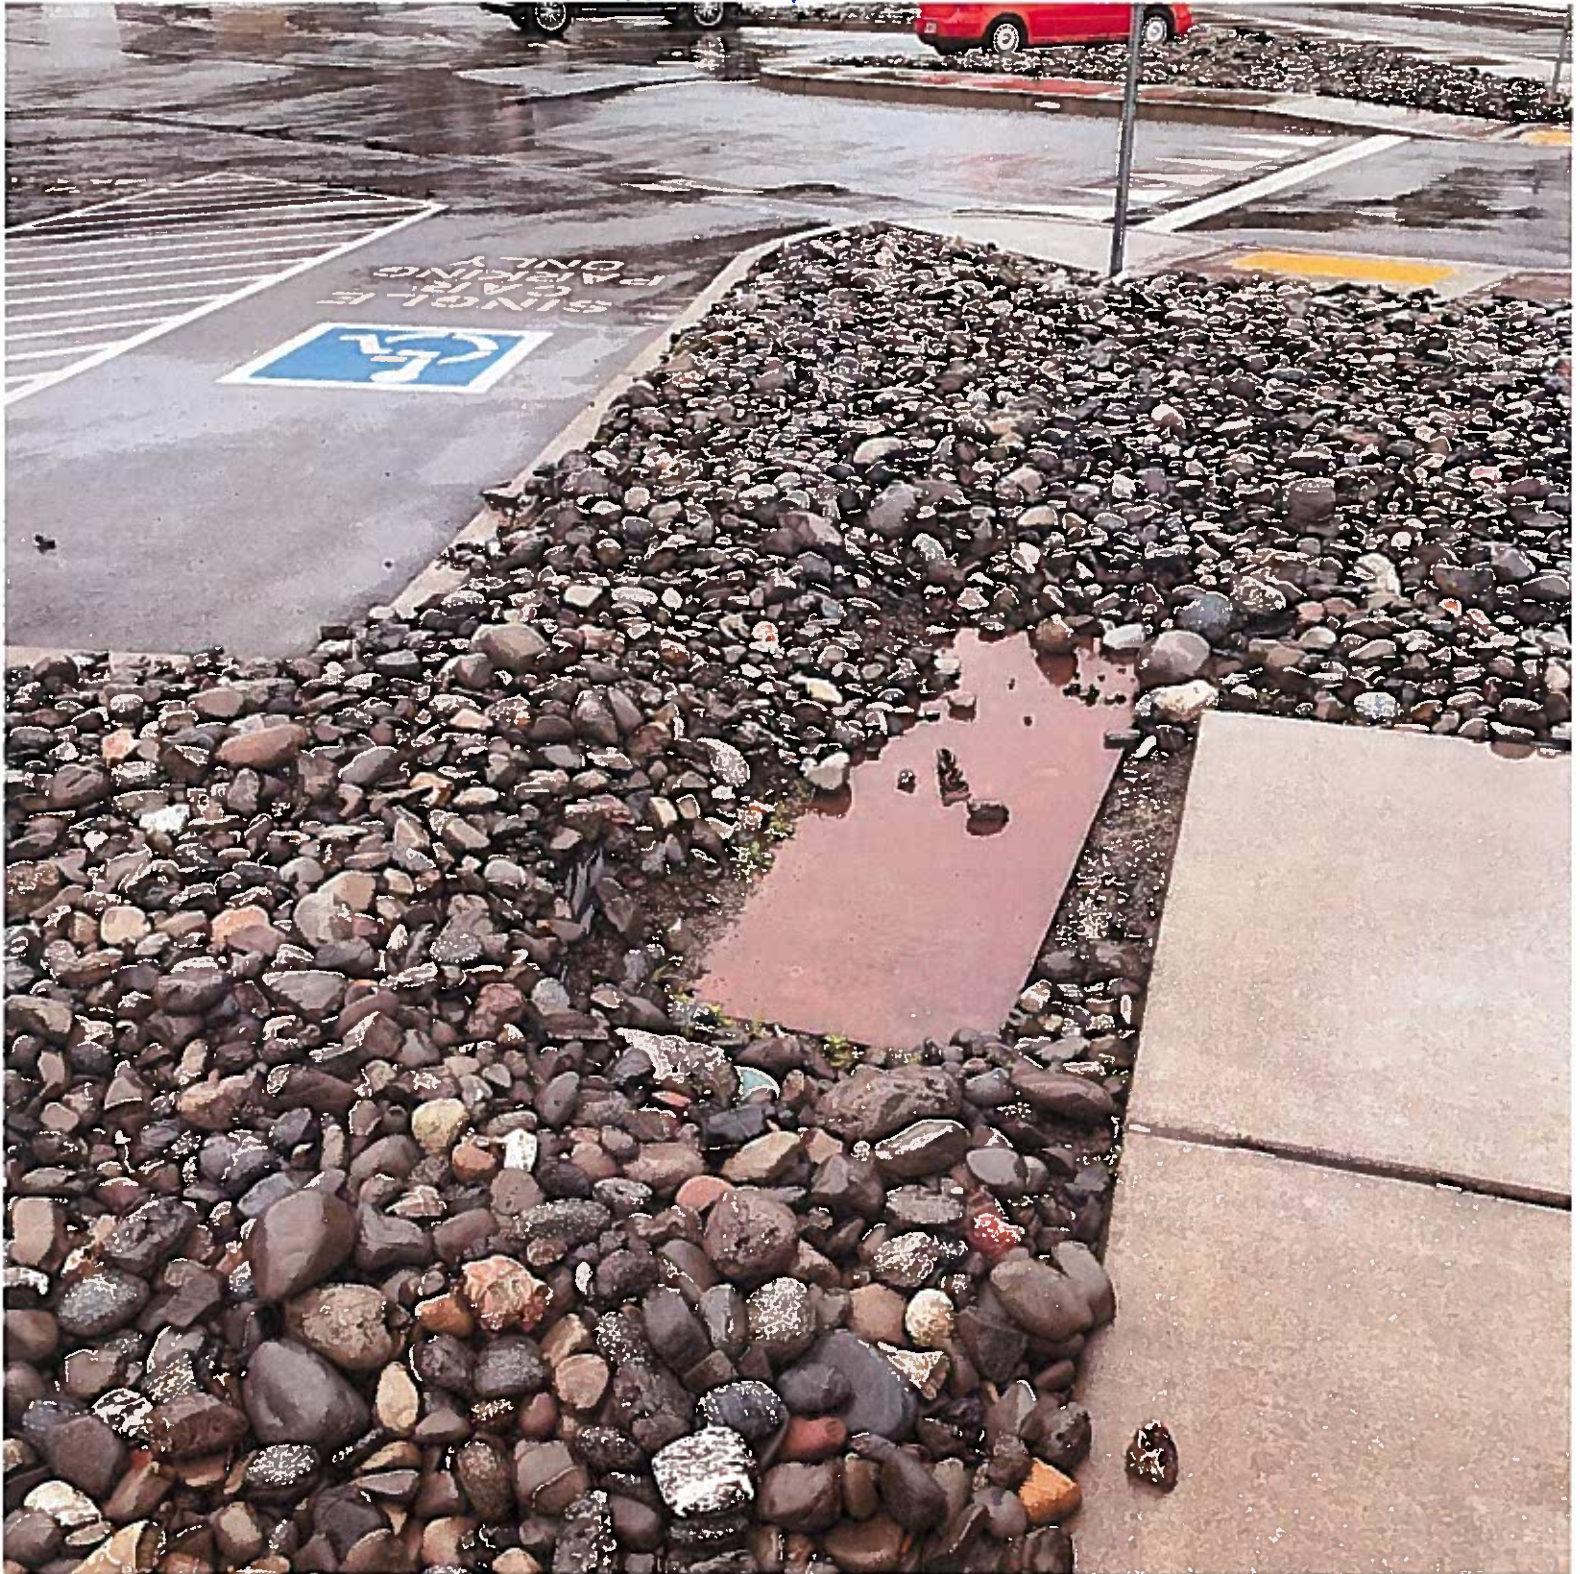
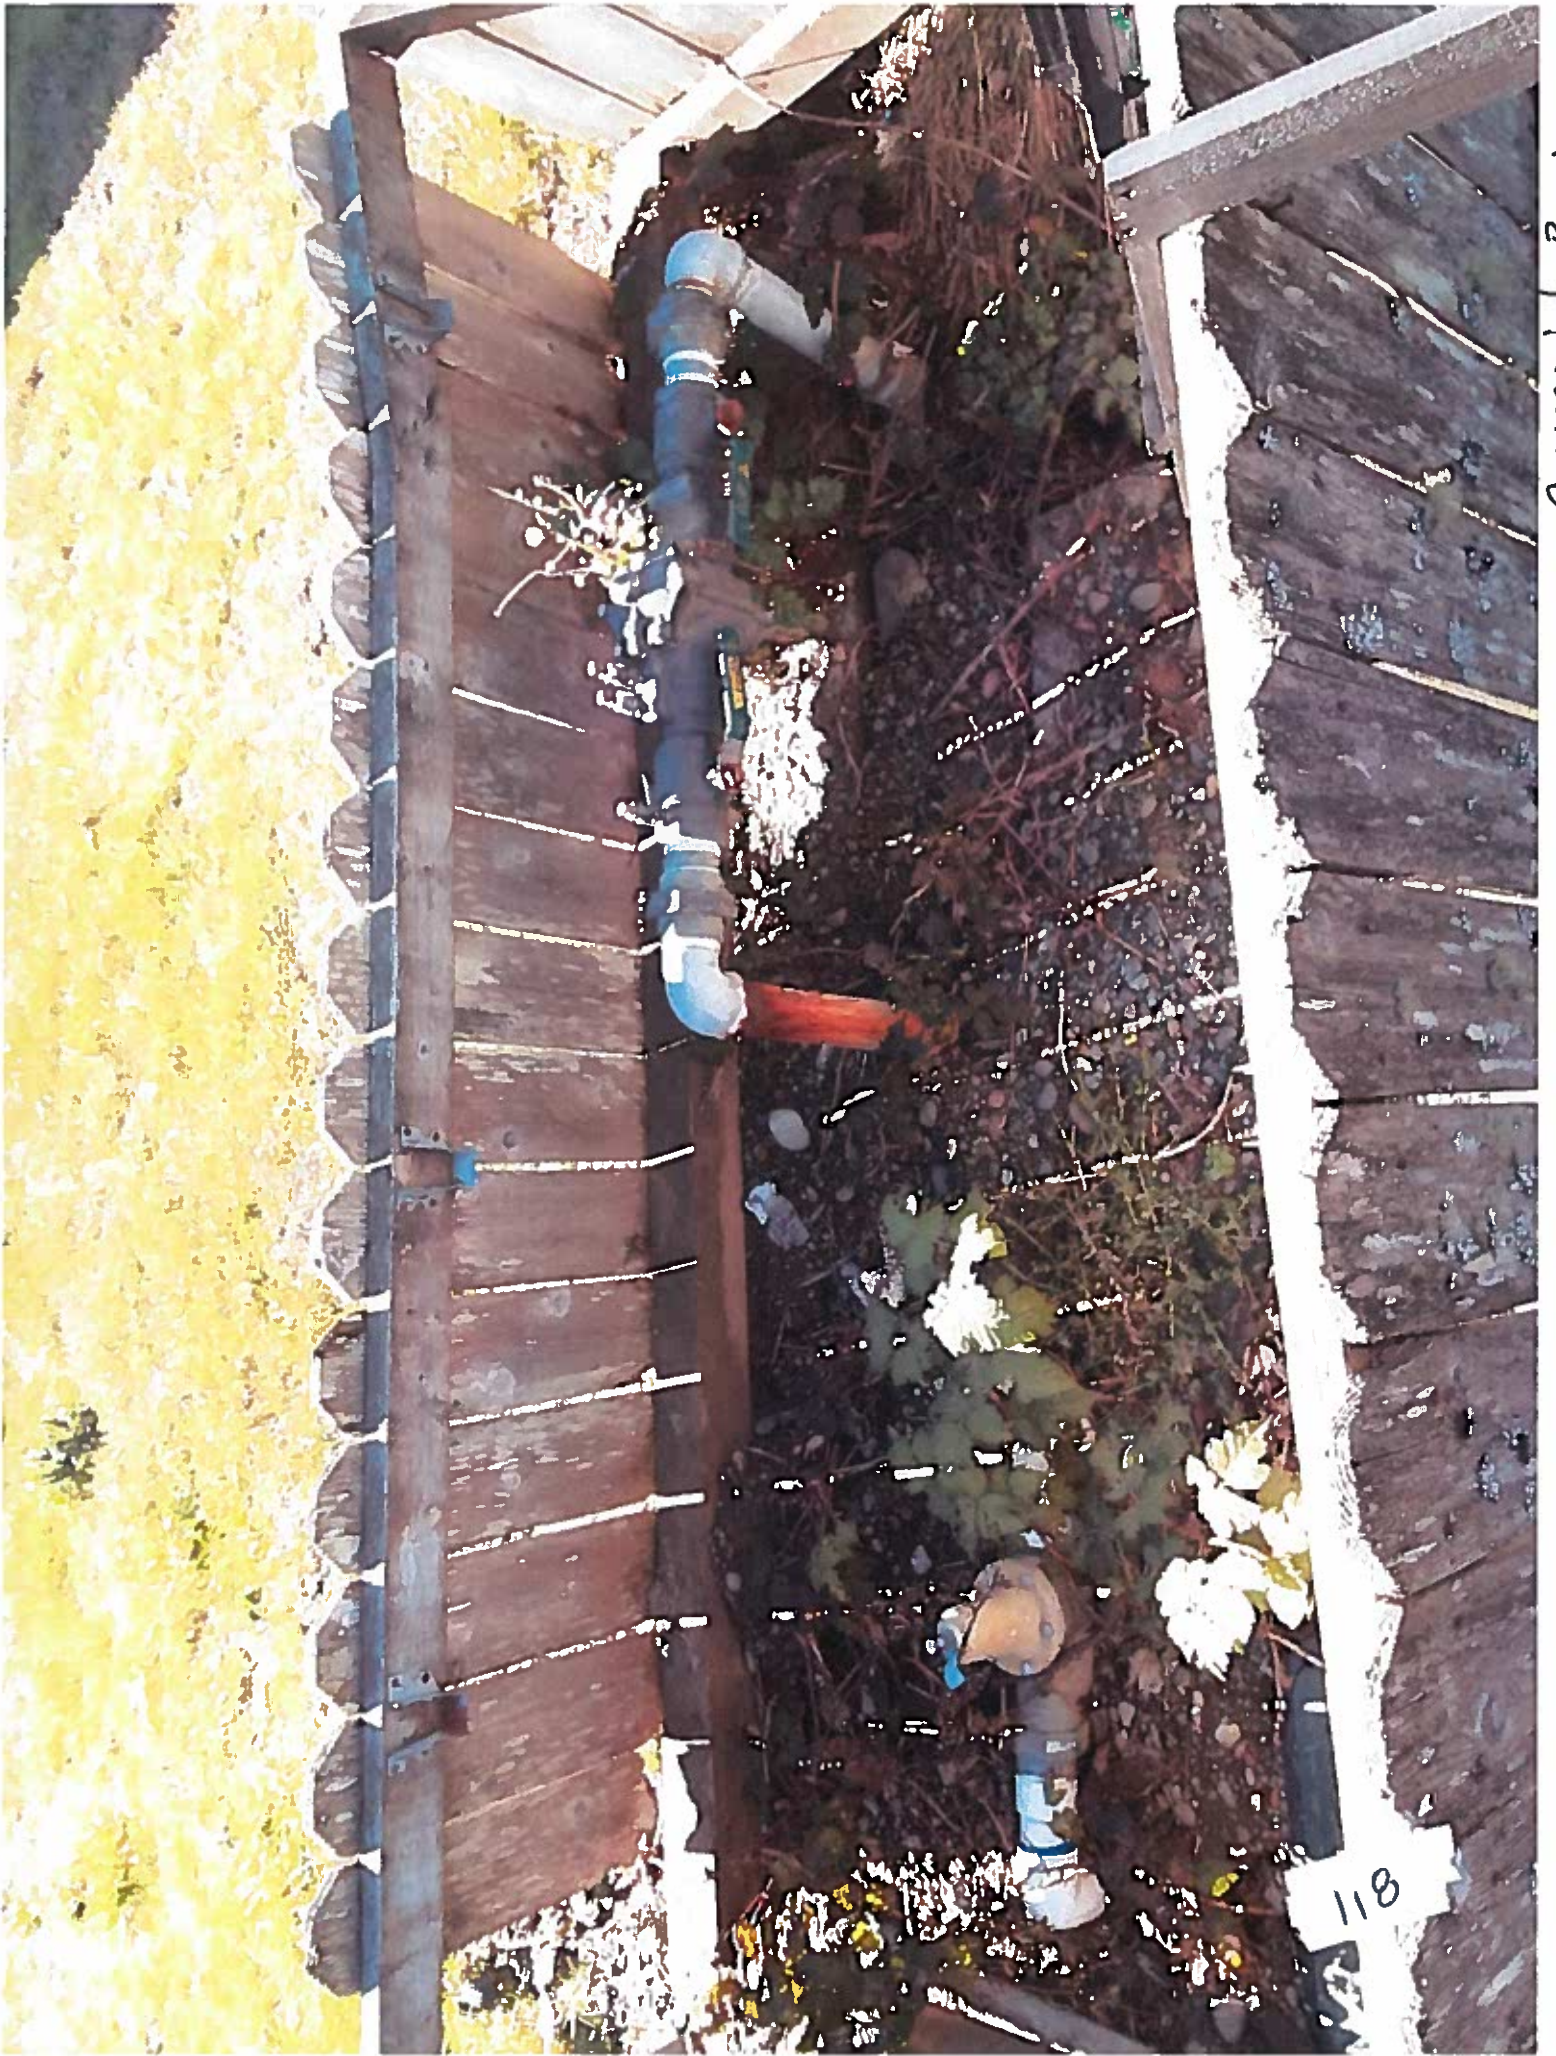
Issue #	CIP Rank	Description of Condition	Priority	Option 1	Estimated Cost	Option 2	Estimated Cost	Option 3	Estimated Cost	Funds Available Y/N
38		Replace worn out backflow device, valves and piping at Boat Launch	1	Replace existing backflow device and build per standards	4,000					Yes
39		Replace worn out backflow device, valves and piping at Retail Center	1	Replace existing backflow device and build per standards	5,000					Yes
40		Replace worn out backflow device, valves and piping at RV Park	1	Replace existing backflow device and build per standards	5,000					Yes
42		Replace backflow device, valves and piping at Commercial Basin	1	Replace existing backflow device and build per standards	5,000					Yes
Board meeting 02-26-2019										
Decision

Option 1

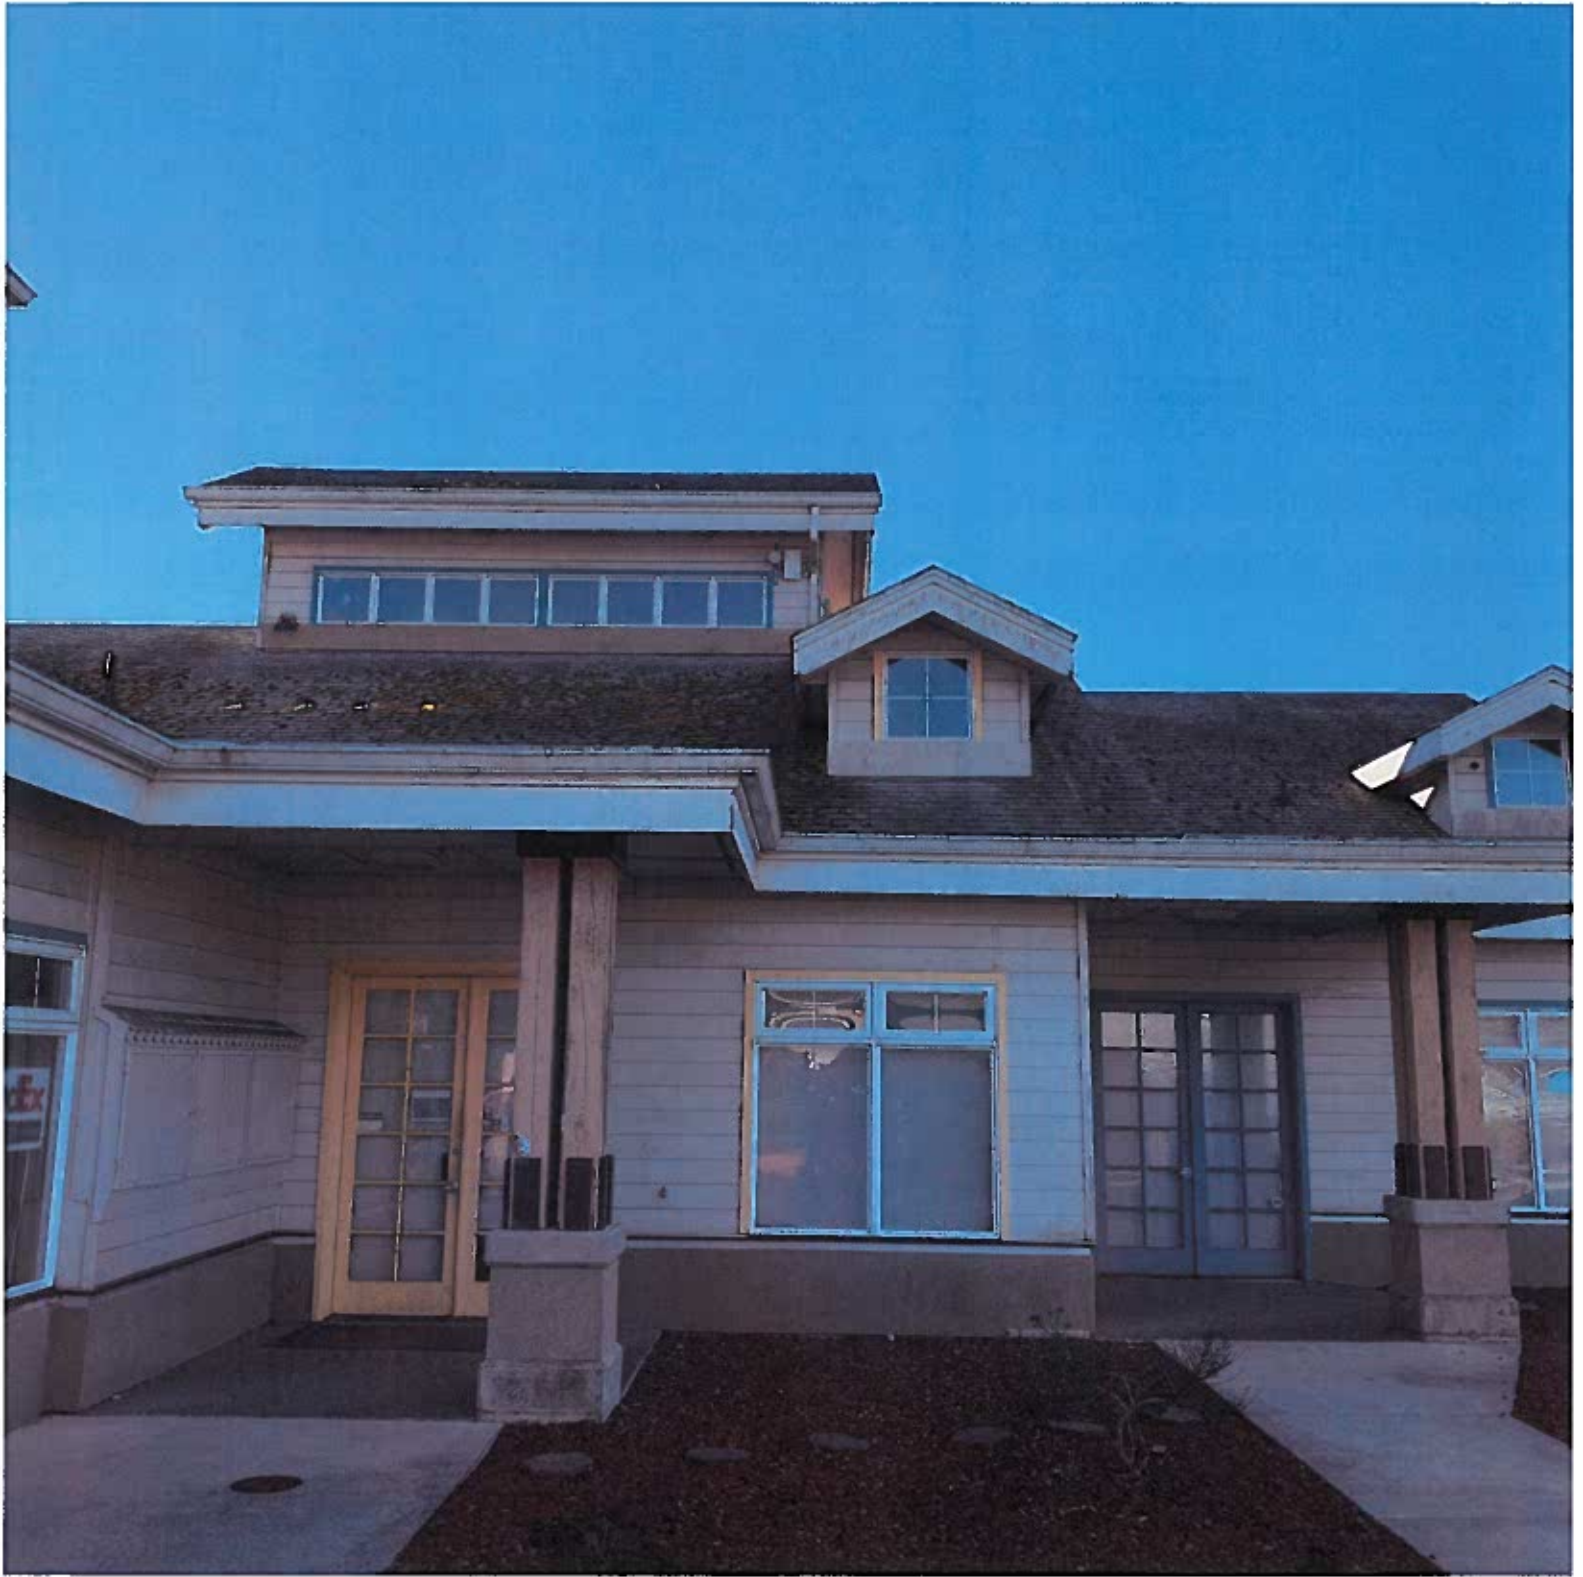
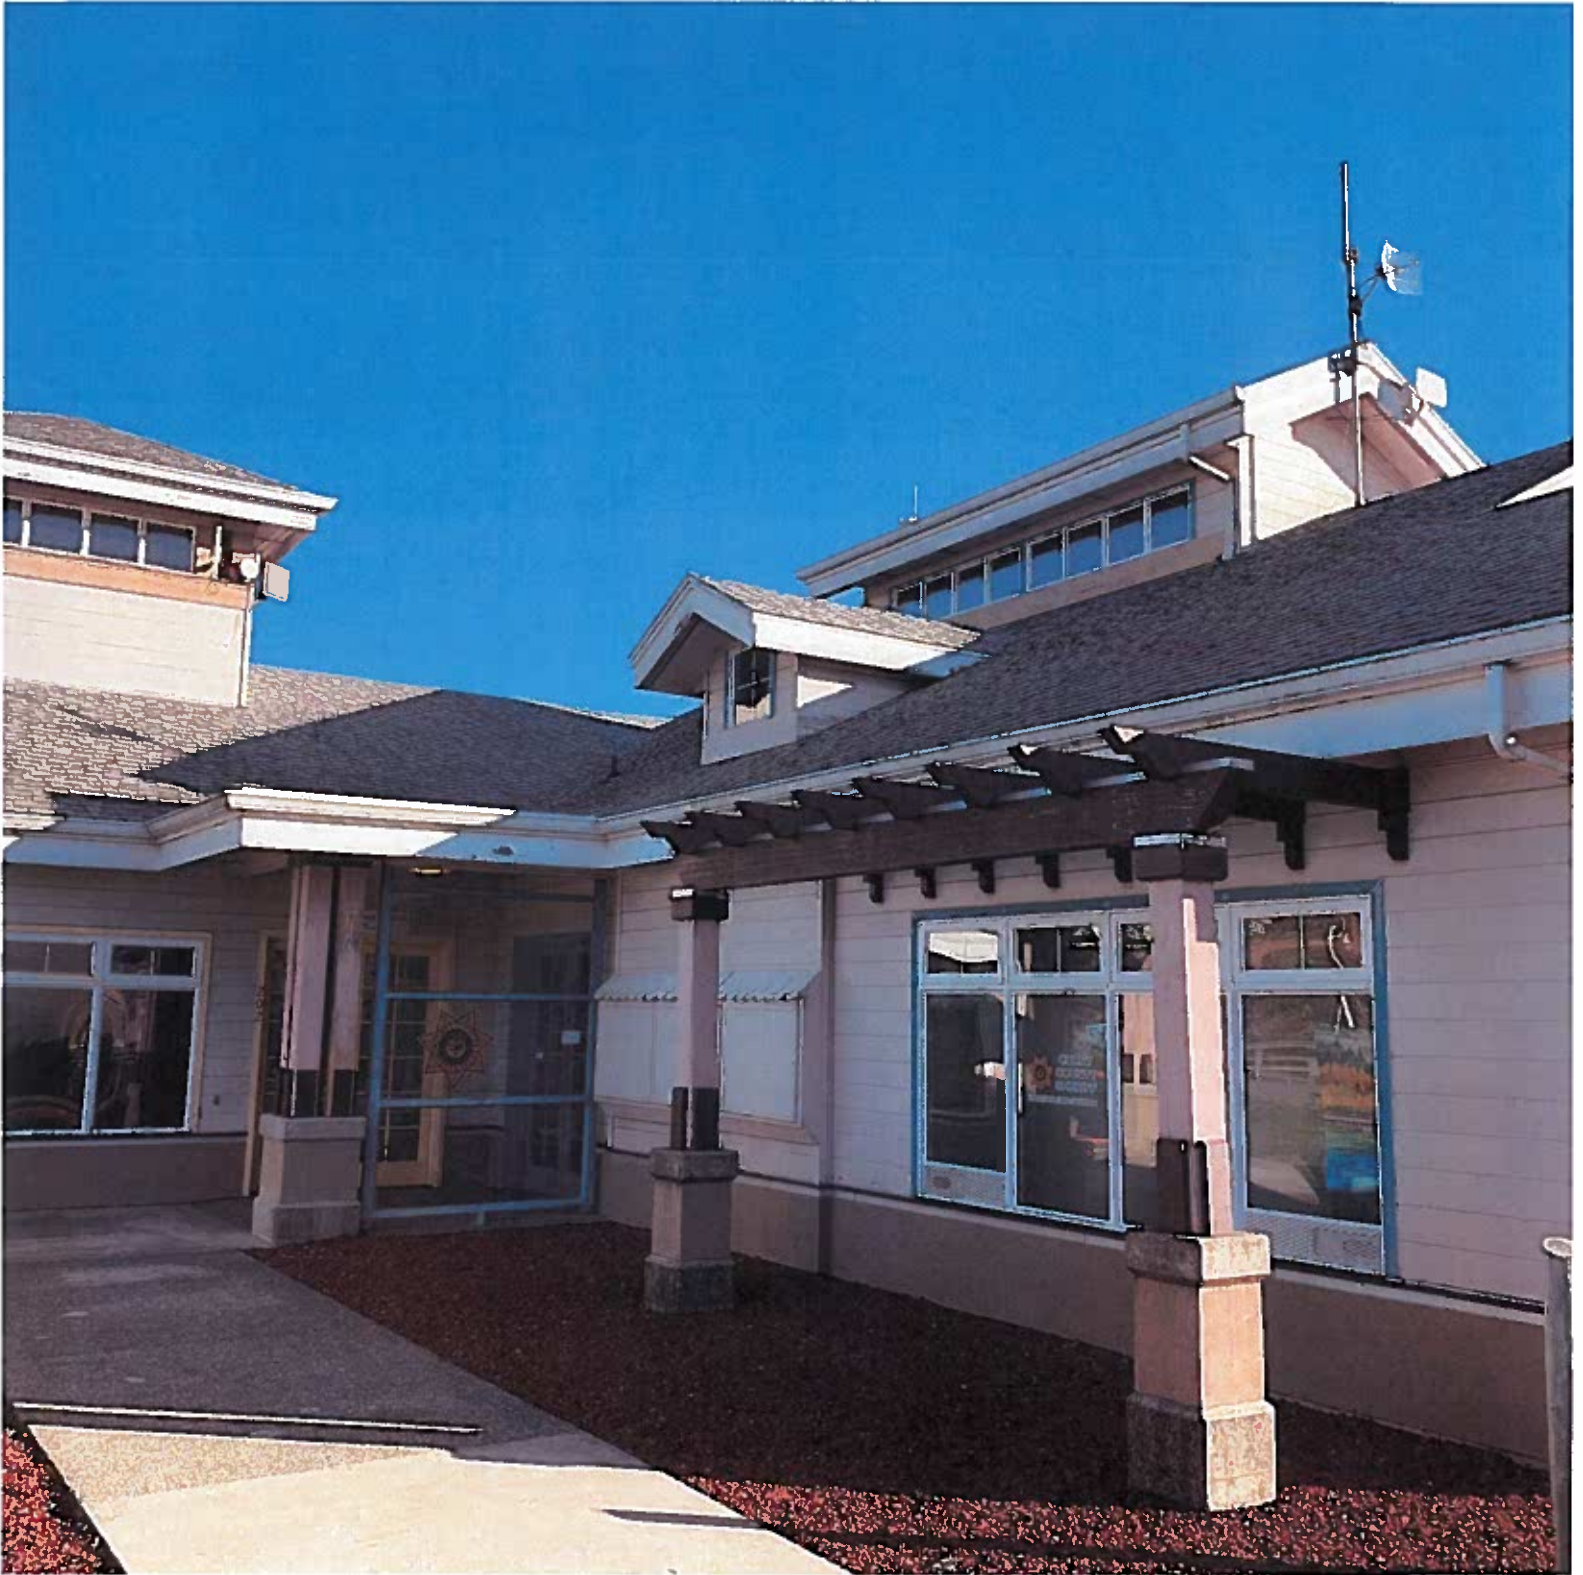
Issue #	CIP Rank	Description of Condition	Priority	Option 1	Estimated Cost	Option 2	Estimated Cost	Option 3	Estimated Cost	Funds Available Y/N
44	18	Repair / Replace Retail Center Building #1 and #2 roofs	1	Repair / Replace existing roofs	120,000	Remove dormers and replace roofs	120,000			No
Board meeting 02-26-2019 Decision

Option 2 could save the Port money in the long run by removing the dormers. Current dormers create more maintenance and leaking issues.
