January 21, 2017 Storm Damage

PORT OF BROOKINGS HARBOR

BASIN 2 DOCK REPAIRS

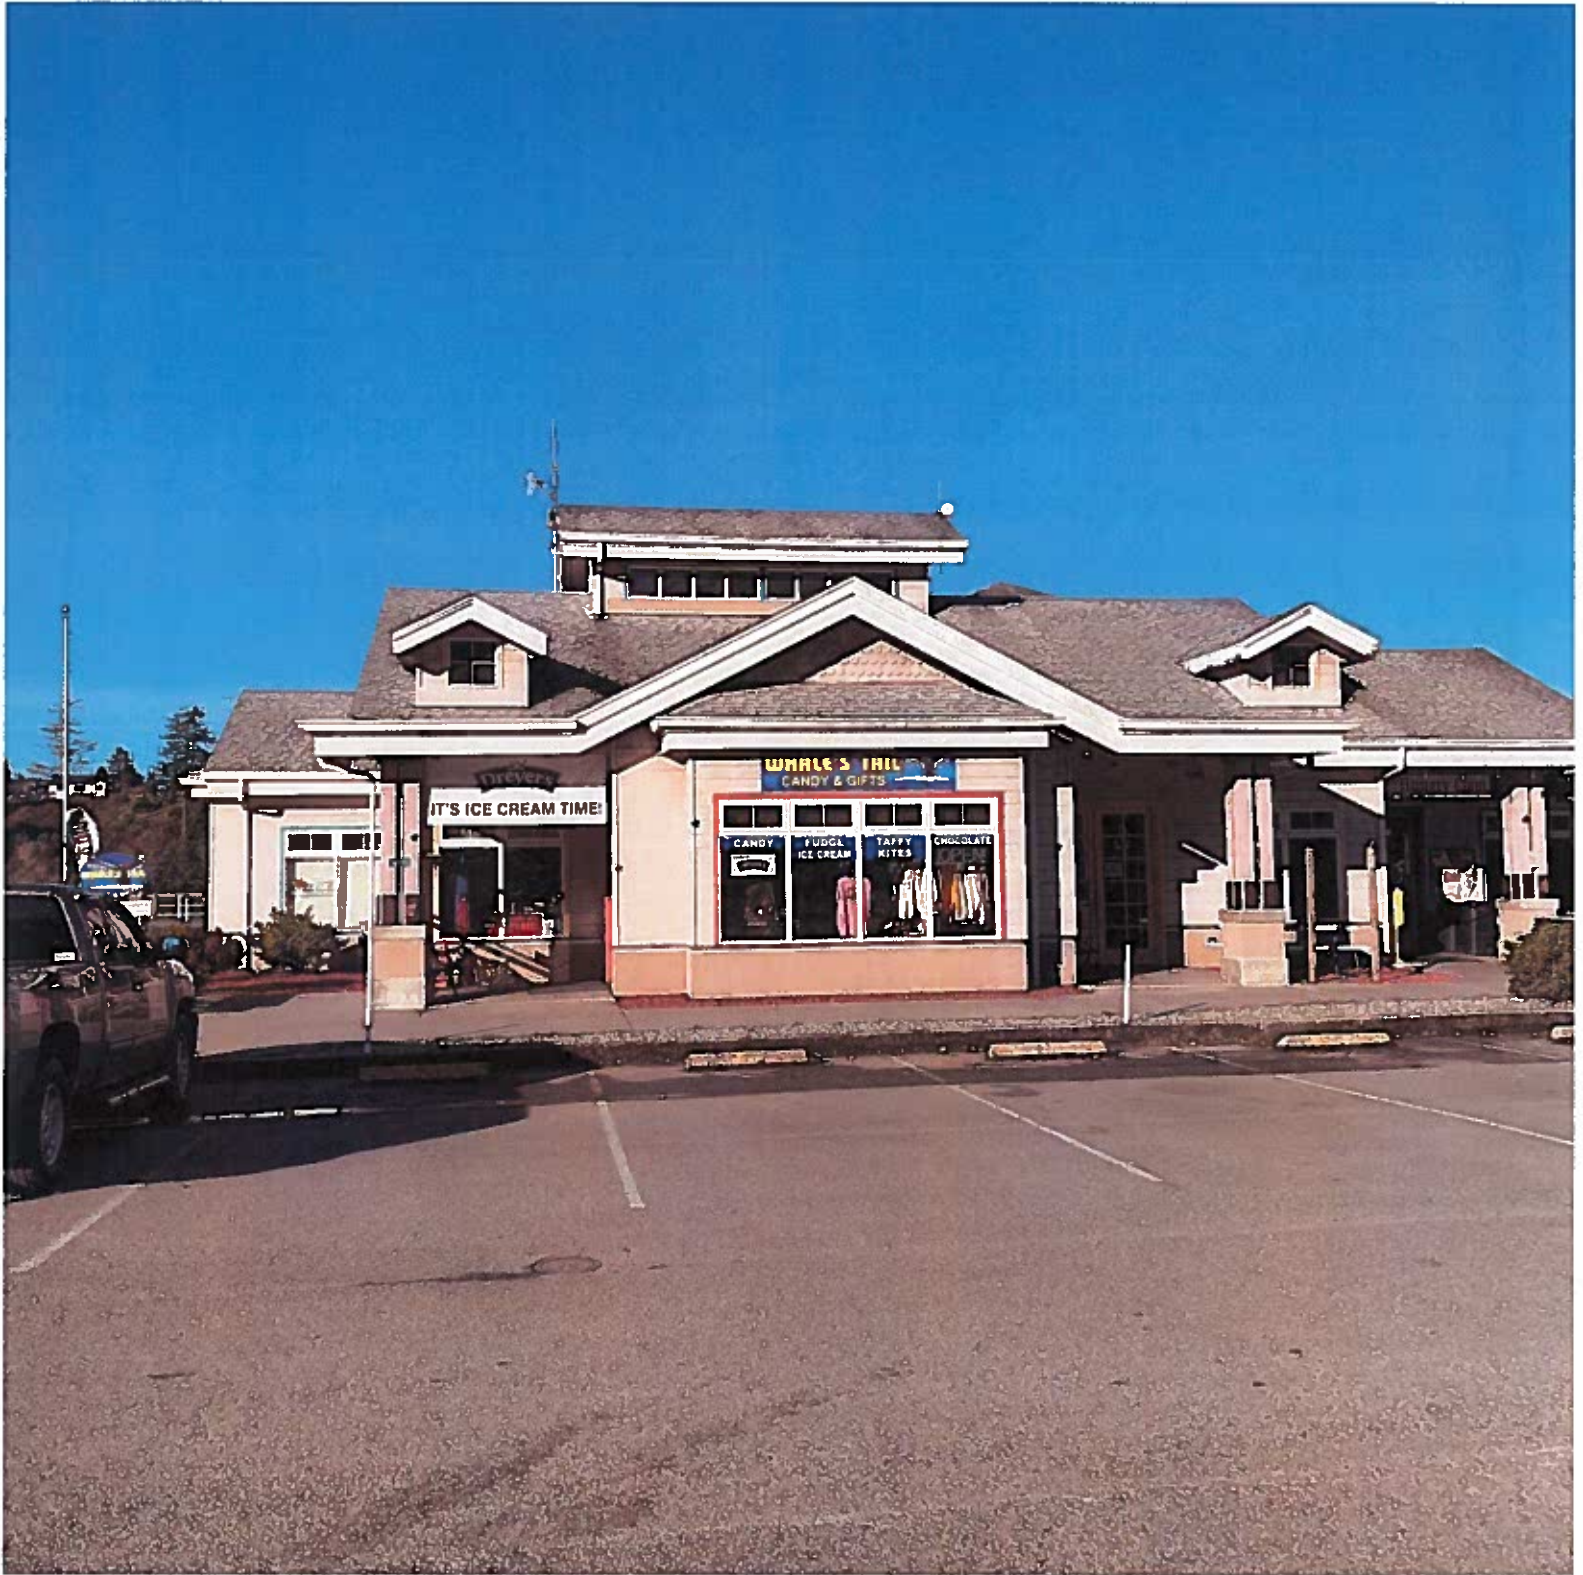
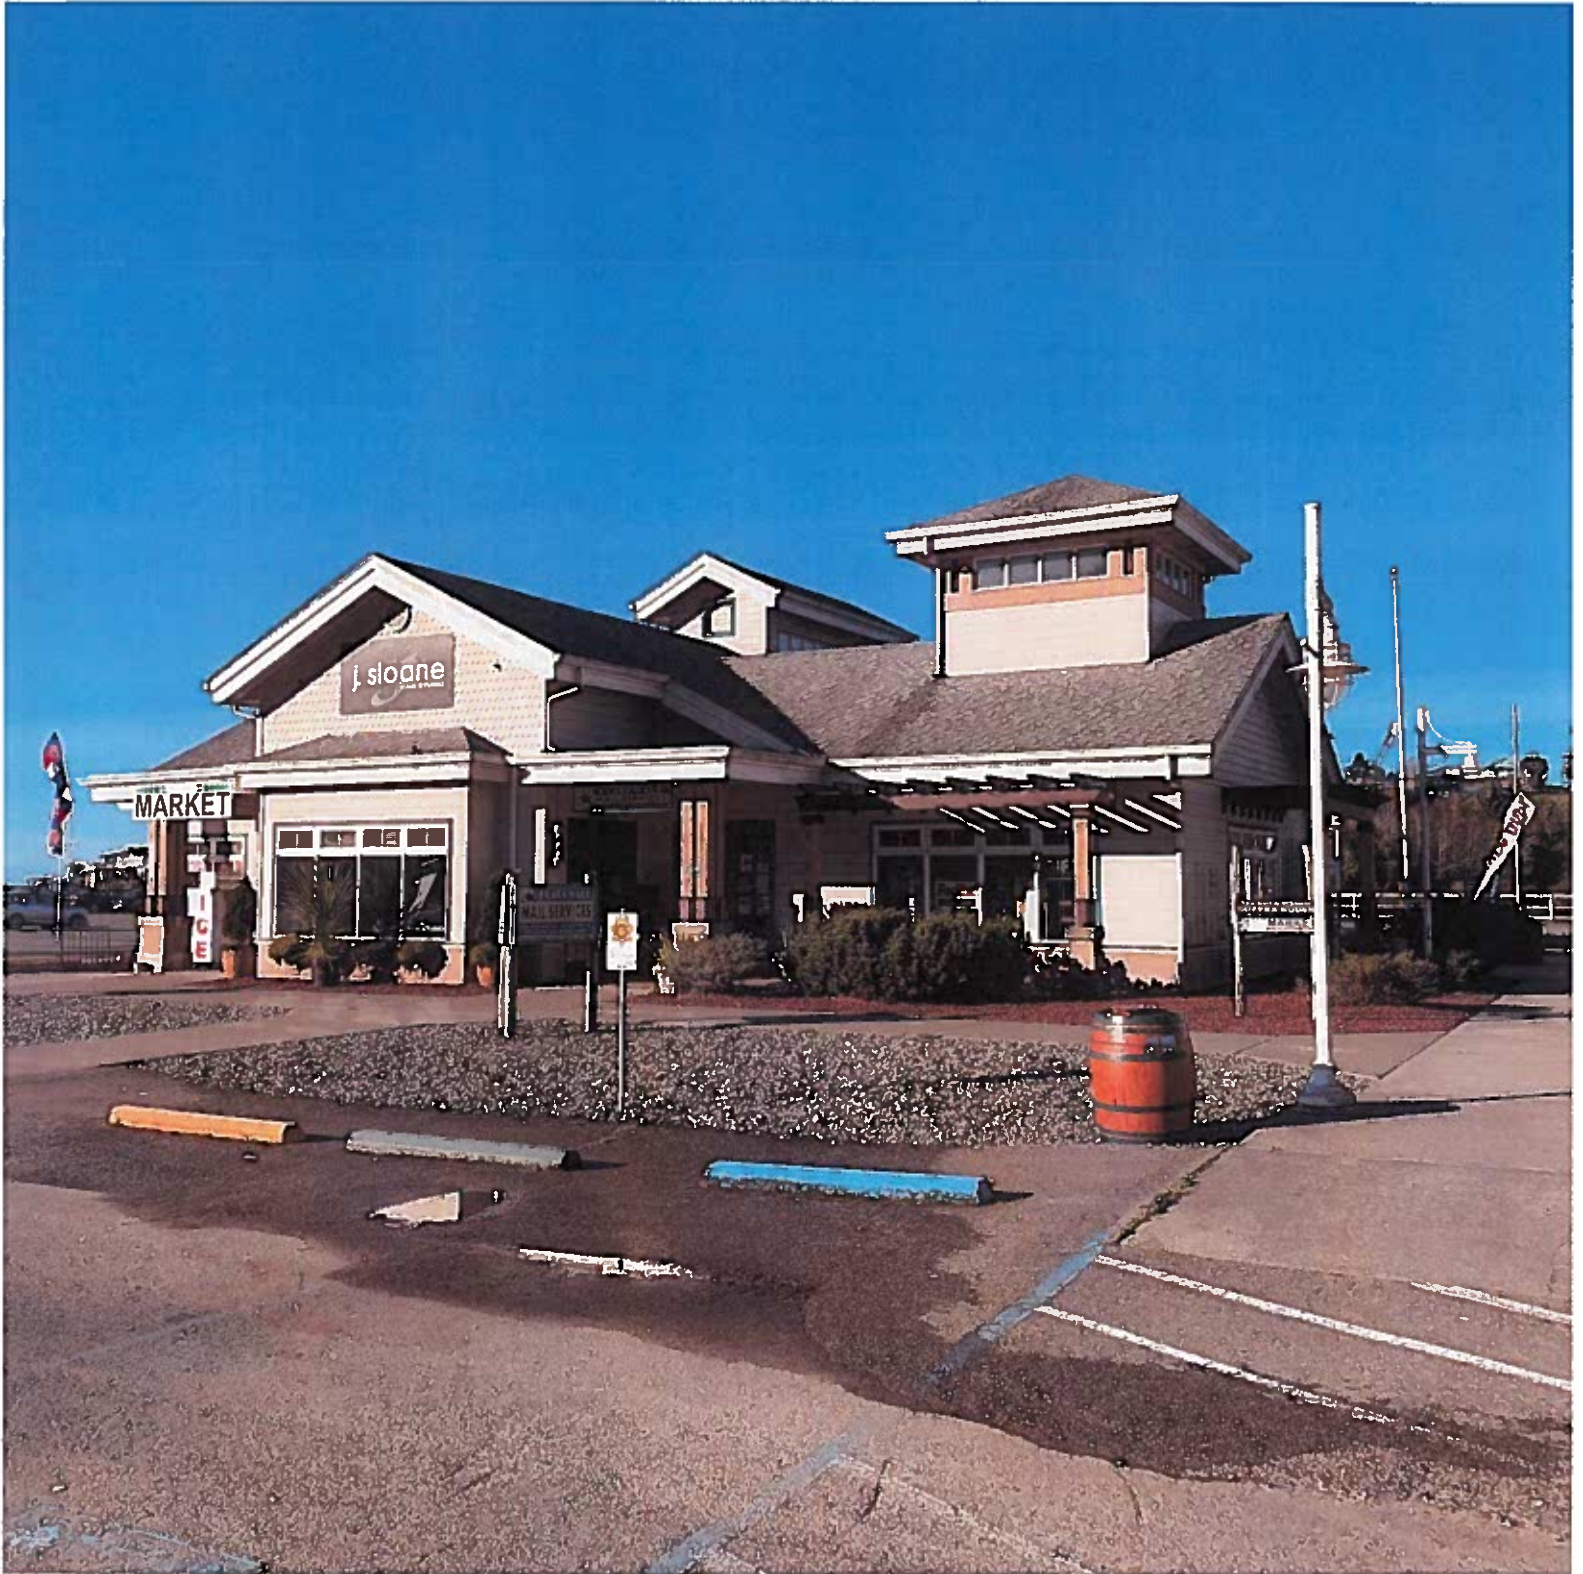
Issue #	CIP Rank	Description of Condition	Priority	Option 1	Estimated Cost	Option 2	Estimated Cost	Option 3	Estimated Cost	Funds Available Y/N
45	18	Repaint Retail Center Buildings #1 and #2	1	Repaint Retail Center Buildings #1 and #2	75,000					No
Board meeting 02-26-2019 Decision

Option 1 if dormers are removed from the roofs, cost of painting would be reduced.

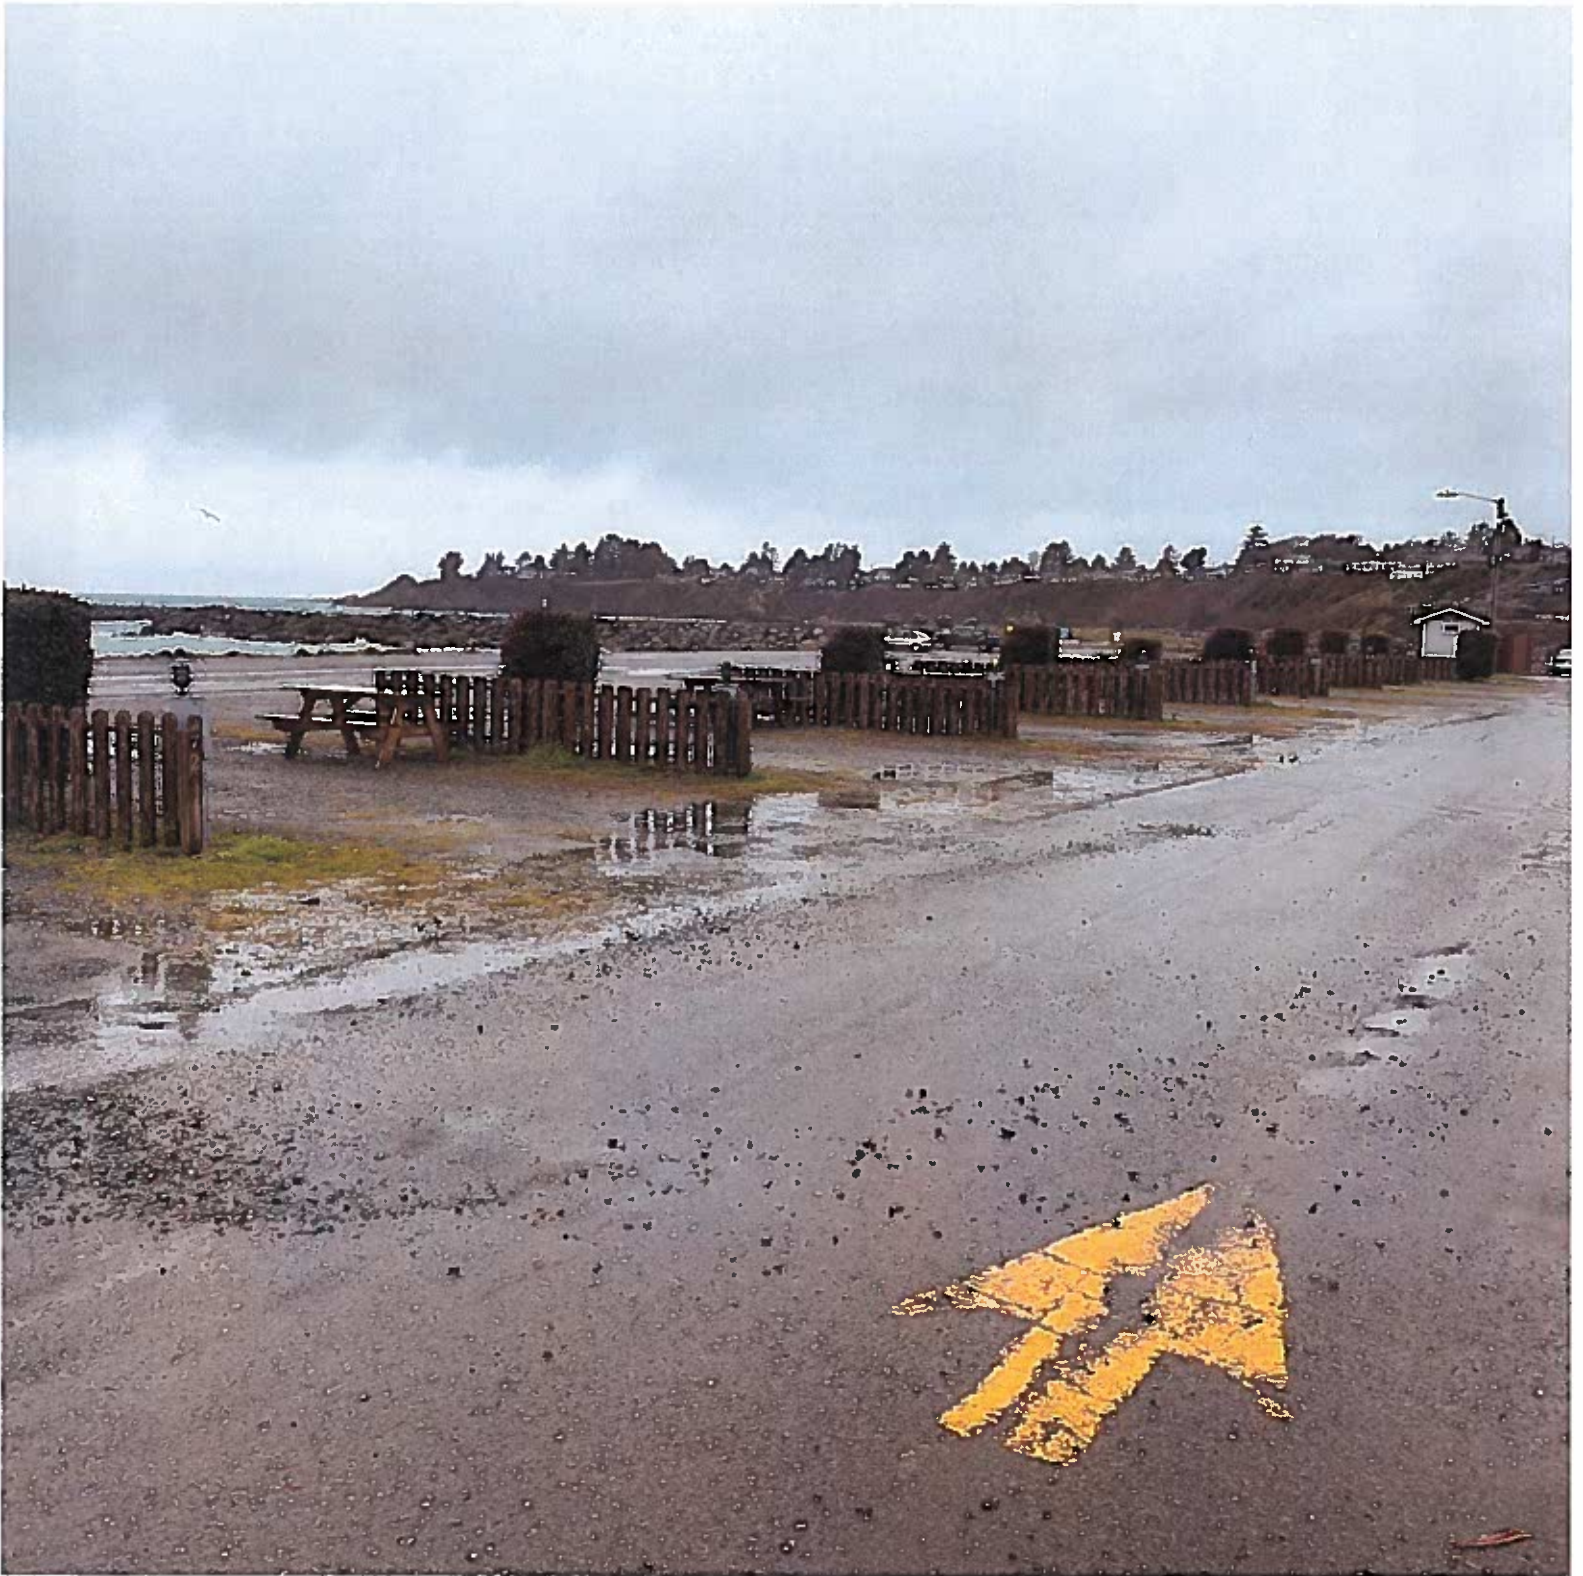
Issue #	CIP Rank	Description of Condition	Priority	Option 1	Estimated Cost	Option 2	Estimated Cost	Option 3	Estimated Cost	Funds Available Y/N
49		Replace worn out fence at RV Park	3	Make repairs as necessary	20,000	Remove old and replace with new	100,000			No
		Board meeting 02-26-2019 Decision

Option 2 if funding is available.

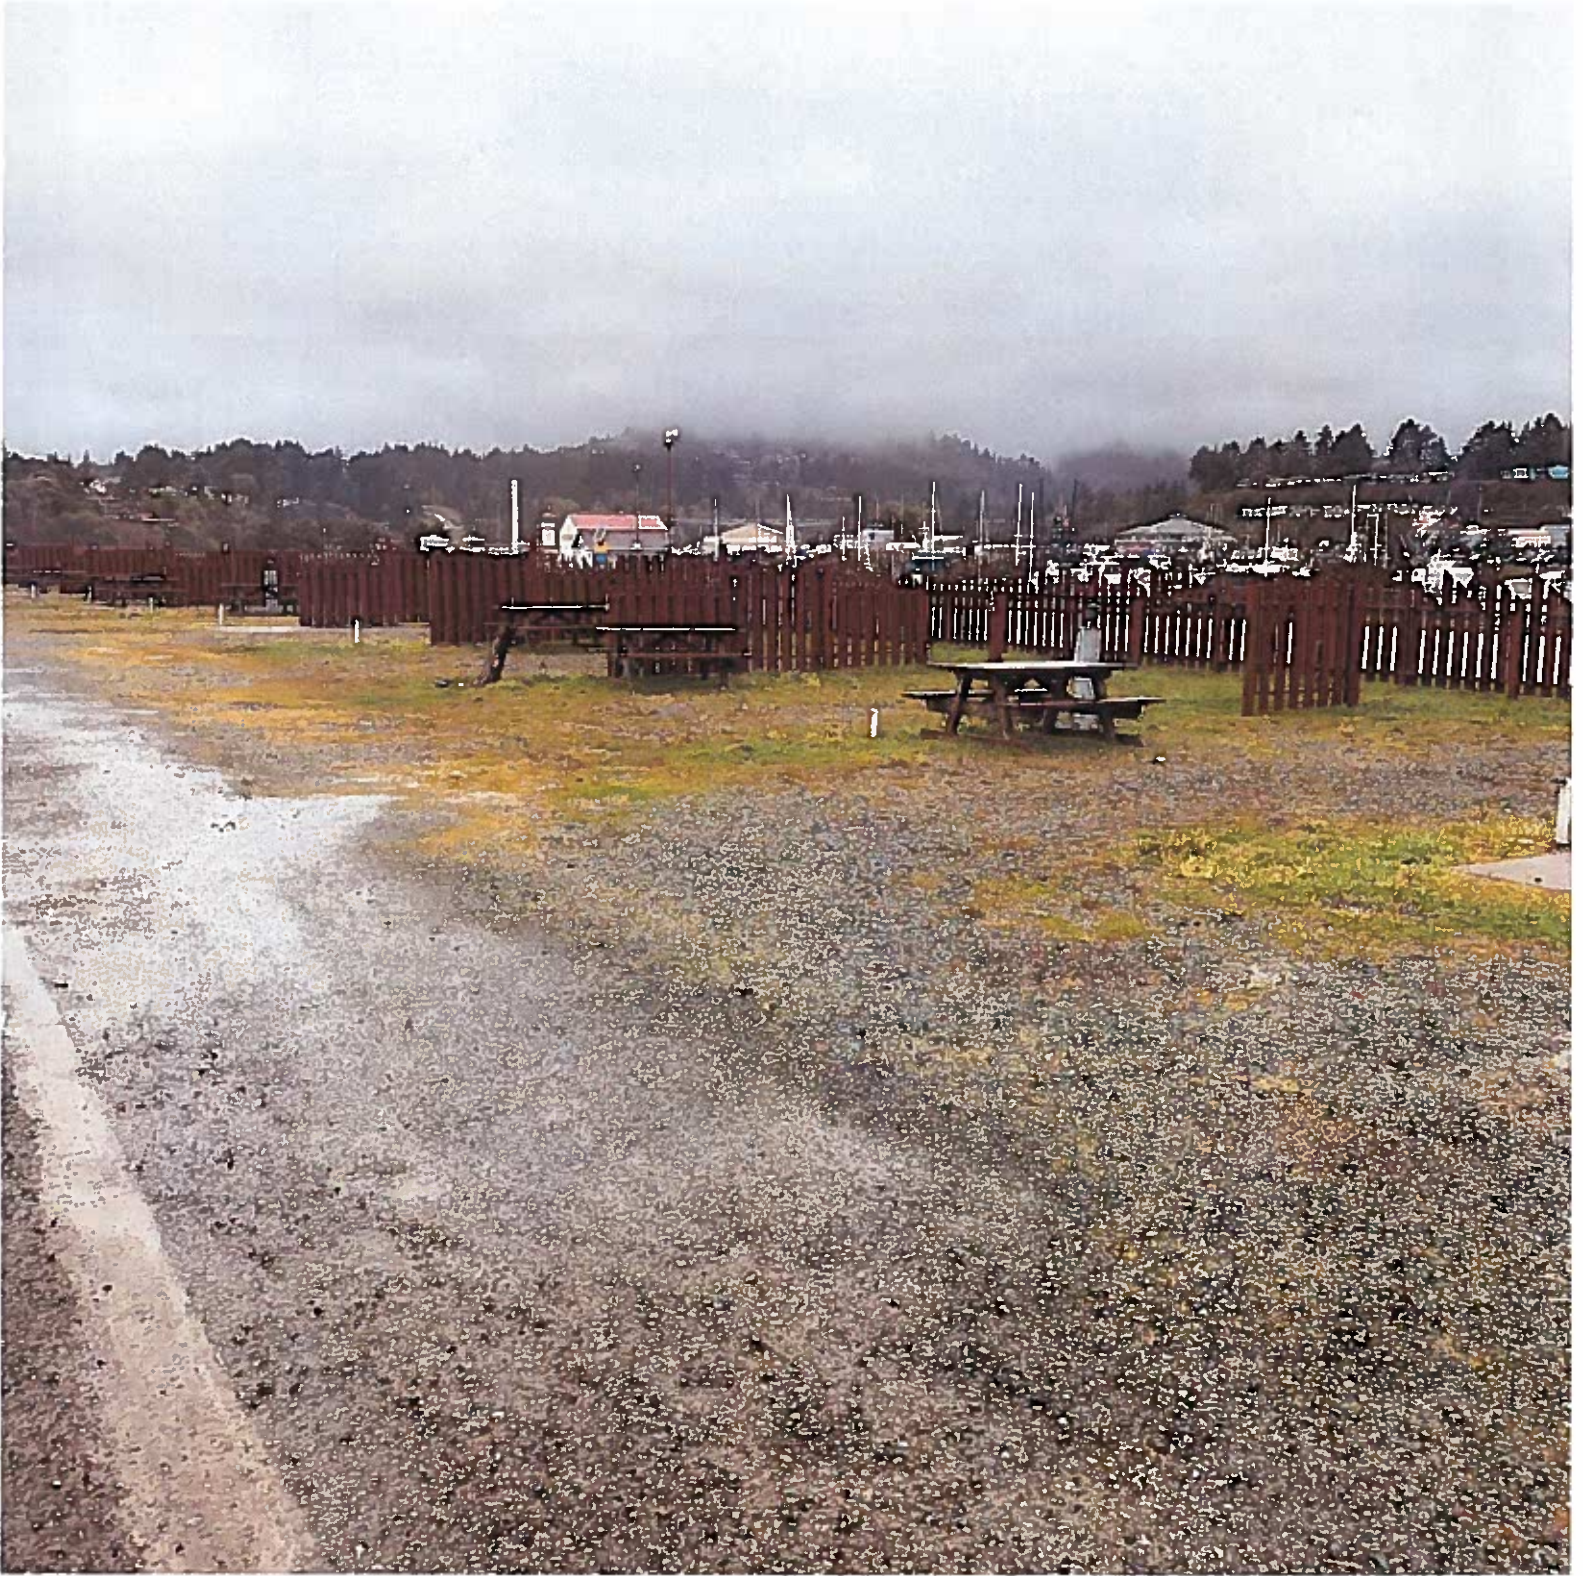
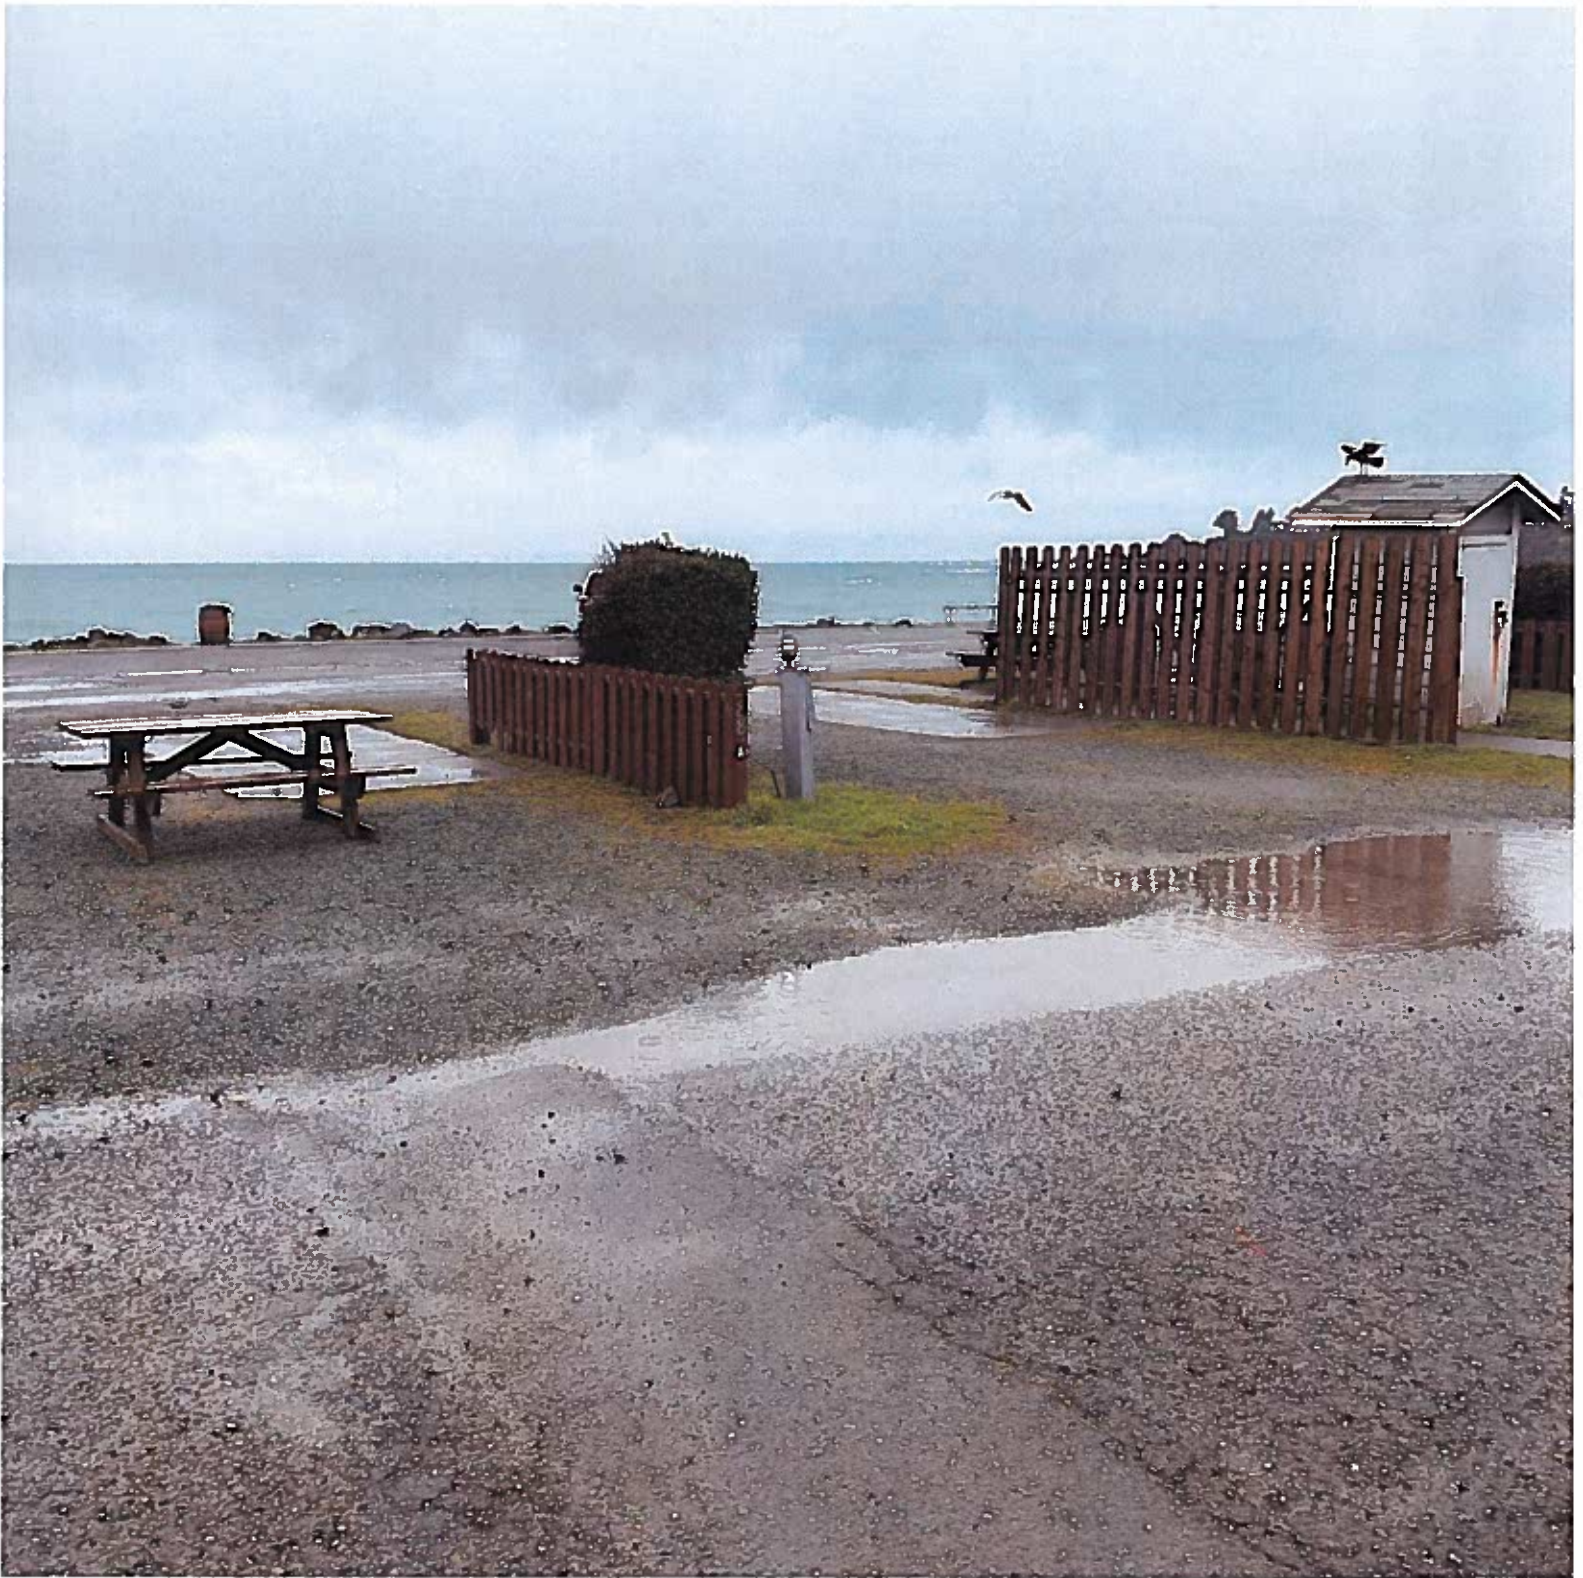
Issue #	CIP Rank	Description of Condition	Priority	Option 1	Estimated Cost	Option 2	Estimated Cost	Option 3	Estimated Cost	Funds Available Y/N
50		Upgrade RV Park sites	4	Pave RV Spaces	300,000	Use concrete instead of paving for the spaces	400,000	Leave ground as-is and maintain the weeds/grass	25,000	No
Board meeting 02-26-2019 Decision

Option 1 or 2 if funding is available. Option 3 is per year cost.

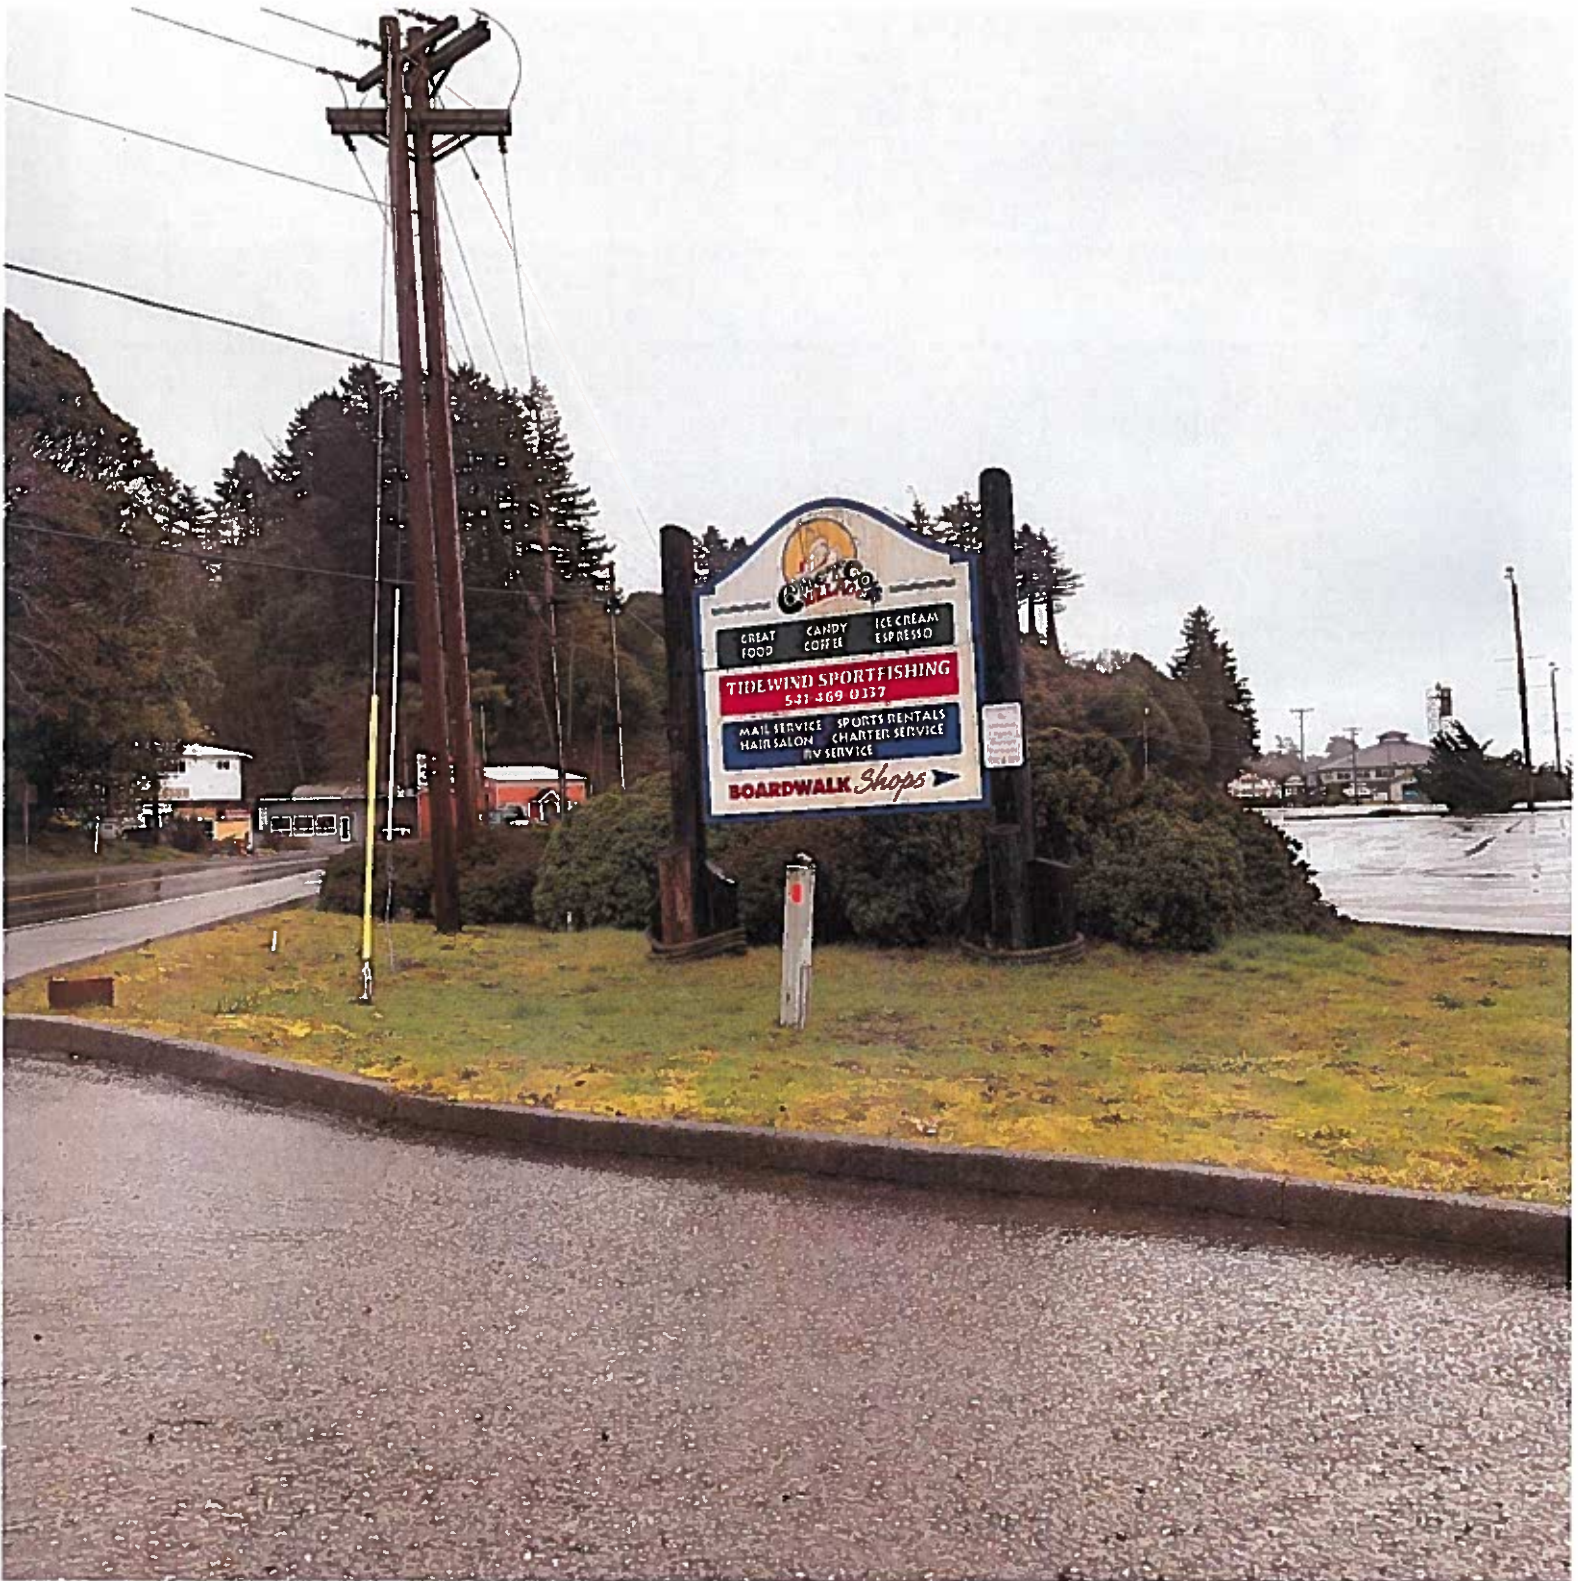
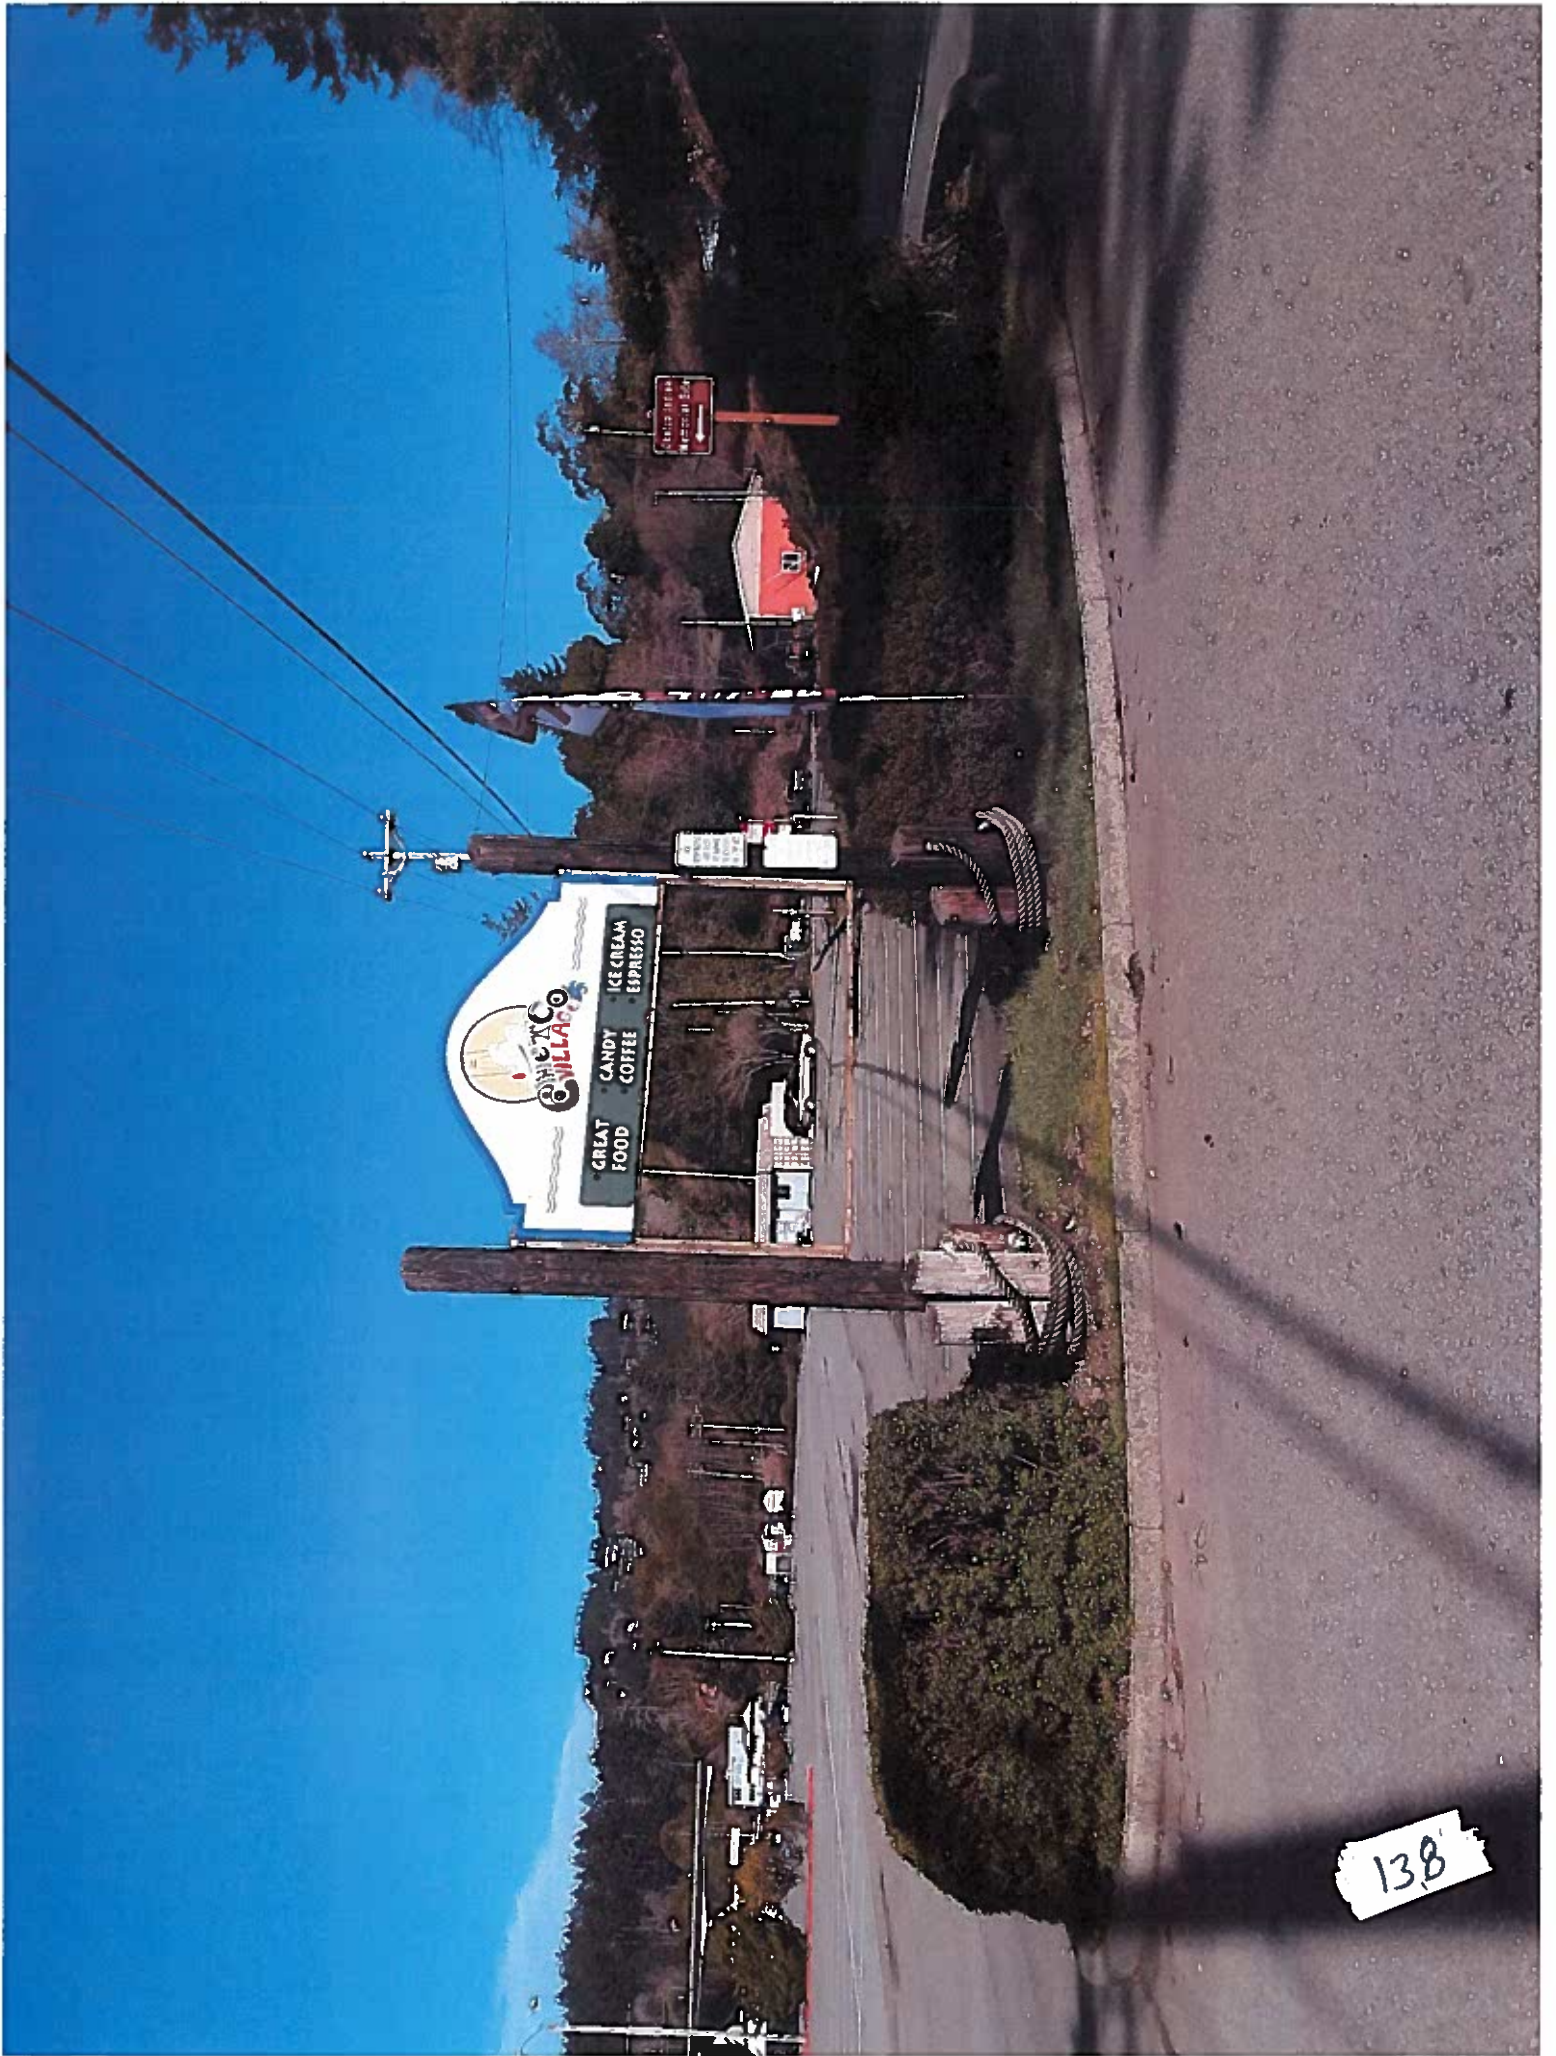
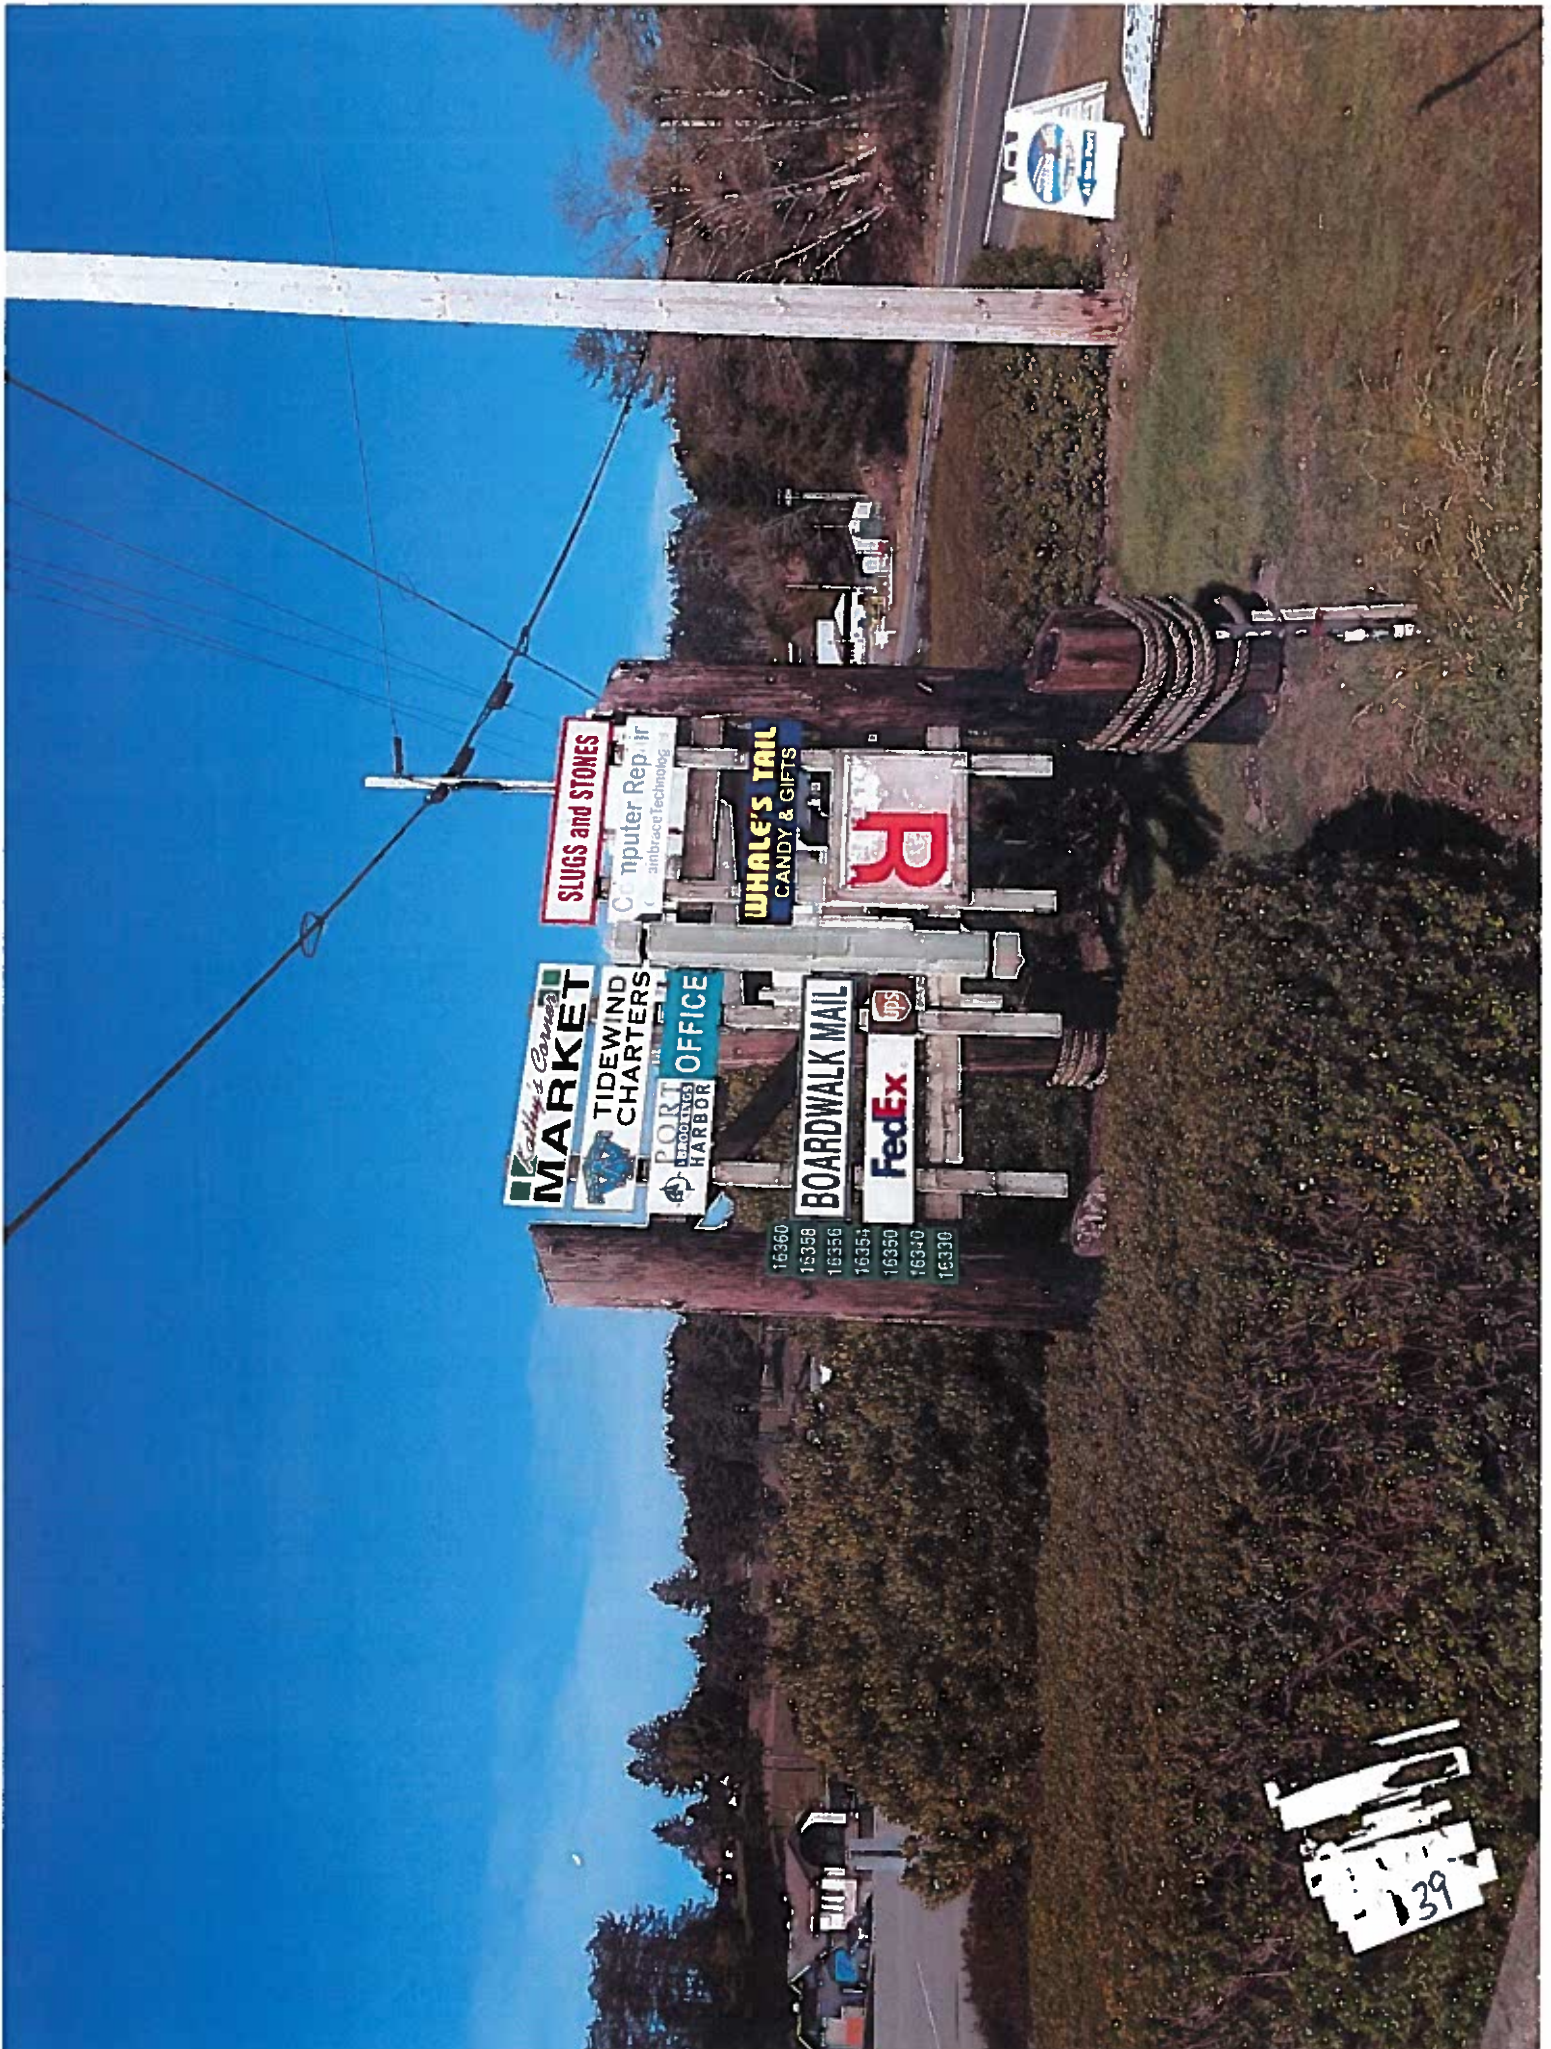
Issue #	CIP Rank	Description of Condition	Priority	Option 1	Estimated Cost	Option 2	Estimated Cost	Option 3	Estimated Cost	Funds Available Y/N
59		Upgrade Port / Tenants Signage	3	Replace and update billboard signs	15,000	Develop and install new signage throughout Port	100,000			No
		Board meeting 02-26-2019 Decision

Option 2
