January 21, 2017 Storm Damage

PORT OF BROOKINGS HARBOR

BASIN 2 DOCK REPAIRS

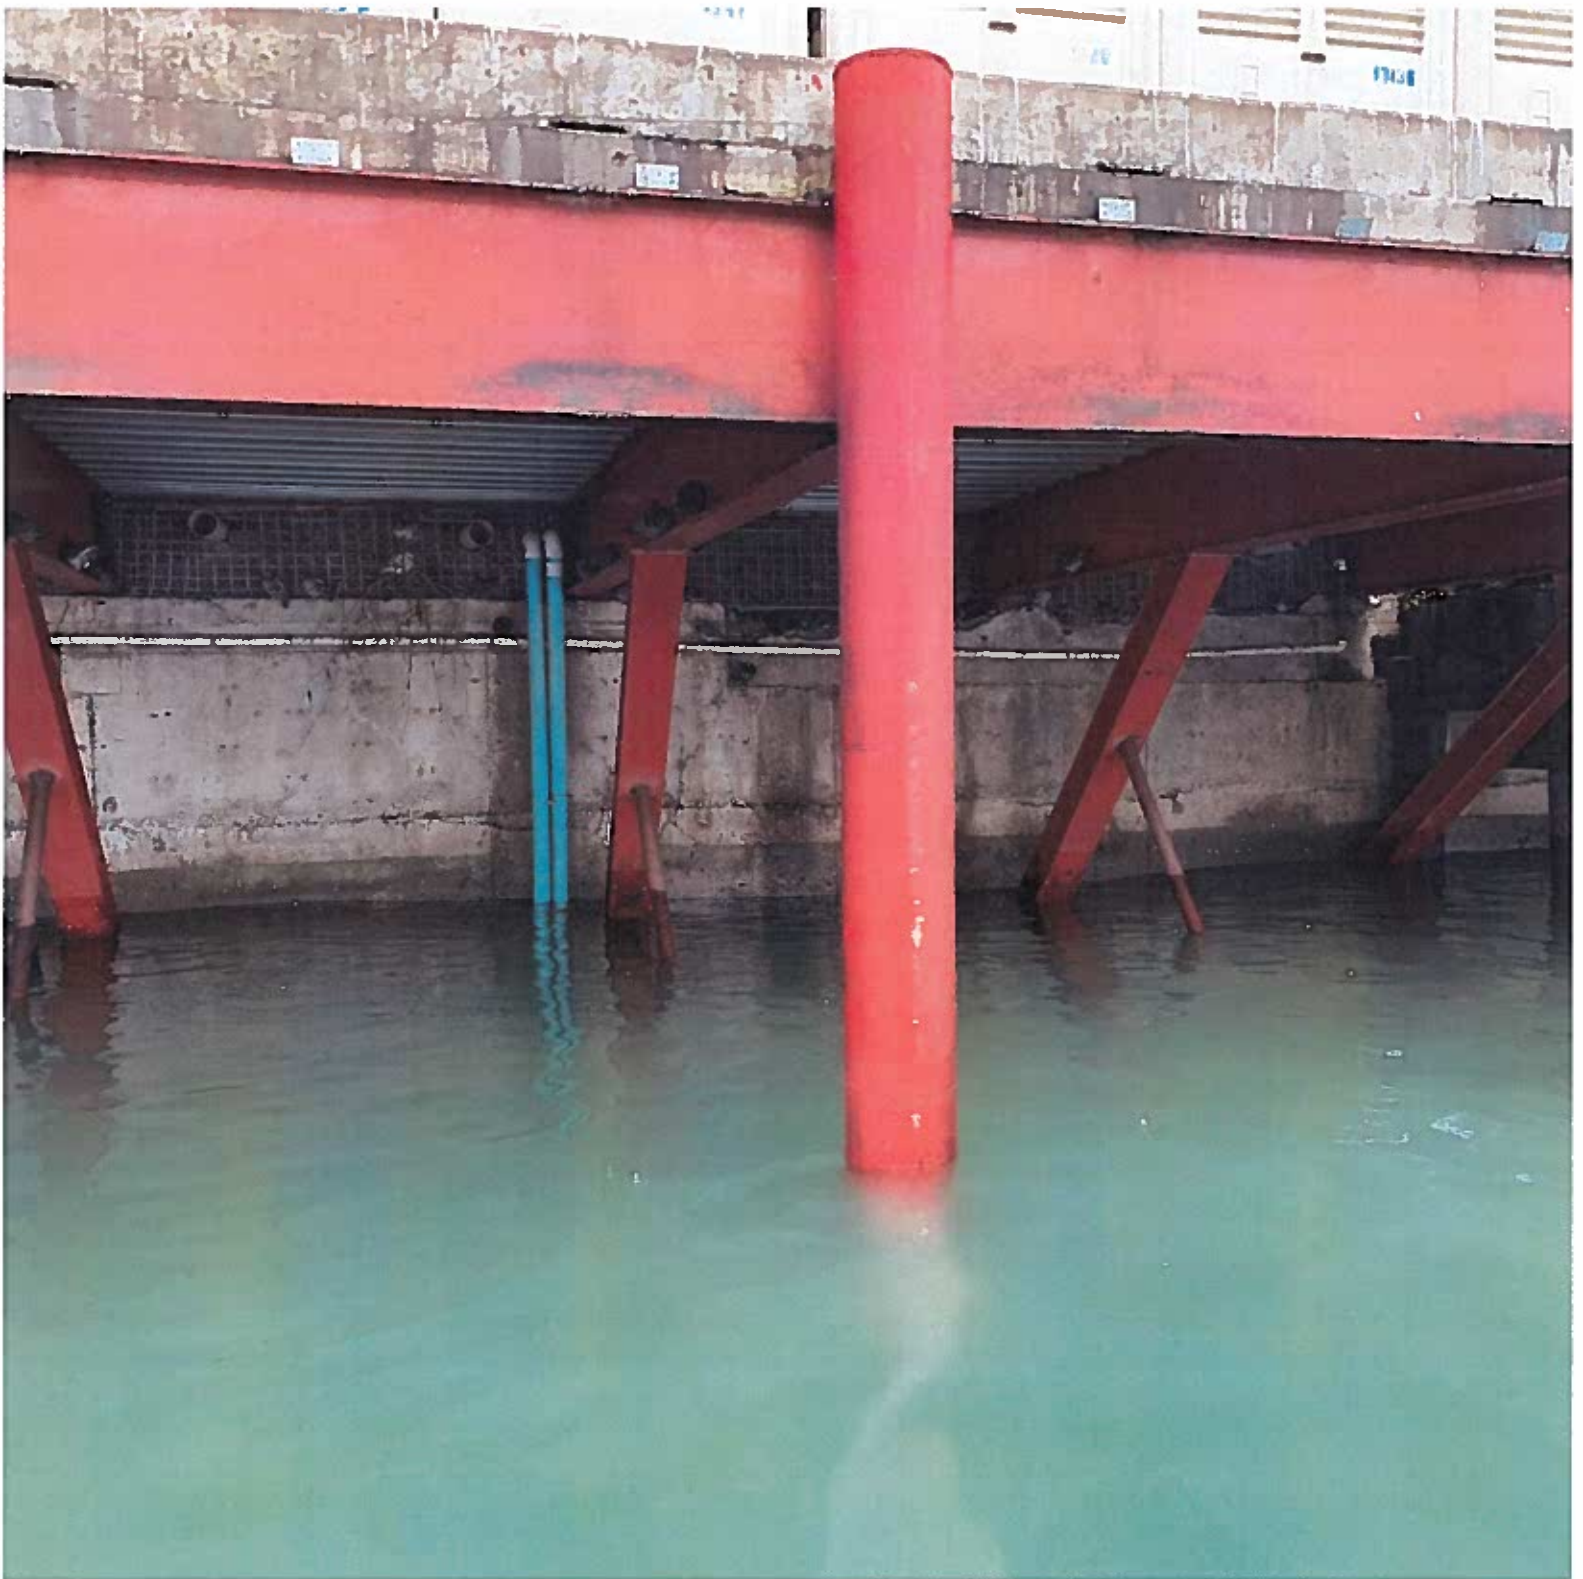
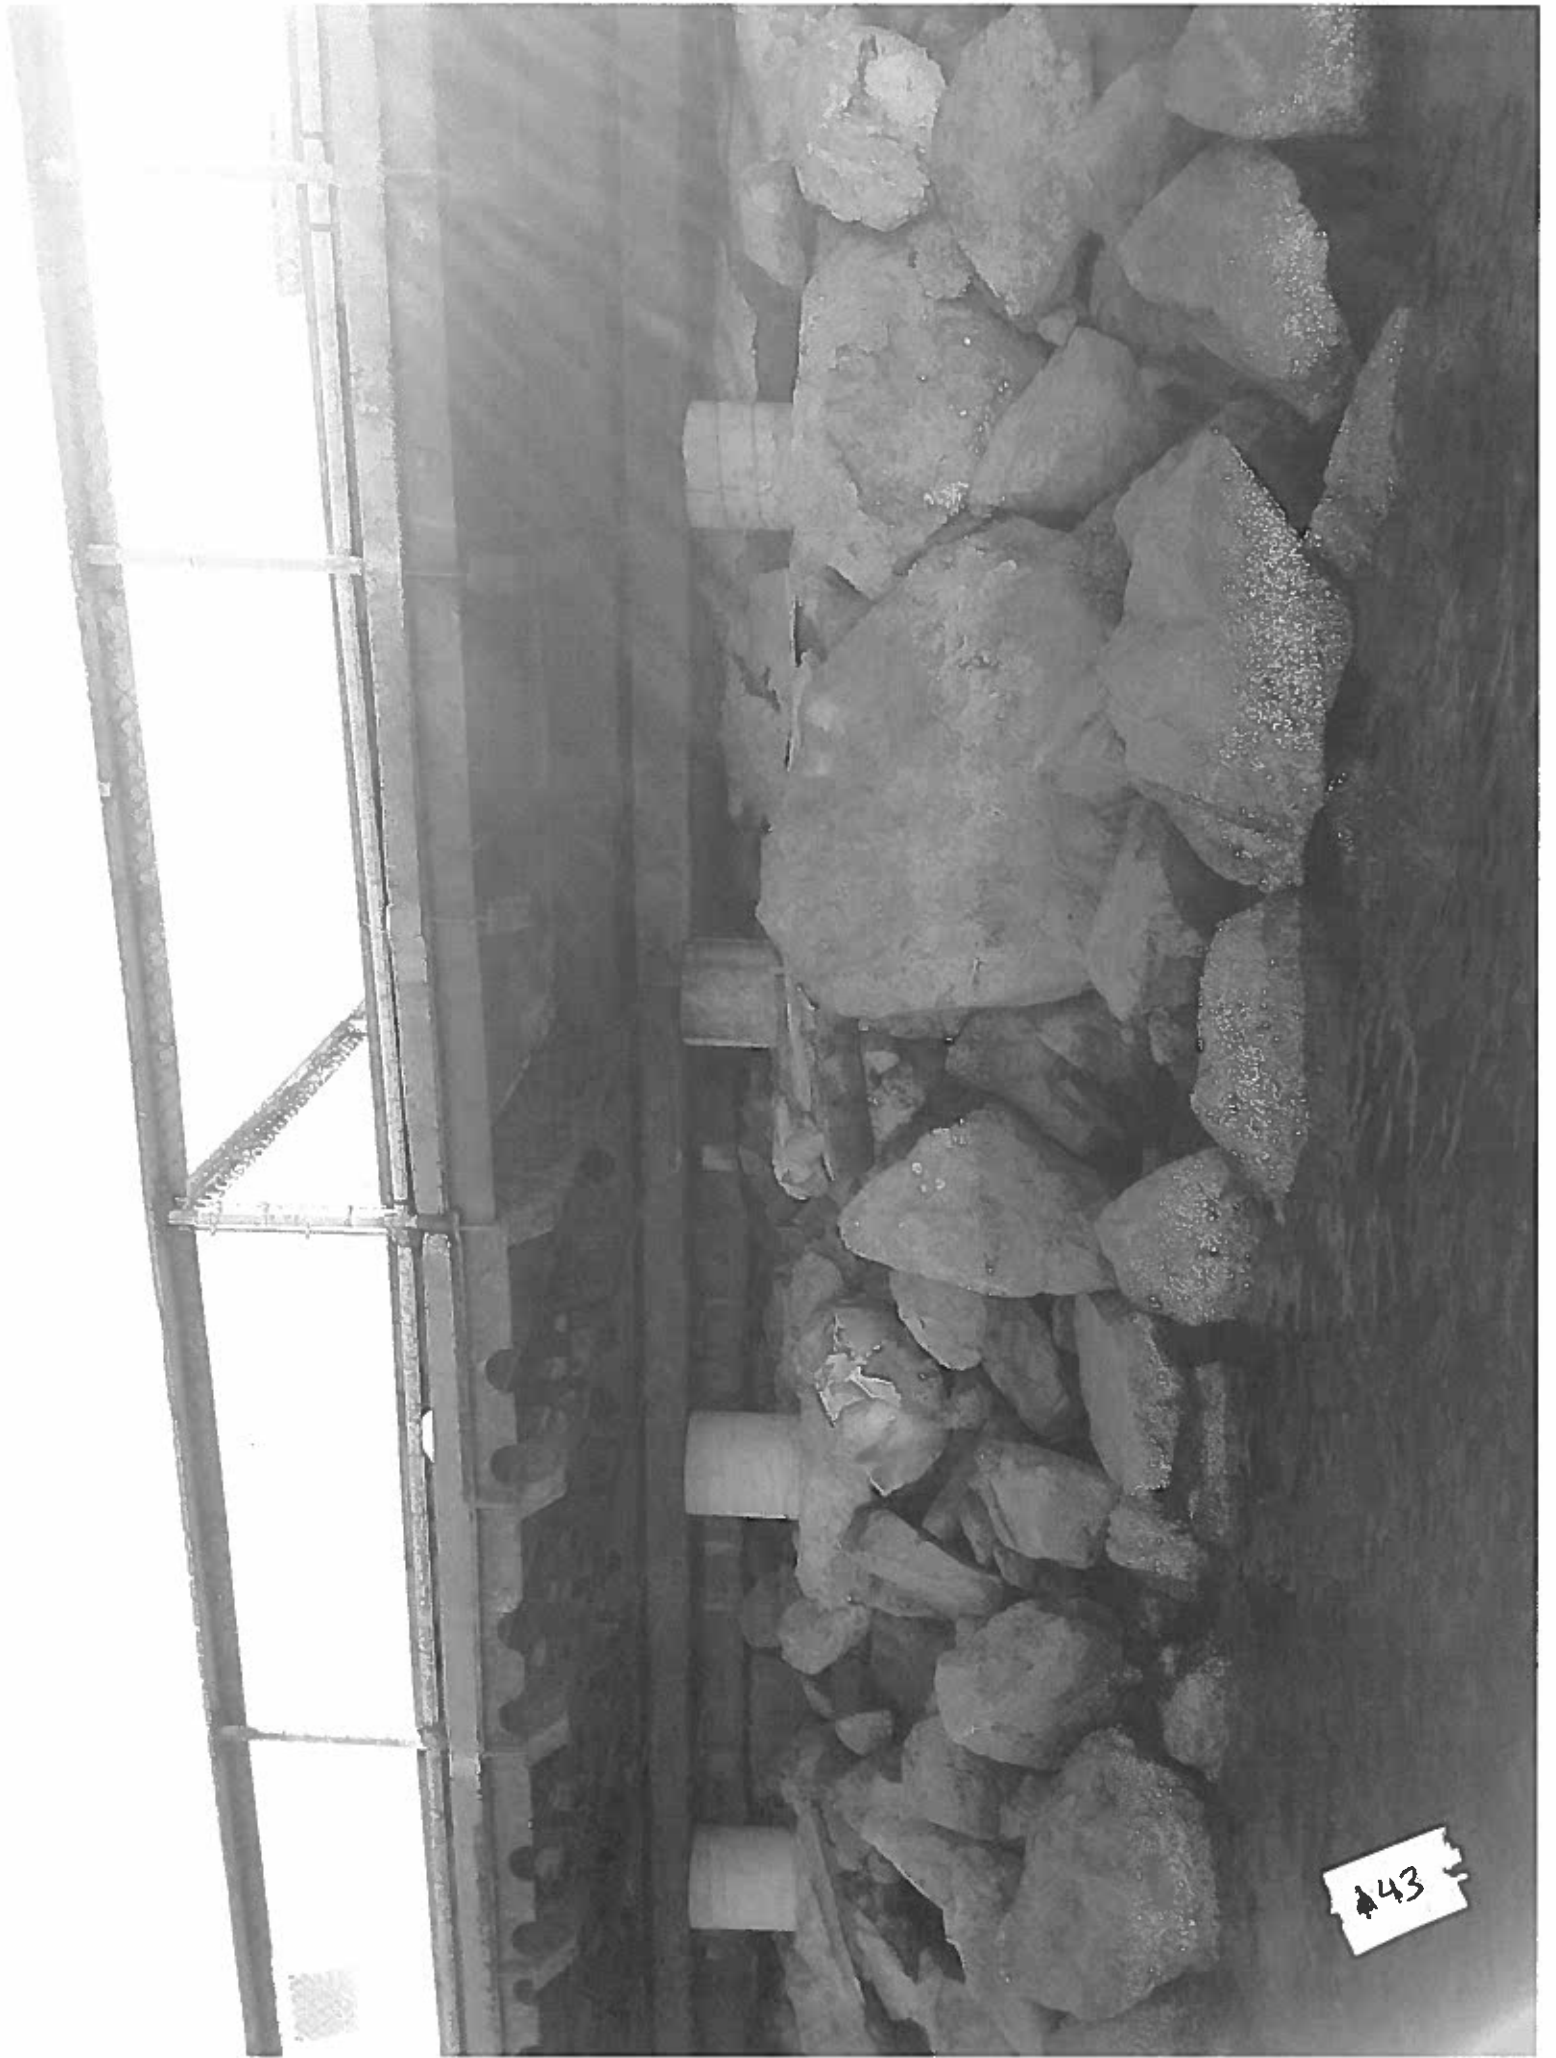
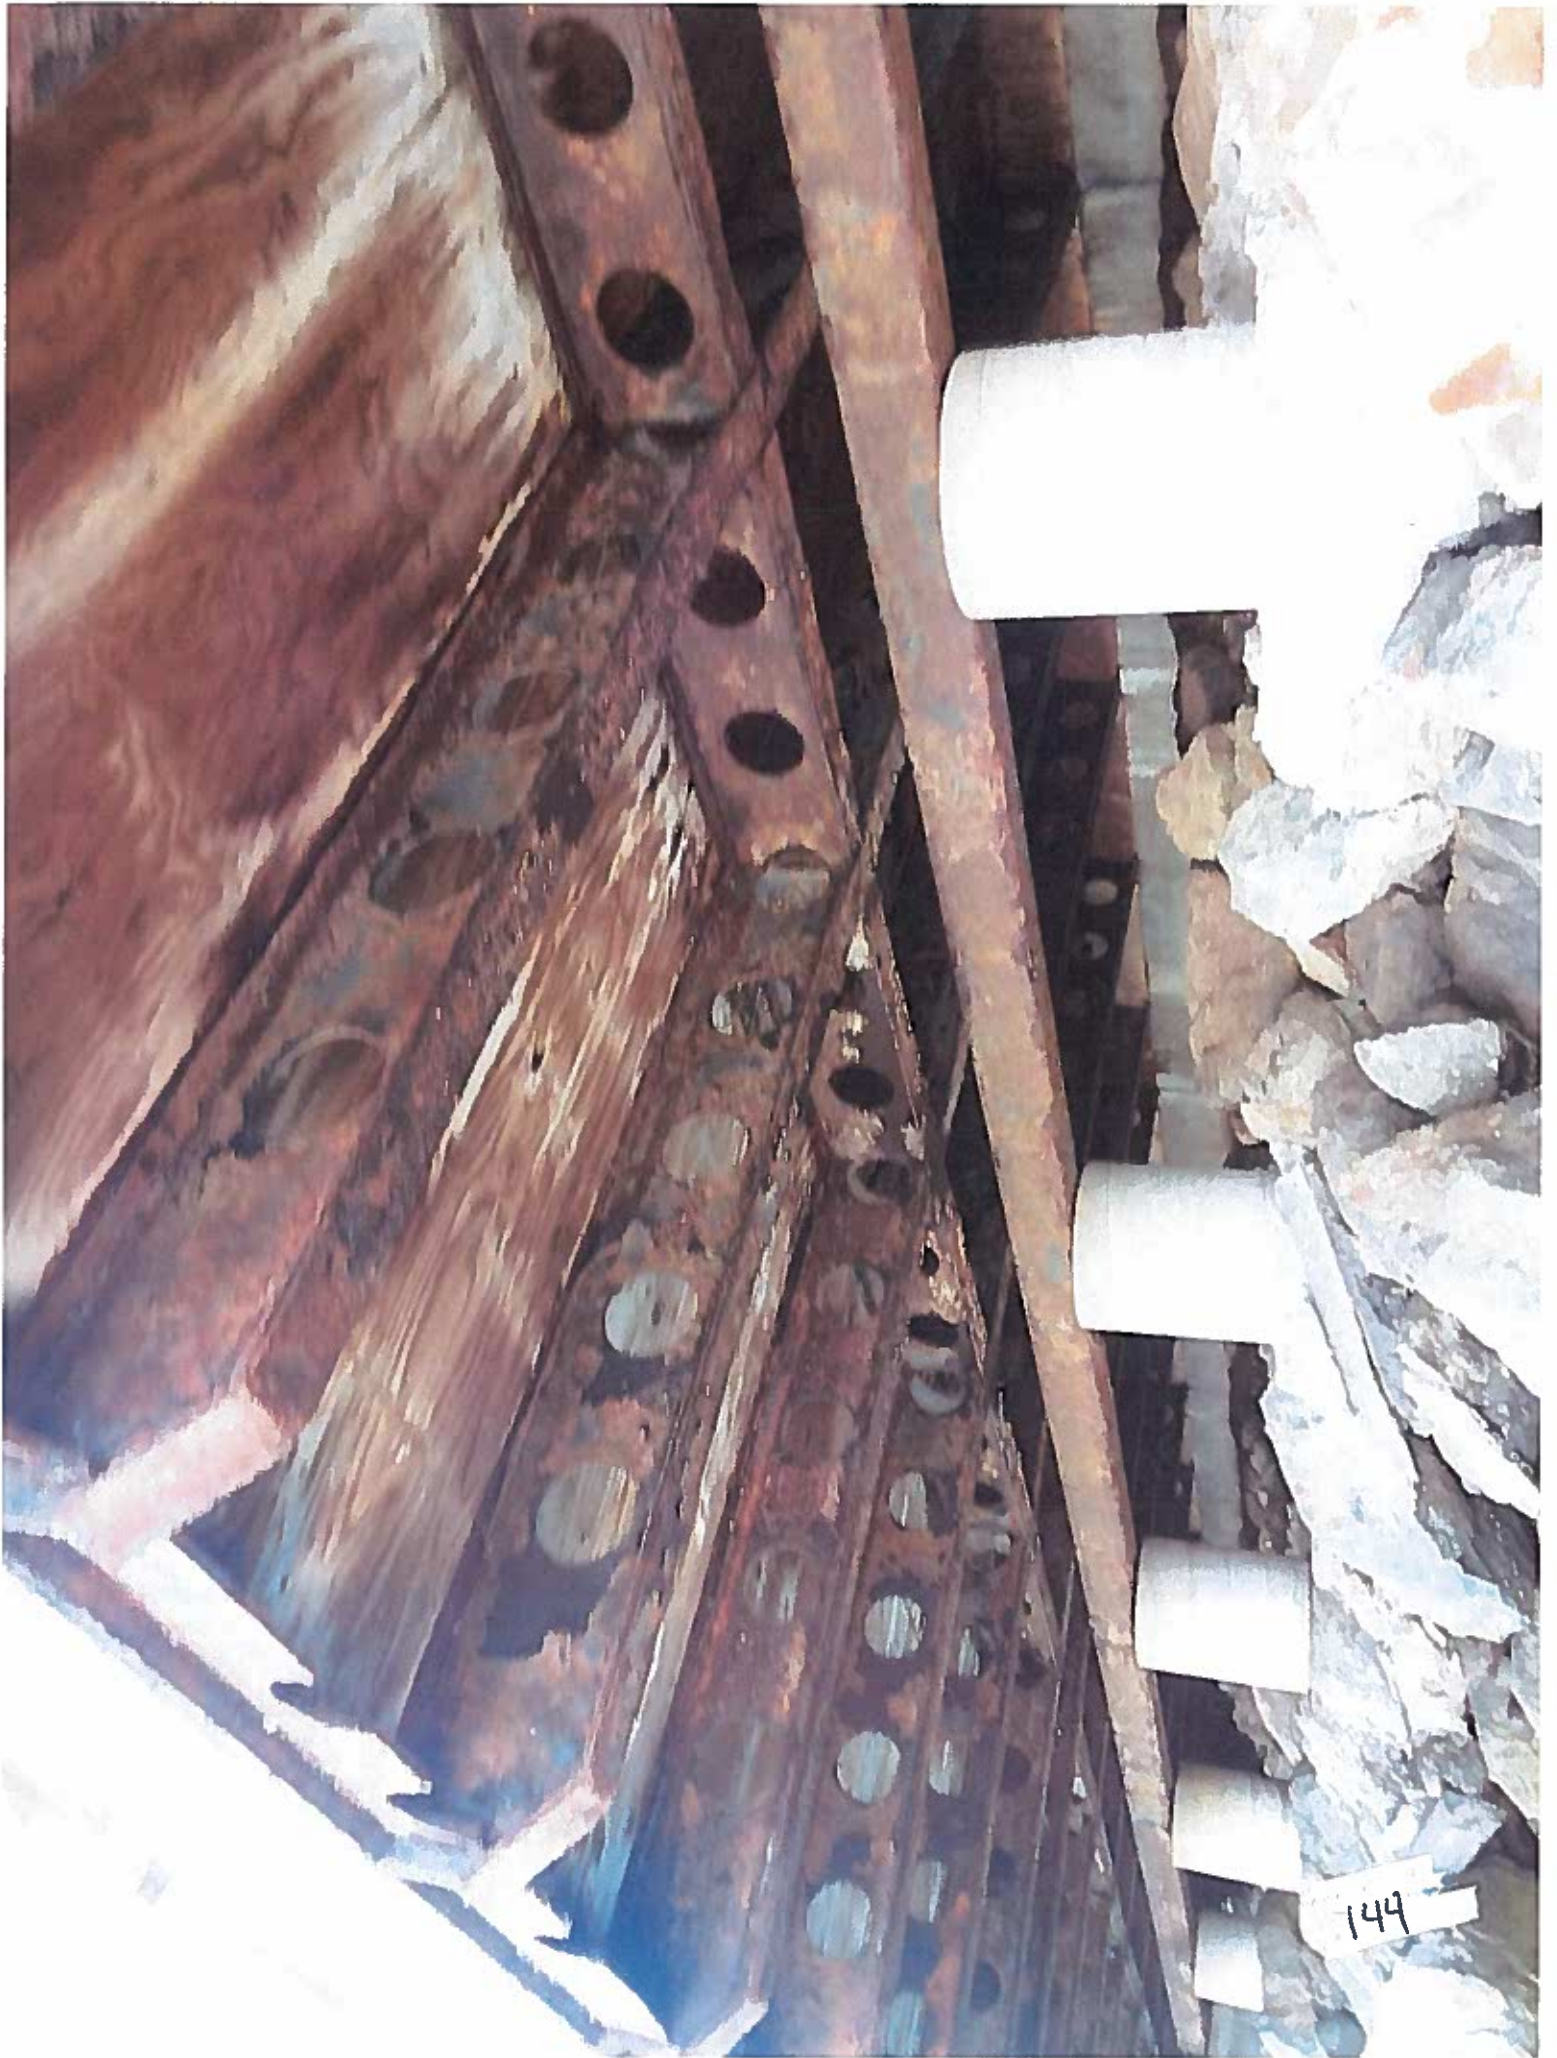
Issue #	CIP Rank	Description of Condition	Priority	Option 1	Estimated Cost	Option 2	Estimated Cost	Option 3	Estimated Cost	Funds Available Y/N
61		Install protective coating to steel under new receiving dock (BC Fisheries)		Paint protective coating	150,000	Spray-on protective coating	100,000			No
62		Install protective coating to steel under Fishing Pier		Paint protective coating	100,000	Spray-on protective coating	75,000			No
Board meeting 02-26-2019 Decision

Protective coating should be installed on the steel to maximize the lifespan of the docks.

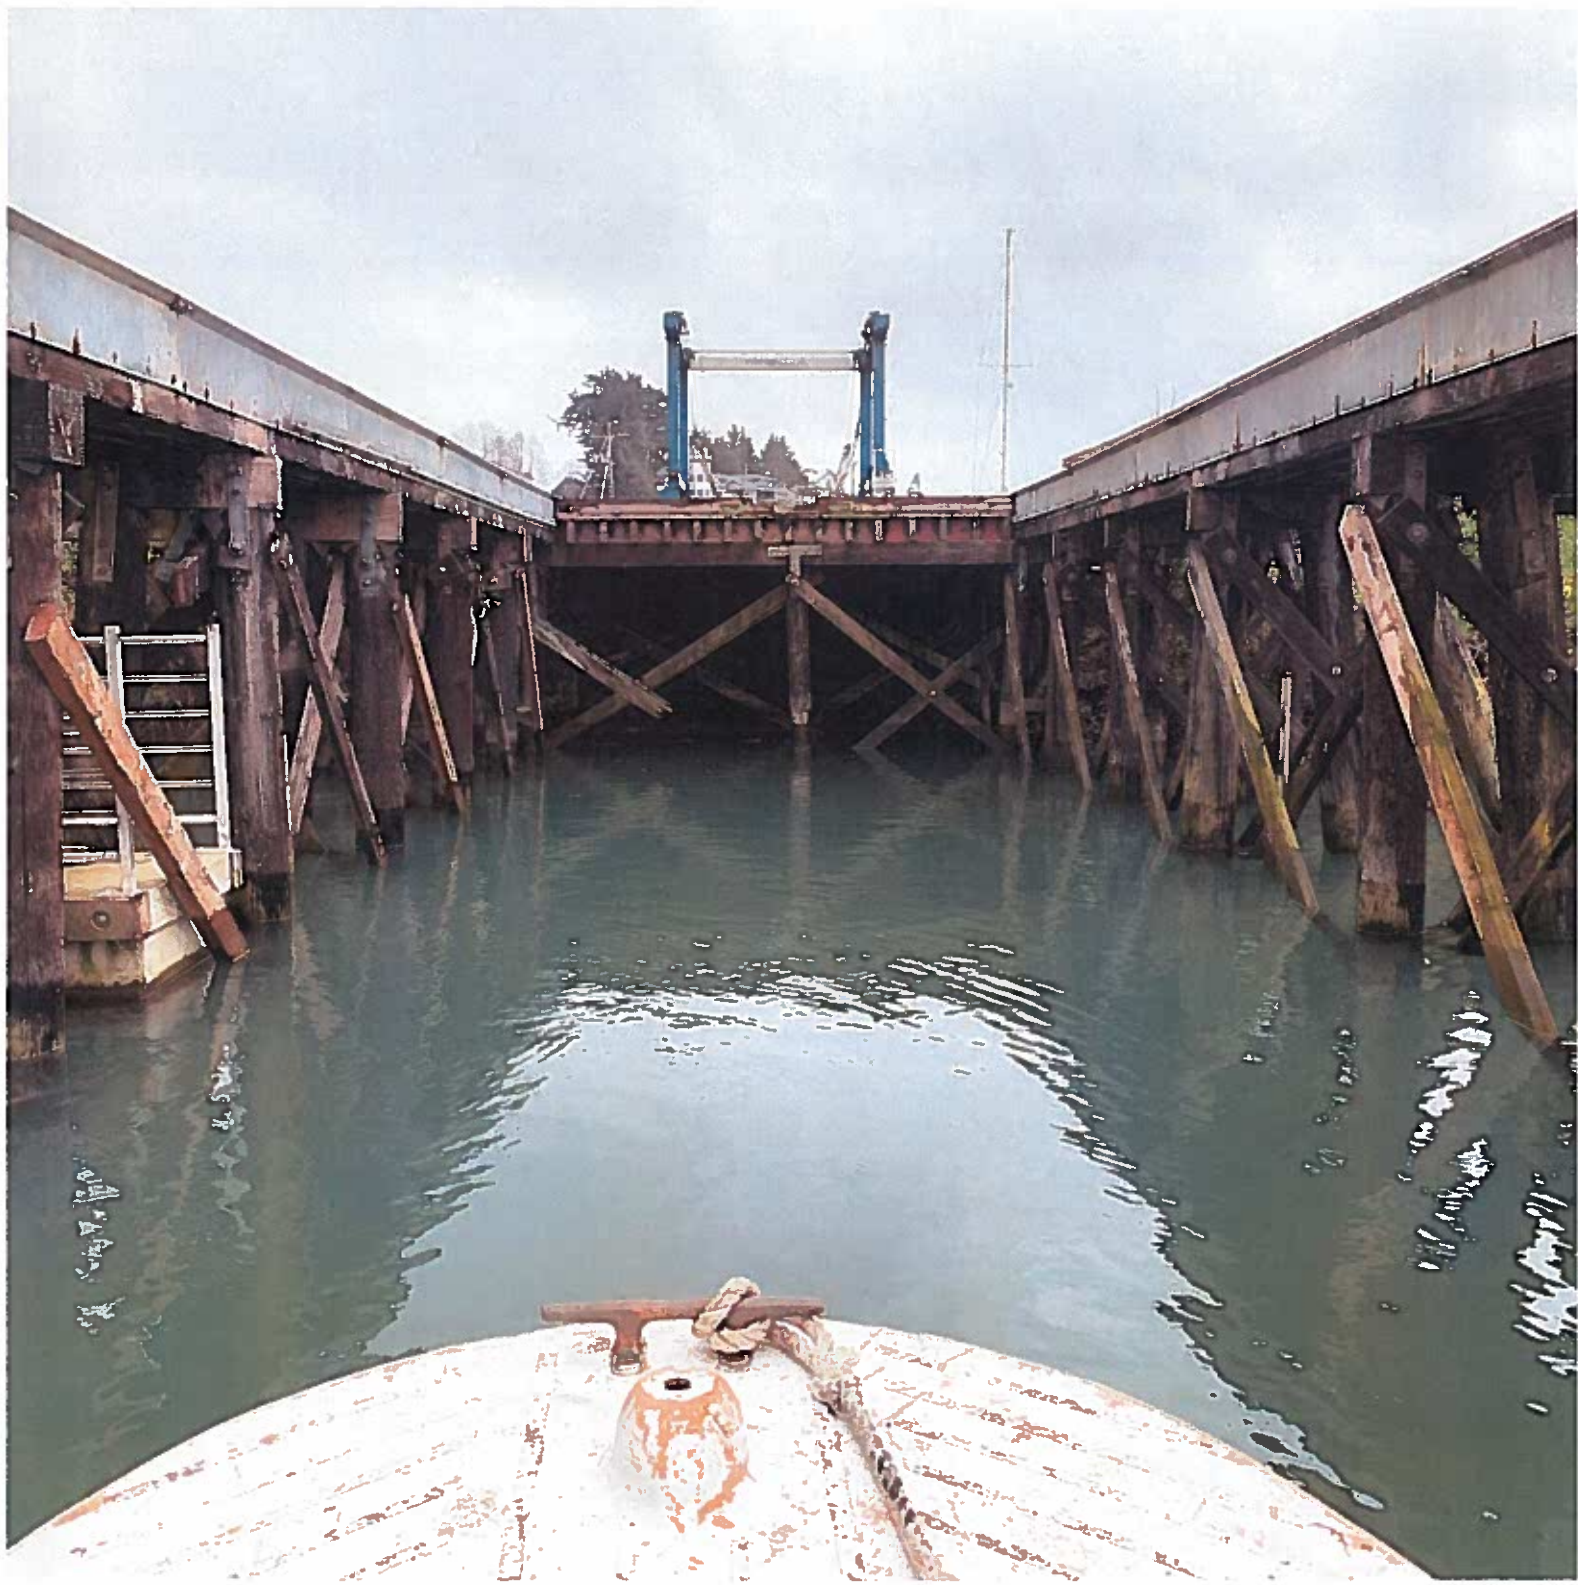
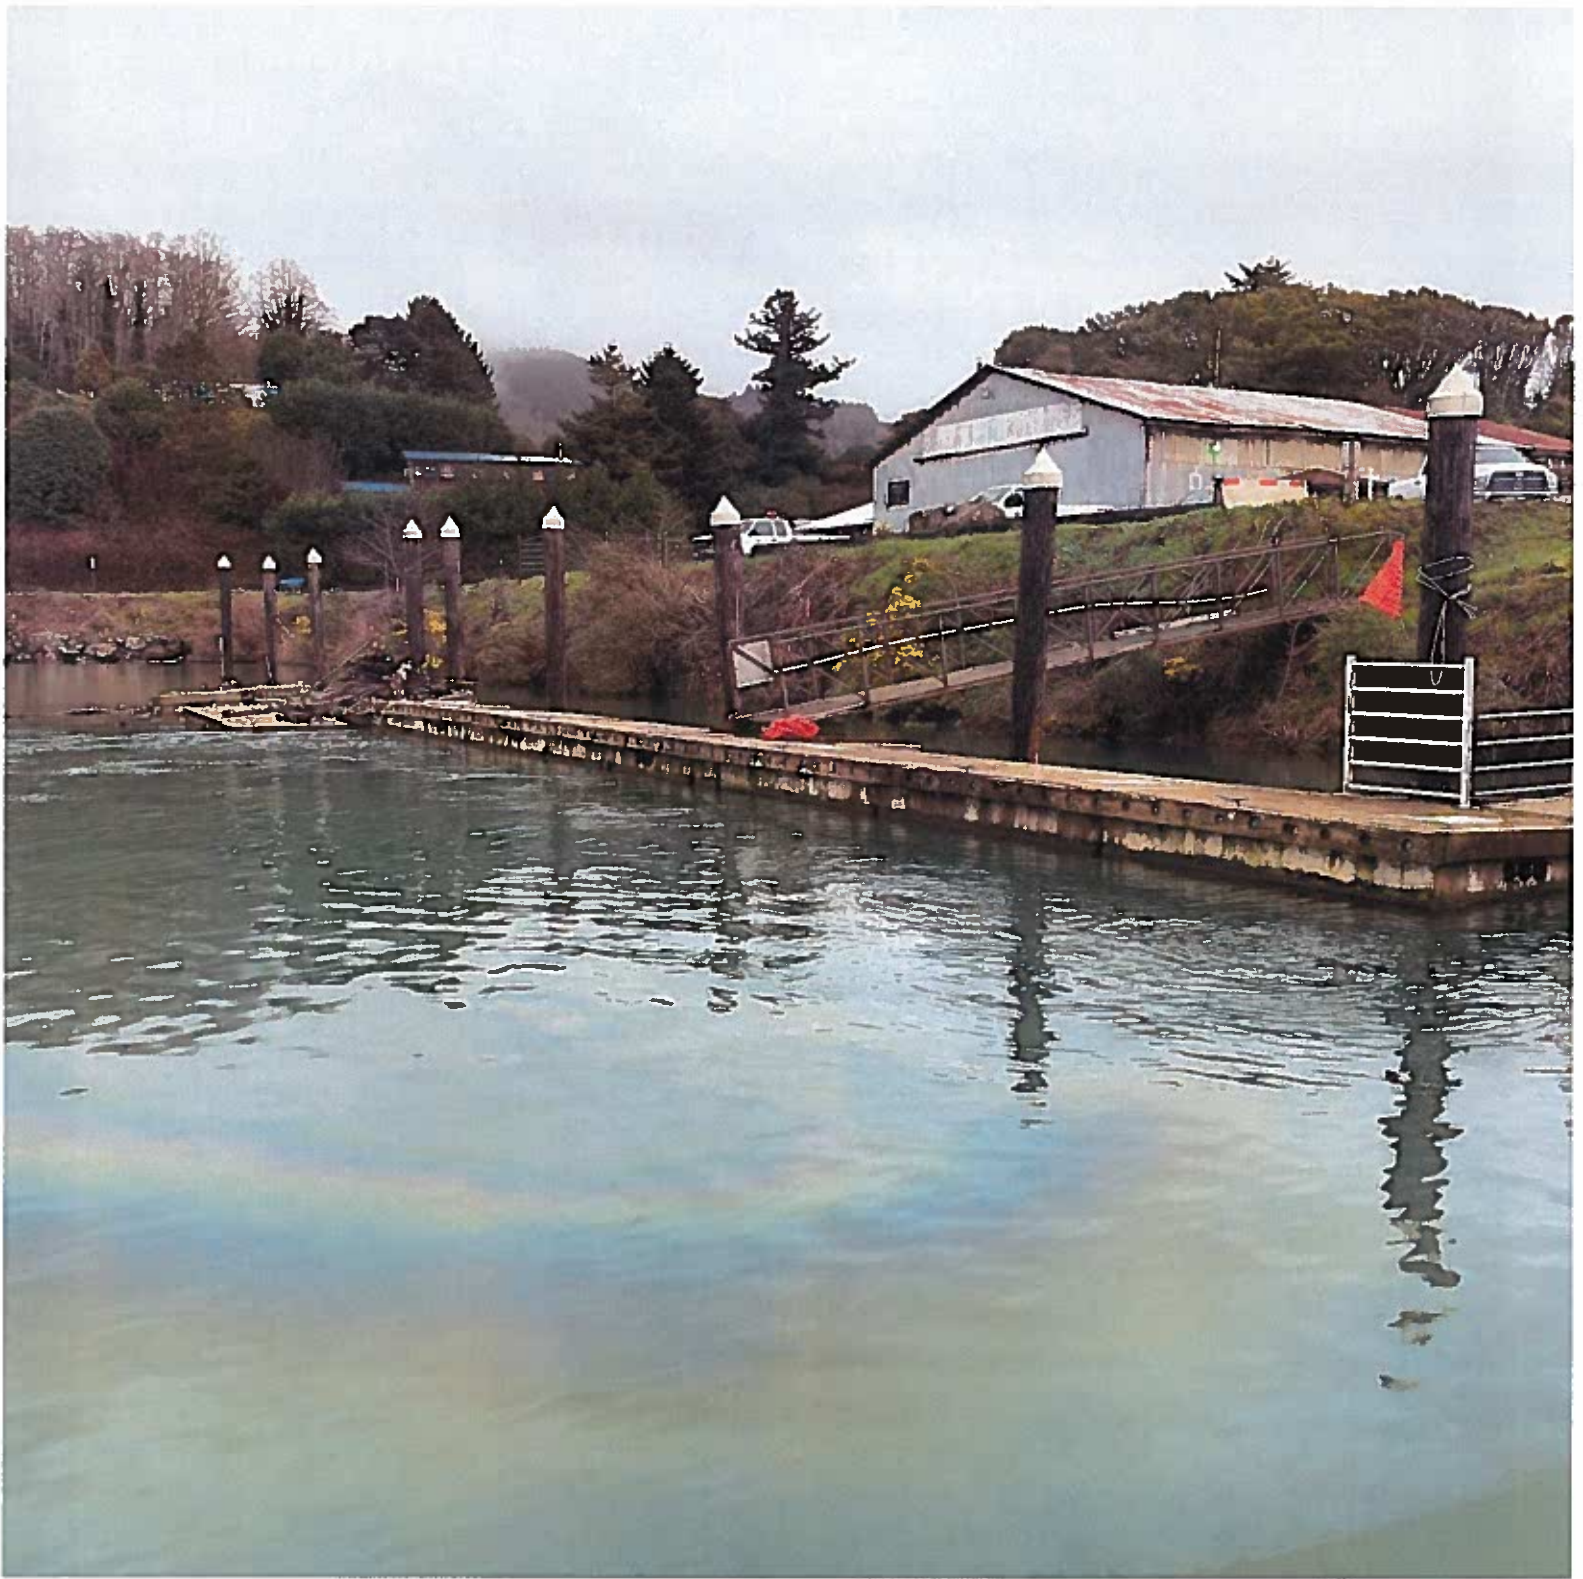
Issue #	CIP Rank	Description of Condition	Priority	Option 1	Estimated Cost	Option 2	Estimated Cost	Option 3	Estimated Cost	Funds Available Y/N
63		Replace Travel Lift Ramp and Work Dock		Rebuild ramp with piling and sheet pile method	750,000					No
Board meeting 02-26-2019 Decision

Option 1, travel lift ramp was built in mid-1970 with wood piles. Over the years the ramp capacity has been downgraded. Lifespan of this type of construction and increasing environmental restrictions to water quality, the ramp should be replaced as soon as possible.
