**PORT OF BROOKINGS HARBOR**  
**Board of Commissioners**  
**Special Meeting Agenda**  
Port Office  
16330 Lower Harbor Rd  
Brookings OR 97415

**DATE:** *January 5, 2018*  
**RE:** *Fuel Dock*  
**TO:** *Port of Brookings Harbor, Board of Commissioners*  
**ISSUED BY:** *Gary Dehlinger, Port Manager*

**MEMO-122917-01**

To: Gary Dehlinger  
Manager, Port of Brookings  
From: Jack Akin  
EMC-Engineers/Scientists, LLC  
RE: Landing to the Port Fuel Dock

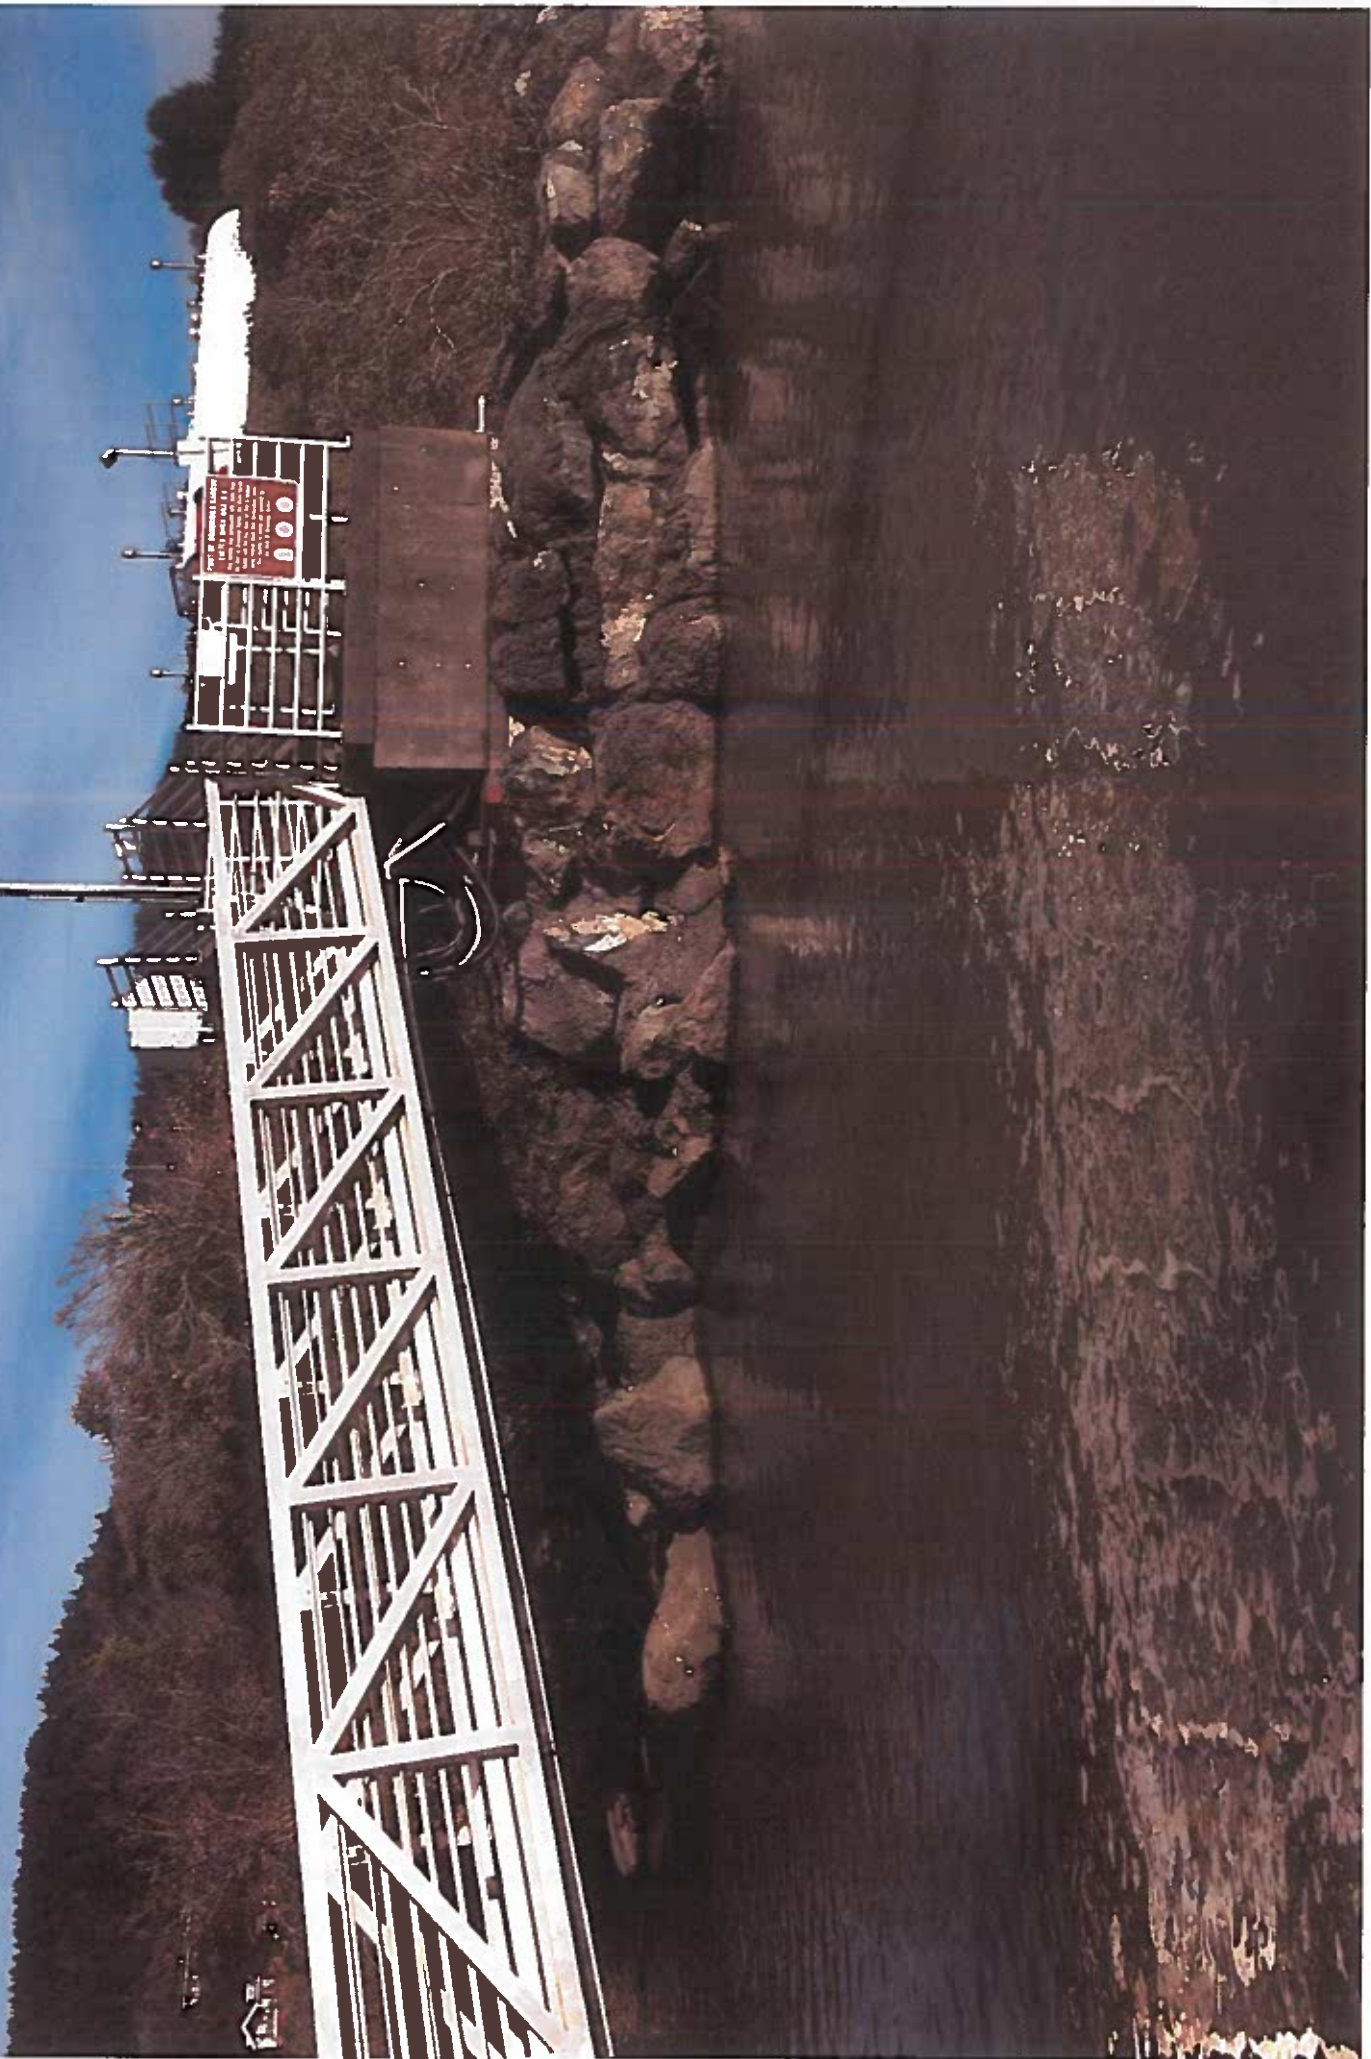
BEFORE

- Fuel dock was closed on Friday 12-22-17 due to failing aluminum ramp connection and continuing slope failure.
- Jack Akin/EMC was requested by me to inspect the slope and ramp connection and provide a report on 12-22-17.

On Tuesday, December 22, 2017, Jack Akin of EMC-Engineers/Scientists, LLC (EMC) discussed temporary (120 days) action at the concrete landing system that provides the access to the fuel dock. Expressed concerns (see **MEMO-11917** and **MEMO-122217-01**) bring forth the concern that the failure may sever fuel and other lines mid-point beyond break-away connections. Additionally, Port staff has expressed concern regarding the poor condition of the existing gangway hinge connection to the failing pad.

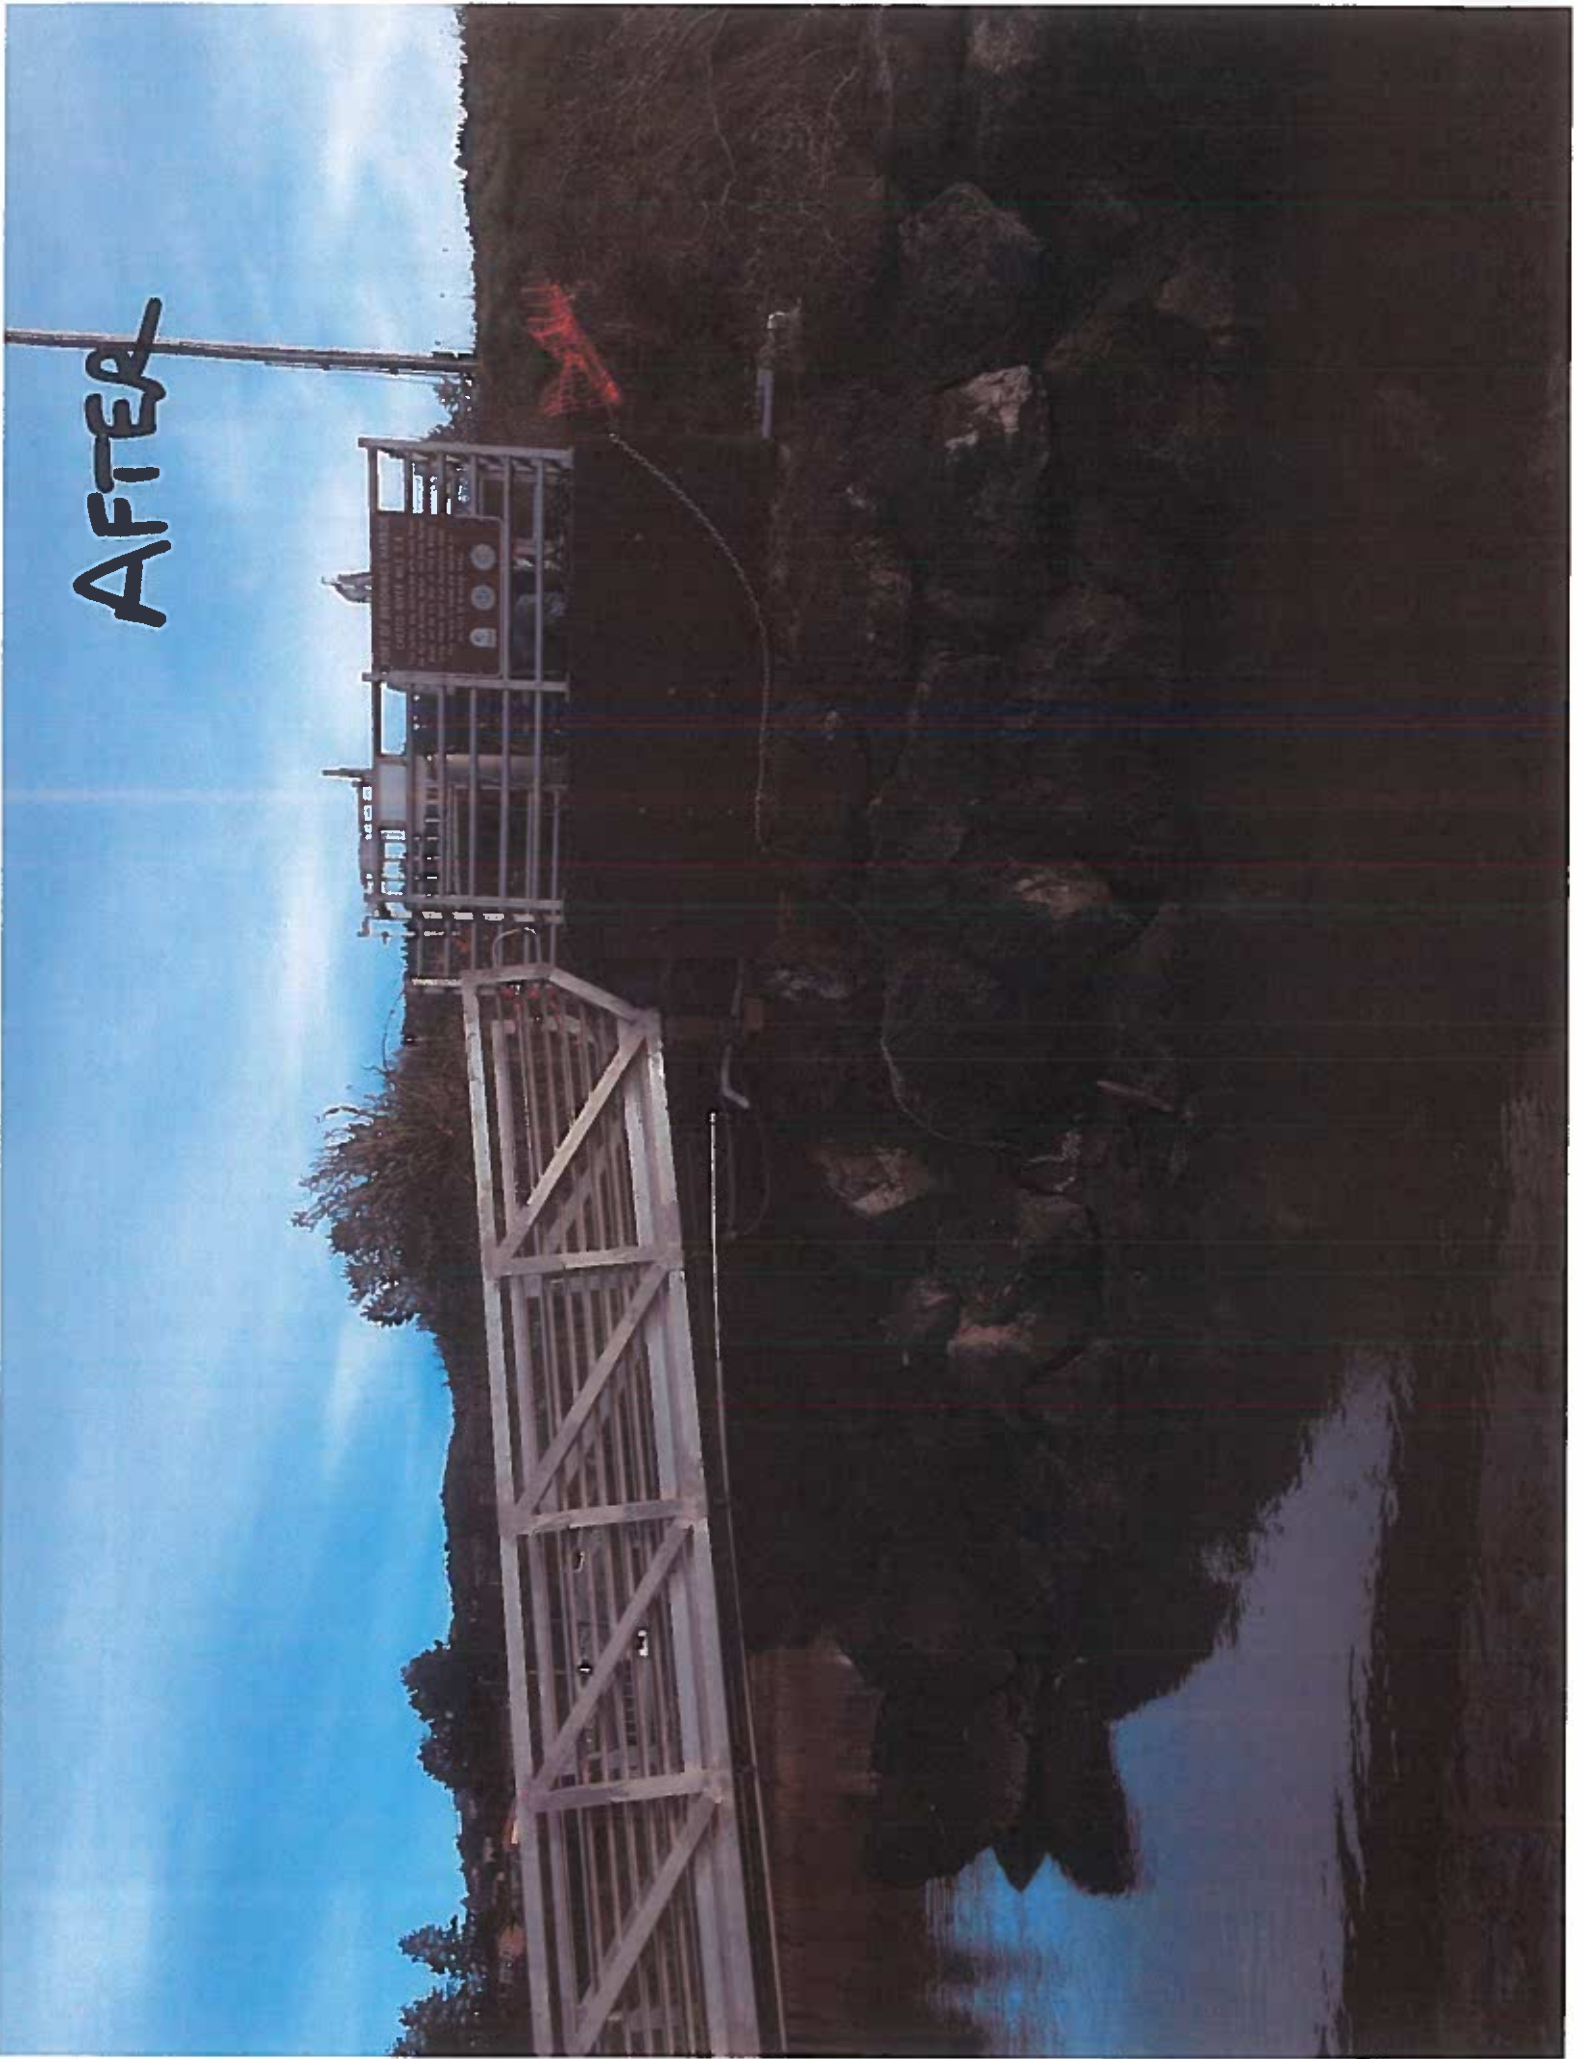
AFTER

- Carson Oil did not have a transfer tanker available for temporary use.
- Port decided to remove the aluminum ramp connection and reconnect it to lower portion of the failing structure to reopen the fuel dock for the commercial and sport vessels.

- Port requested vender John's Welding to perform the welding work on the relocated ramp. Staff assisted with the work and reopened the fuel dock on 12-30-17.

- Top and bottom of the ramp was barricaded off to prevent use of the ramp.
