PORT OF BROOKINGS HARBOR
Special Commission Meeting
Thursday, February 4, 2021 • 9:00am
Teleconference / Meeting Room *(limited capacity)*

ACTION ITEM – A

Discovery of Riprap Base

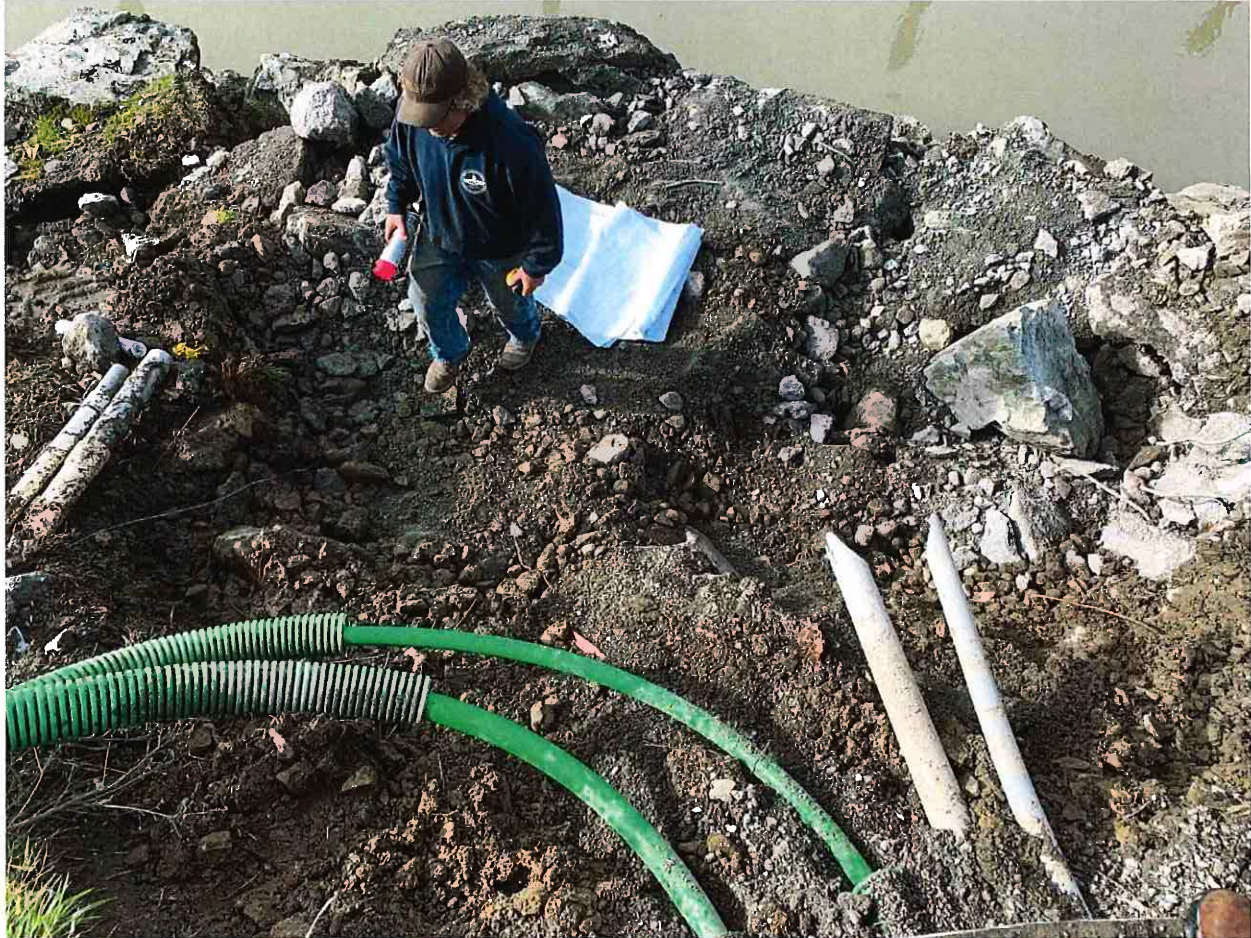
Existing Subgrade for Access Structure

Upon removal of the top plate, sidewalls and bottom plate of the concrete fuel dock access pad we found another, subsurface plate (as much a three feet thick in some places) beneath the bottom plate. That plate was pinned to riprap, which was discovered to underlay the entire pad. This may explain why those that constructed the pad some thirteen years ago had elected not to conform to the engineered drawings.

So now we know that the entire fuel dock access pad was placed on a riprap foundation. The design proposed for this project is prescribed on independent support from driven columns (H-Piles), to avoid the threat of “daylighting”, that is: the shifting of the embankment, primarily due to storm and groundwater pore pressure, combined with tidal scour.

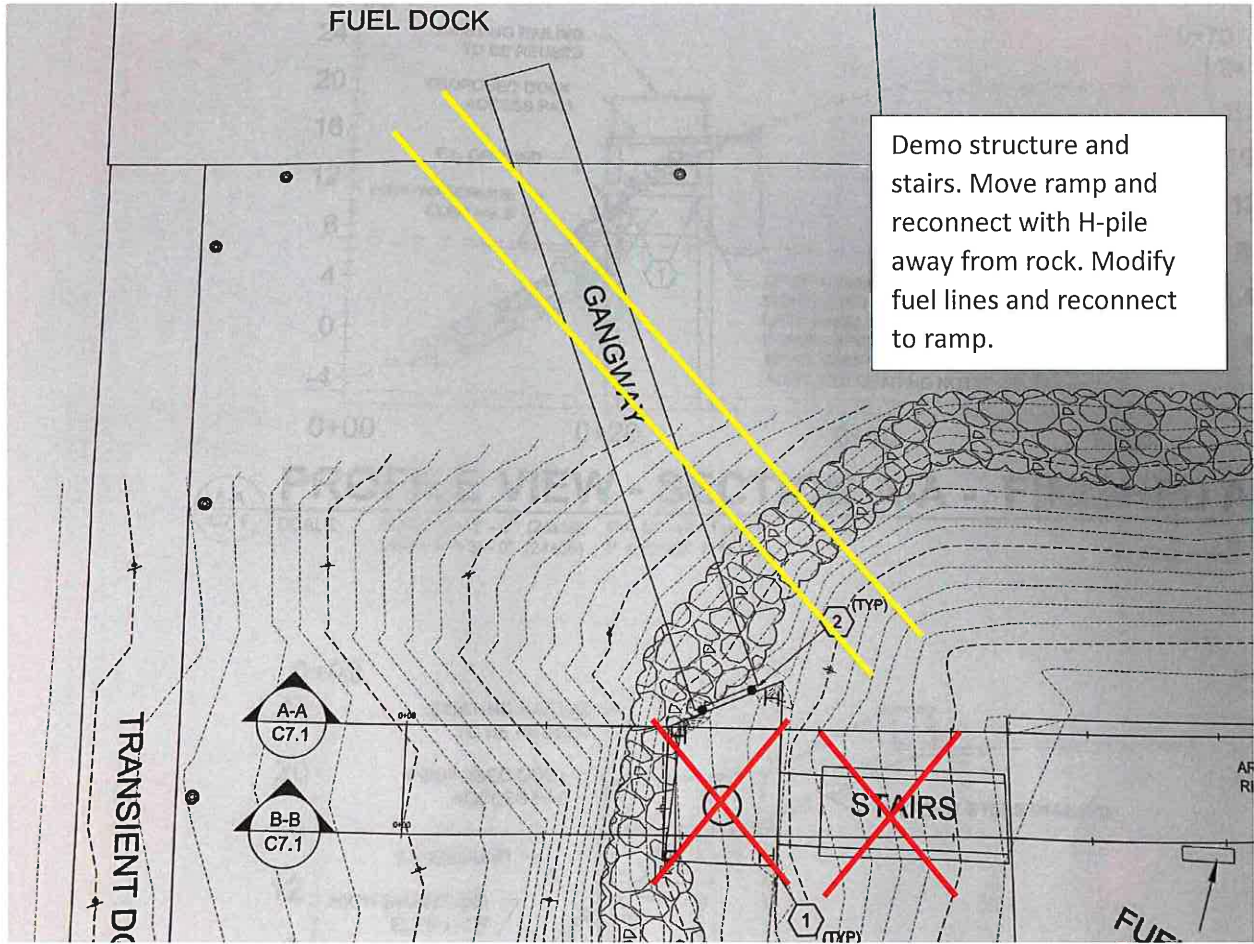
Proposed Change for Access to Fuel Dock

However, during discussions with Port Management, the question was posed as to whether an access pad was really necessary, since access to the fuel dock was the function of the pad, if another access route could be found. The primary advantage of the pad was to reduce the slope of the gangway (maximum at low tide).

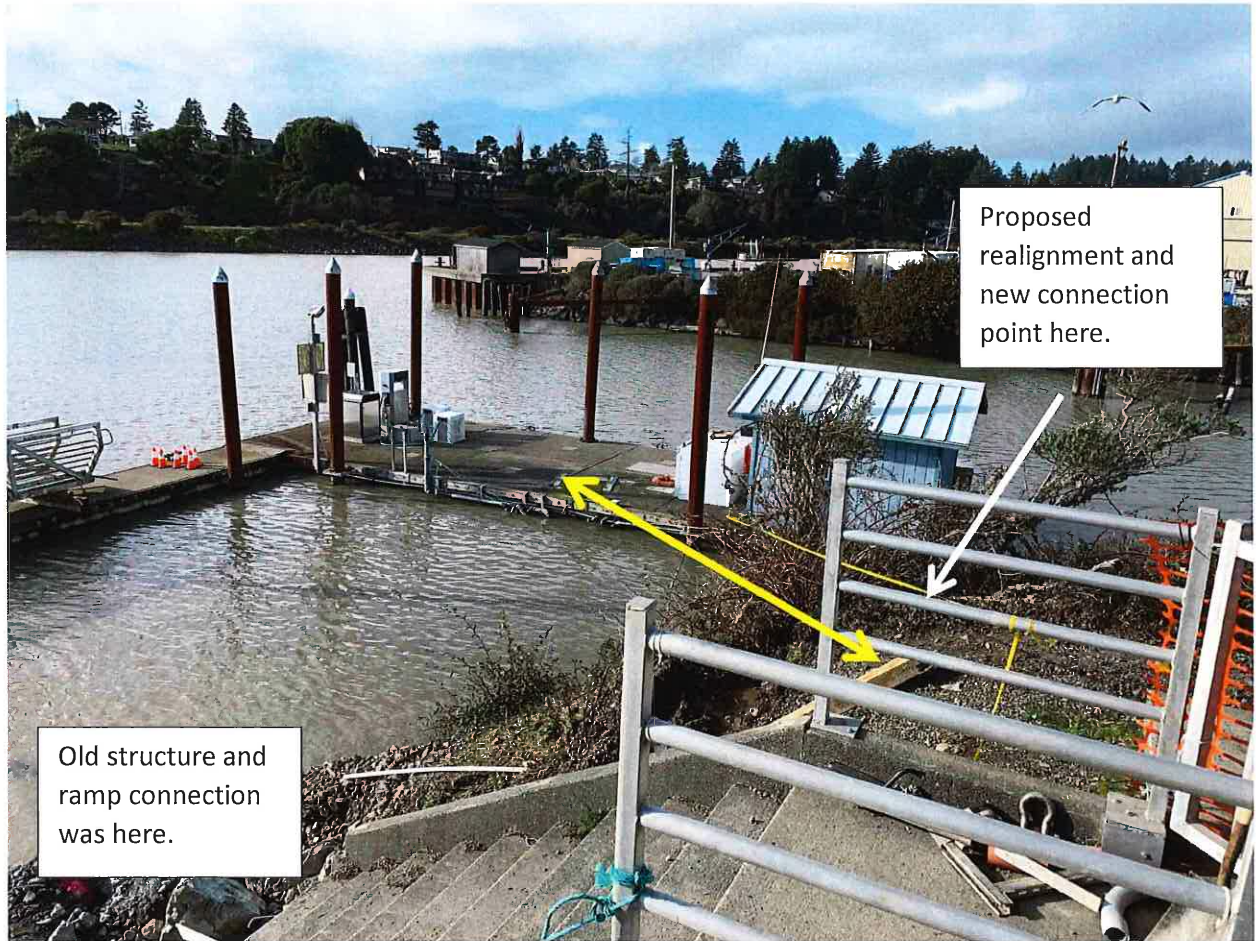
Proposed Change for Access to Fuel Dock

Old structure and ramp connection was here.

Proposed realignment and new connection point here.
